Performance of tall buildings in Viña del Mar in the 27 February 2010 offshore Maule, Chile earthquake[‡]

SUMMARY

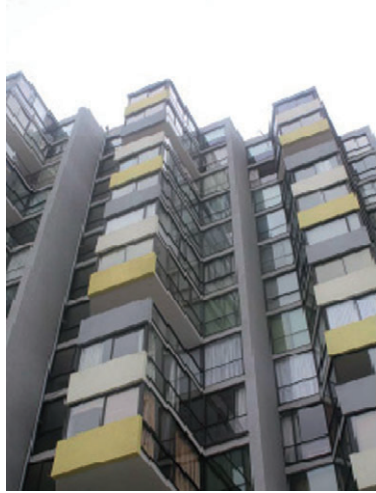
(a)

- Exterior portions of concrete walls experienced some minor damage

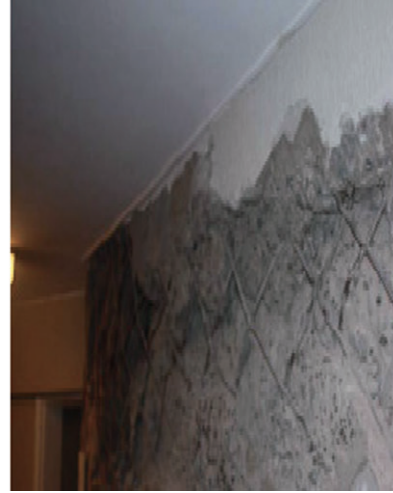
(b)

The Acapulco building at 821 Ave. San Martin, was designed to the 1965 Code and built in 1967 (Figure 6). The location is on the ocean side of Avenida San Martin about at 10 Norte and is the farthest away from the river. The 15-storey building with one basement has shear walls varying from 20, 25, 30, 45 and 60 cm (8 to 24 in.) in width. Interestingly, the shear reinforcing was oriented in a diagonal pattern (Figure 6). However, the end of wall vertical reinforcing was not confined with ties and cross ties (Figure 7).

- Diagonal shear reinforcing and extensive spalling (on both sides of the wall)

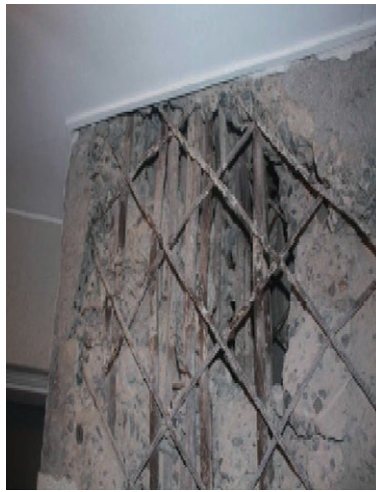
(a)

- Diagonal shear reinforcing outside of "end of wall" zone vertical reinforcing
- End of wall reinforcing not enclosed in ties

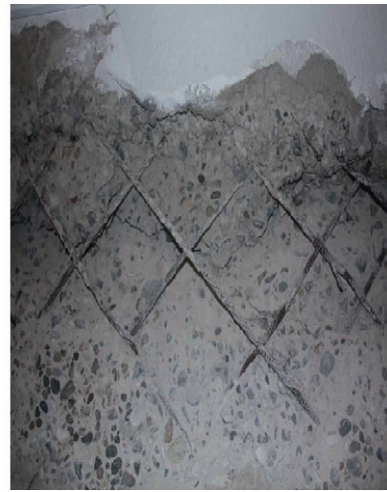
(b)

- Cross ties not apparent
- Wall has vertical load along full length
- Aggregate moderately large and rounded

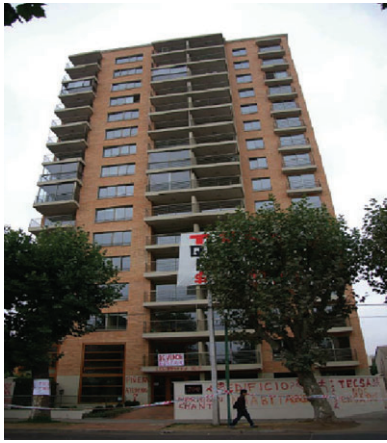
(a)

- Thin “brick” cladding mortar set

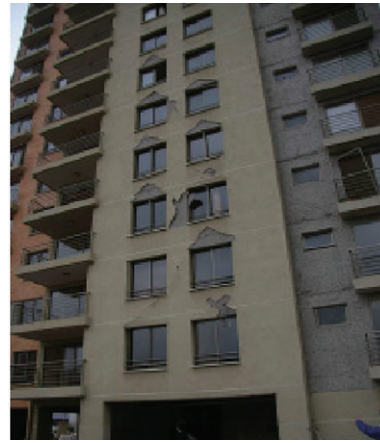
(b)

- East face with spandrel distress
- Lower right base of shear wall

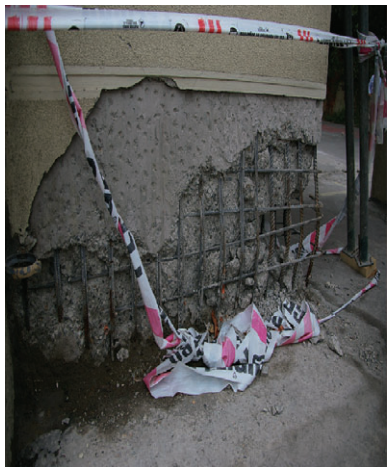
(a)

- Horizontal reinforcing is outside of vertical reinforcing at the end of the wall
- Horizontal reinforcing is inside of vertical reinforcing in the center portions of the shear wall.

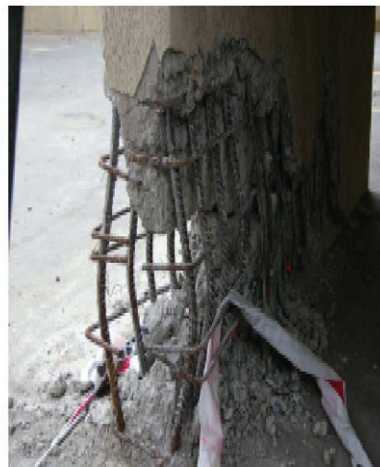
(b)

- Shear wall crushing failure
- Horizontal reinforcing 90-degree hooks
- End of wall zone ties and crossties not apparent

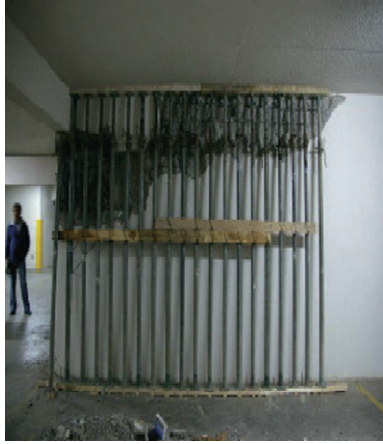
(a)

Antigona at 5 Oriente 260 was 16 storeys with 1 basement (Figure 8). The location is more inland and also three blocks from the river. The shear walls were constructed without ties and cross-ties. The vertical reinforcing at each end of the wall was located inside of the horizontal reinforcing, but the vertical reinforcing was outside of the horizontal reinforcing in the centre portion of the walls (Figure 9). The horizontal reinforcing was terminated at the ends of the wall with 90° hooks (Figures 10 and 11).

- Basement shear wall with severe crushing at end of wall

- (5) For buildings similar to Antígona, most of the supporting columns and walls are not heavily damaged. The heavily damaged walls are at the ground level and parking, which should accommodate some retrofit by thickening the concrete walls also.
- (6) For buildings similar to Acapulco with the diagonal reinforcing and lack of ties and cross-ties, the walls are probably thick enough to accommodate the loadings. To prepare for the next earthquake, the shear walls would need to be retrofitted with ties and cross-ties at least in the

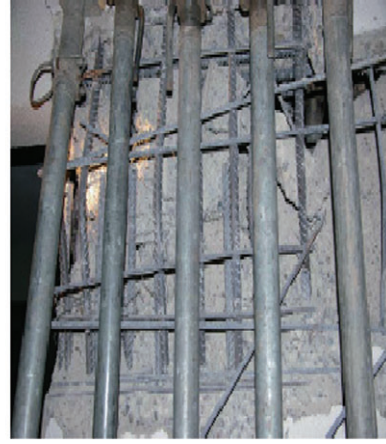
(b)

- Basement wall at end; some end of wall enclosing ties are apparent but widely spaced with 90-degree hooks
- Horizontal reinforcing not anchored inside end of wall zone and 90-degree hooks

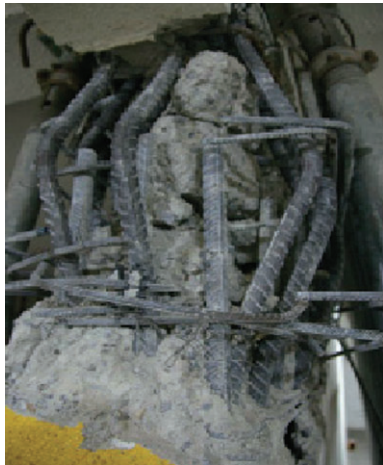
(a)

- End of wall with top of dowels
- Horizontal reinforcing with 90-degree hooks
- End of wall enclosing reinforcing with 90-degree hooks

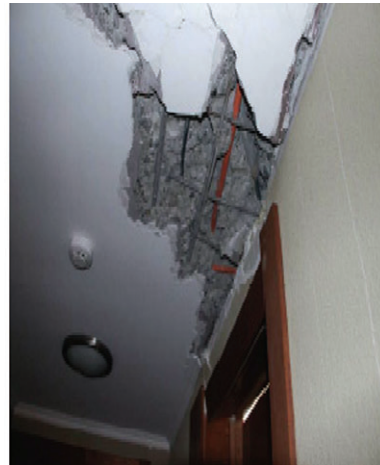
(b)

- Prevalent slab distress at “coupling” of walls over doorway openings
- Also slab flexural bending along wall face

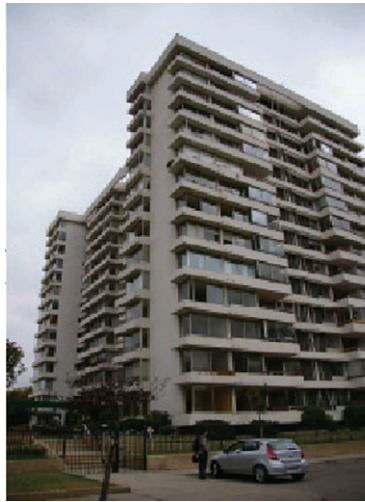
(a)

- I shaped footprint
- Longitudinal shear walls 10 cm added each side of 30 cm original thickness as remedial/repair after March 1985 earthquake

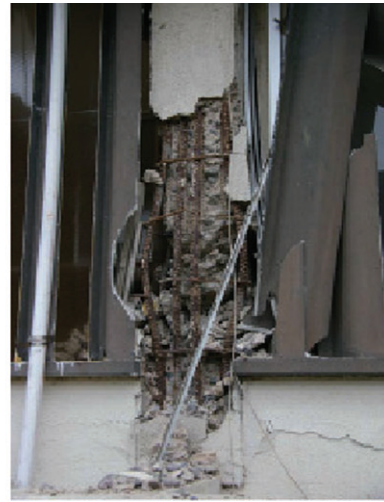
(b)

- End of wall failure at ground floor
- Horizontal reinforcing 90-degree hooks
- End of wall ties and cross-ties not apparent
- Short column due to adjacent spandrels.

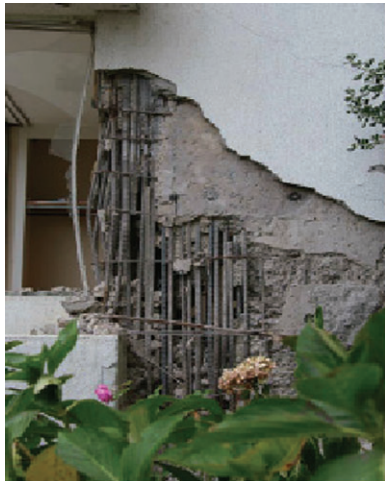
(a)

- End of shear wall reinforcing
- Wide spacing of ties
- Ties are horizontal shear reinforcing with 90-degree hooks

I-shaped in plan, with the long axis oriented north–south. The shear walls were constructed with 90° hooks on the horizontal reinforcing at the ends of the walls (Figure 13). Ties and cross-ties were not evident. The primary north–south corridor walls and some primary east–west walls were damaged (Figure 14). These primary walls were retrofitted after the 1985 earthquake by adding concrete on each face but this retrofit work was severely damaged and separated from the original walls (Figure 13).

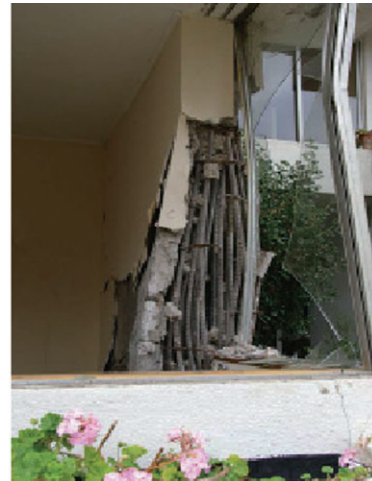
(b)

- End of shear wall
- Without ties at end of wall
- Horizontal shear reinforcing with 90-degree hooks

- (18) In one building (Festival), shear walls damaged in the 1985 earthquake were repaired with the addition of 100 mm layers of reinforced concrete on each face of the wall. The damage during the 2010 earthquake separated these retrofit layers from the initial wall. The retrofit layers did not appear to be tied through the original wall thickness in order to engage all three elements into one thicker wall. Apparently, roughening of the initial wall was the primary load transfer anticipated by the retrofit designer. Short dowels may have been incorporated to engage the retrofit layers to the walls. However, epoxy grouted reinforcing into unconfined concrete is not expected to be successful.

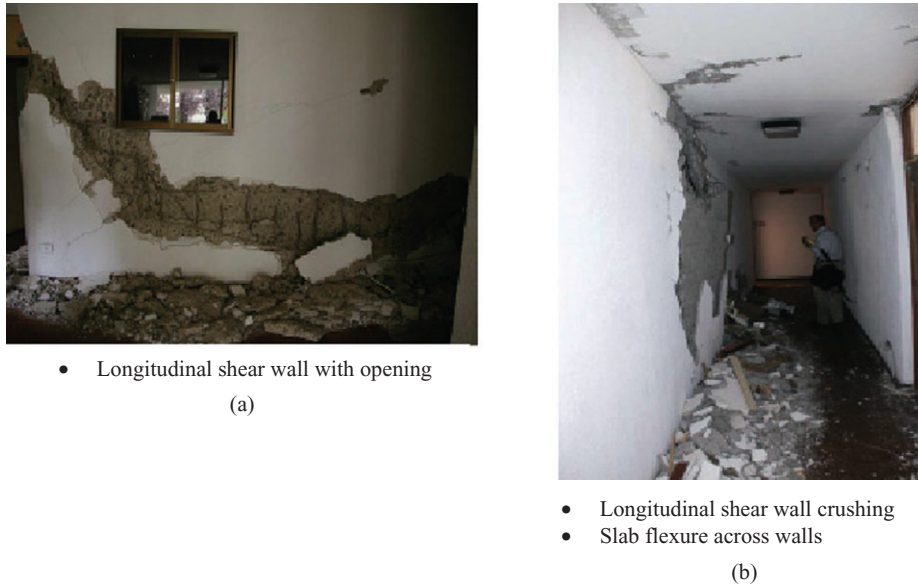
Figure 14. Festival building: (a) longitudinal shear wall (b) corridor longitudinal shear wall and slab flexure.

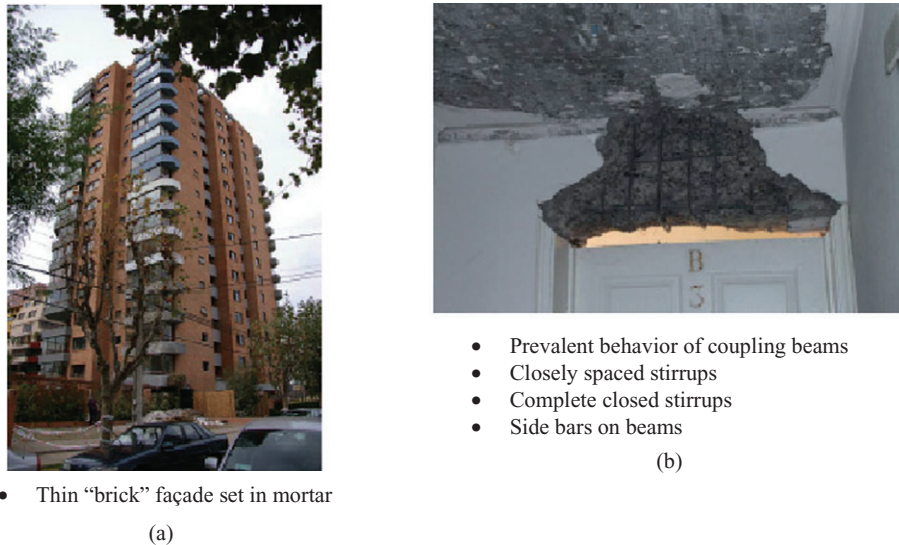
Figure 15. Rio Petrohue building: (a) exterior perspective (b) coupling beam over doorway.

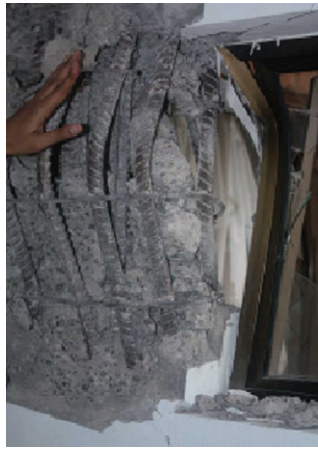
(a)

- Column ties wider spacing
- Cross ties not apparent

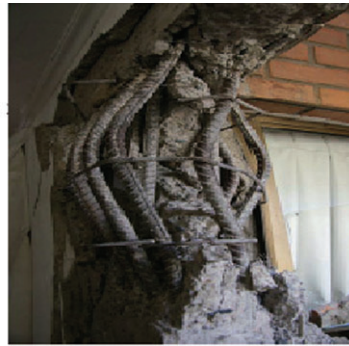
(b)

- End of shear wall crushing
- Some end of wall ties at wide spacing
- Horizontal shear reinforcing 90-degree hooks

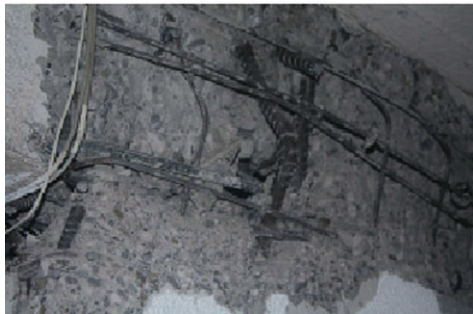
(a)

- Prevalent end of basement shear wall at gravity beam
- Fractured vertical reinforcing
- Shear wall reinforcing with 90-degree hooks
- Ties and crossties not apparent

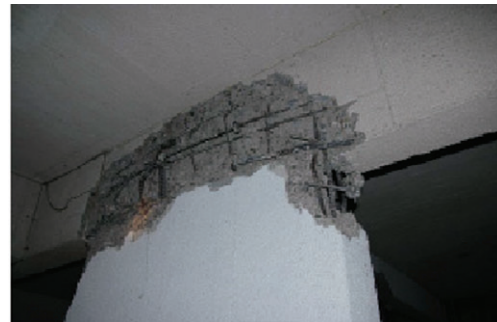
(b)

- Prevalent short shear wall in basement
- Crushing at both edges
- Shear wall horizontal reinforcing with 90-degree hooks
- Ties and crossties not apparent
- Crossties not apparent over the depth of the beam
- Beam reinforcing outside of wall "cage"

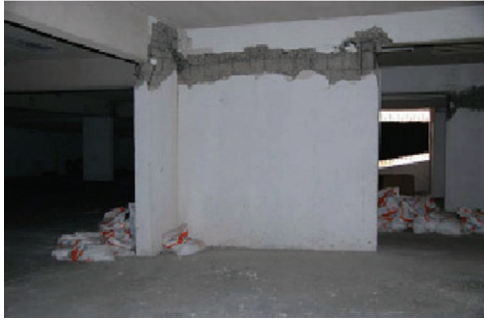
(a)

The Rio Petrohue Building at 7 Norte 585 is 17 storeys over 1 basement (Figure 15). The location is about six blocks from the river. The longitudinal axis is oriented east–west. Some ties were evident but alternated with horizontal reinforcing with 90° hooks (Figure 16). Interestingly, fracture of the vertical reinforcing was also observed in severely crushed areas at the ends of some walls (Figure 17). ‘T’ walls in the below grade basement/parking area indicated crushing across the flange and more severe crushing at the tip of the stem (Figure 18).

- Prevalent basement shear wall with T at end
- Crushing at T end and gravity beam
- Shear wall horizontal reinforcing with 90-degree hooks
- Ties and cross-ties not apparent.

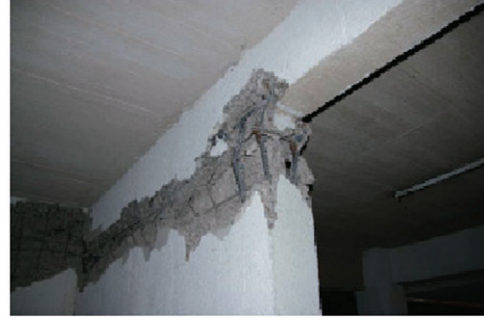
(b)

- End of basement shear wall at narrow end (opposite end with T)

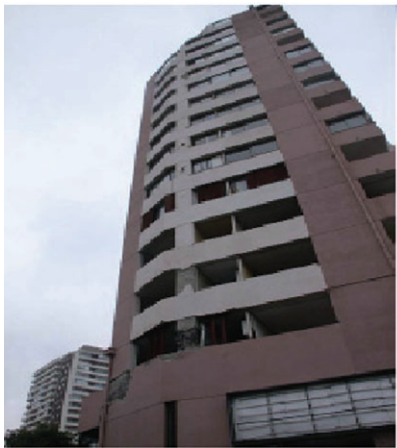
(a)

- Change of structure at Level 3

- (3) For buildings like Torre del Mar that have a transition irregularity with the damage relatively localized at the transition and at the offsets at the stair, the repairs and retrofit can be made. Again, the investigation would determine how far up the building the retrofit aspects are appropriate.
- (4) For buildings like Rio Petrohue, the significant damage is located at the base and parking areas. These areas could accommodate thickening and encasement to improve the characteristics of

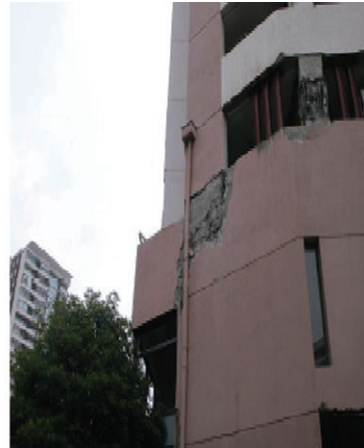
(b)

- Damage at transfer of short upper wall transfer to wider lower wall.
- Column damage also present at some locations

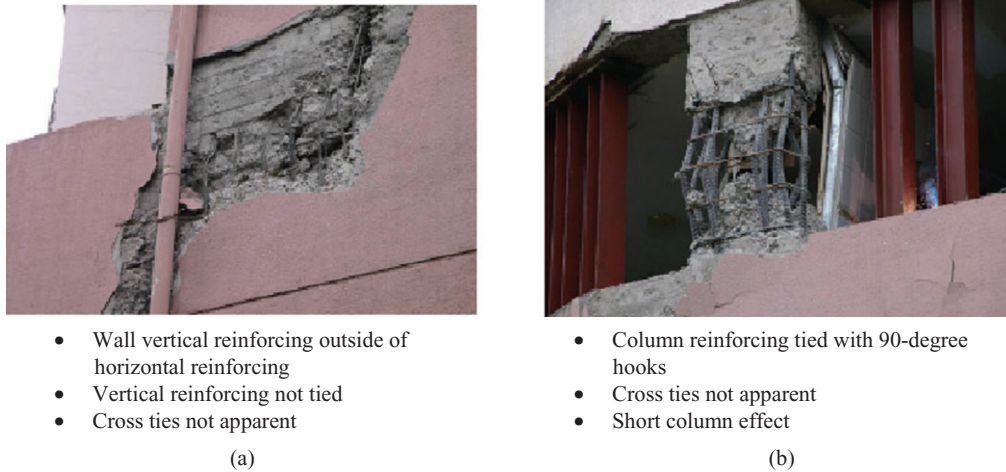
Figure 20. Torre Del Mar building: (a) wall transfer (b) column at transfer.

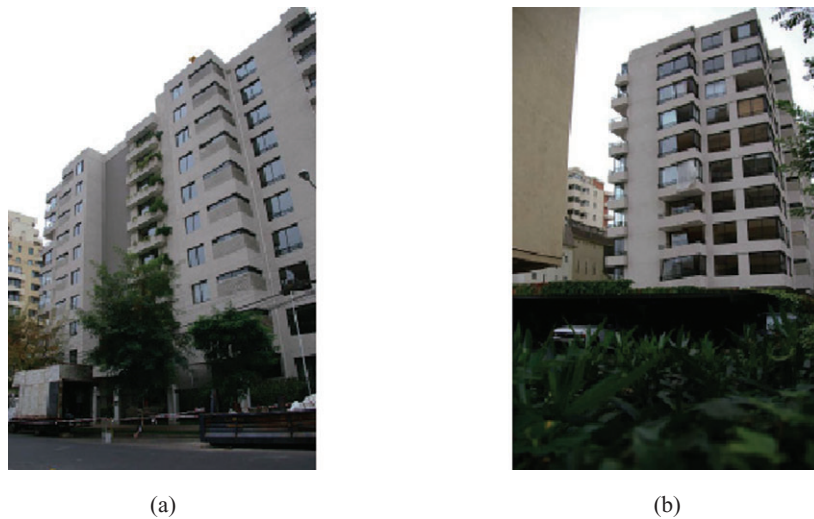
Figure 21. Toledo building: (a) exterior perspective (b) transverse shear wall at end of building.

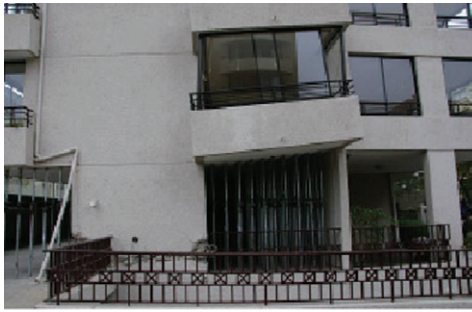
(a)

The Toledo Building at 3 Norte 487 is 10 storeys over 1 basement (Figure 21). The location is about two blocks from the river. Severe crushing of shorter (north–south) walls (about 30 cm vertical shortening) caused very significant distortions (Figures 22 and 27)[§]. The ends of walls were neither tied nor cross-tied. The horizontal reinforcing was outside of all vertical reinforcing and was 90-degree hooked at ends of the walls (Figures 23, 24, 25, and 26). The longer (north–south) walls exhibited some spalling and tension cracking near the south ends (Figure 24)[§].

- Crushing damage at short shear wall at end of building
- Crushing across the full length of the wall of about 30 cm
- Upper shear wall longer than Ground story and Basement walls
- Significant distortion of floor level

- (1) Repair and retrofit may be extensive but possible at high costs for heavily damaged buildings with most shear wall damage localized at one storey[§] such as in the Toledo Building. The feasibility is based on minor damage in the front portion with long transverse and longitudinal shear walls. The primary issue is lifting the back portion or deconstructing the back portion and reconstructing.
- (2) For buildings like Festival, the retrofit could again consider the addition of shear wall thickness with the appropriate ties and cross-ties in order to extend the life of the project. The investiga-

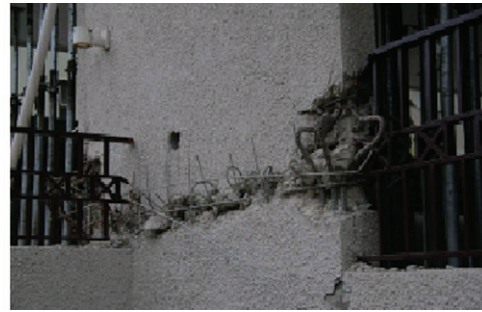
(b)

- Crushing damage
- Typical wall vertical reinforcing completely free of the wall

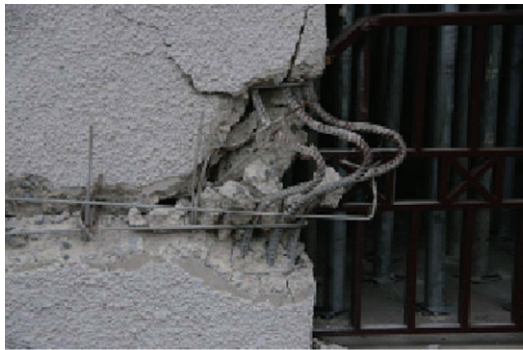
(a)

- Crushing and shortening of shear wall
- Horizontal wall reinforcing 90-degree hooks
- End of wall ties around end of wall vertical reinforcing not apparent
- Crossties not apparent.

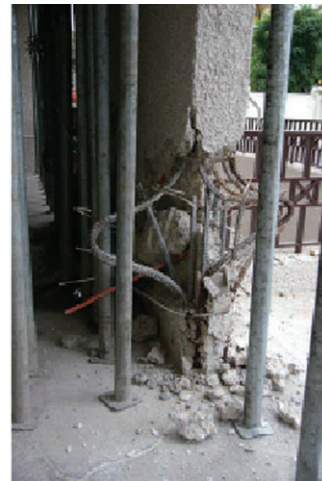
(b)

- Opposite end of crushed and shortened shear wall
- Horizontal wall reinforcing 90-degree hooks
- End of wall ties around end of wall vertical reinforcing not apparent
- Crossties not apparent.

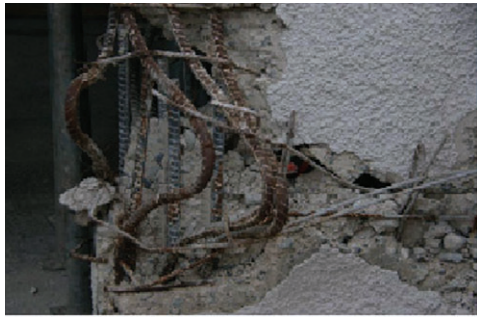
(a)

- Opposite end of crushed and shortened shear wall
- Horizontal reinforcing 90-degree hooks
- End of wall ties around vertical reinforcing not apparent
- Crossties not apparent

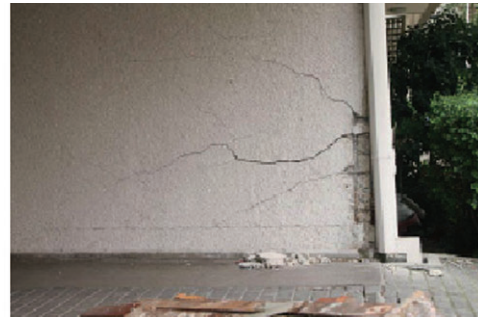
(b)

- Tension cracking on street side ends of typical “interior” transverse shear walls

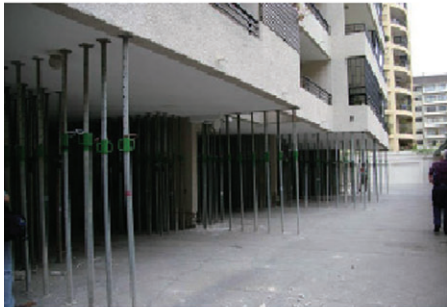
(a)

- Cantilevered portions of floors and walls beyond the ends of the transverse shear walls at first story (and end shear walls)

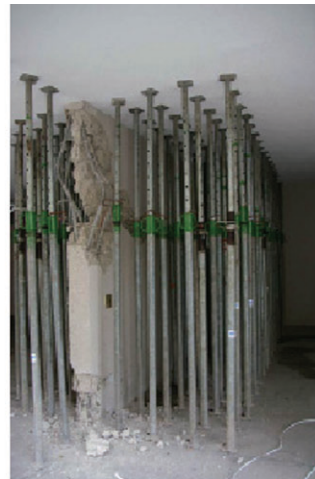
(b)

- Prevalent crushing at end of “interior” transverse shear walls
- Crushing at both top and bottom of the wall

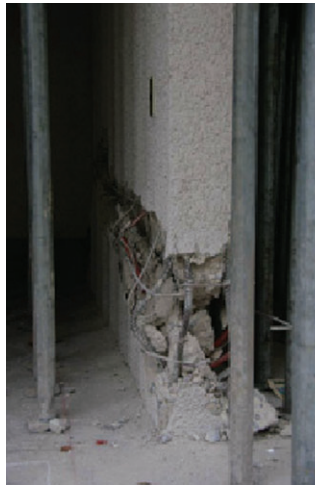
(a)

- Prevalent crushing at the base of the transverse shear wall at the ground floor
- Horizontal reinforcing 90-degree hooks
- End of wall zones ties not apparent
- Crossties not apparent

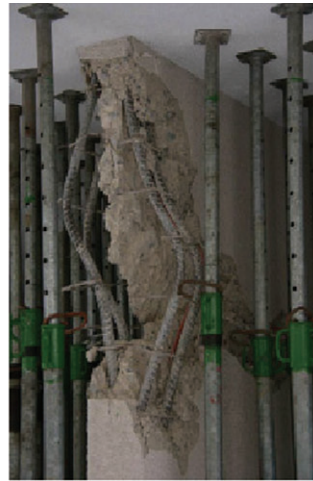
(b)

- Prevalent crushing at the top of the transverse shear wall
- Horizontal reinforcing 90-degree hooks
- End of wall zones ties not apparent

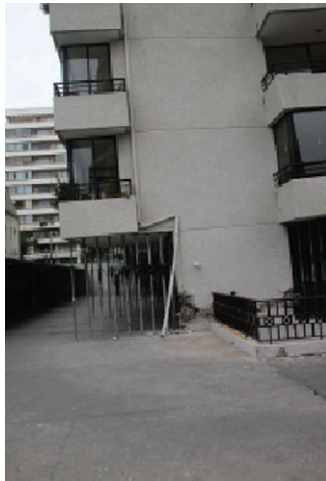
- Cantilevered back portion of floors
- Set back of upper shear wall at the Ground Floor story effectively shortened the length of the shear wall
- This shear wall crushed and shortened about 30 cm at the base of the wall at the Ground Floor
- Other shear walls along the complete backside of the building had severe crushing
- But the building did not collapse!!!

Figure 27. Toledo building: cantilevered floors and set back of shear wall at the ends of the building and corresponding interior shear walls.
