## Catastrophic, rainfall-induced debris flows in Andean villages of Tarapacá, Atacama Desert, northern Chile

**Keywords** Debris flows · Landslides · Atacama · Altiplano

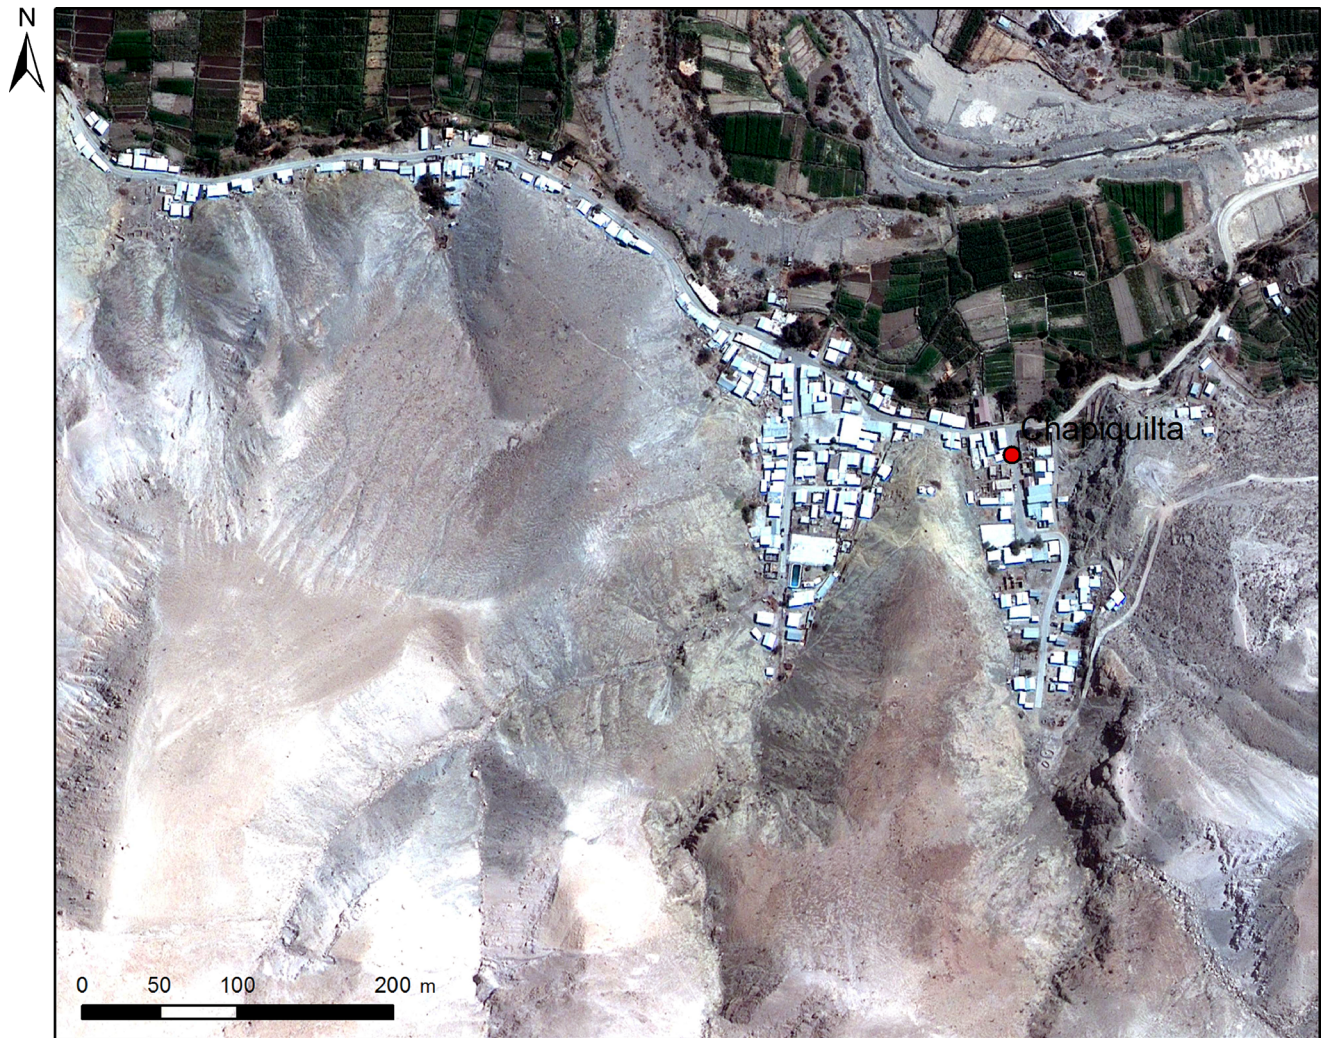
**Fig. 2** Example of settlements on top of alluvial fans, village of Chapiquilta, Camiña Valley. In this case most of the village is built on two fans, leaving farming land on fluvial terraces free for subsistence agriculture. Location in Fig. 1 (Image source: Google Earth)

The Chapiquilta village (Fig. 1), placed on top of two alluvial fans (Fig. 2) was probably the most destroyed settlement due to this climatic event. Eighty four houses, streets and even the village school were completely destroyed or badly damaged by debris flows of heights up to 3 m according to splash marks (Fig. 4). The gullies are about 700-m long and incised in rock until reaching the alluvial fan. The deposit reaches up to 2 m of thickness, spreading on most of the fans until reaching the Camiña valley fluvial terraces at the fan toes. Deposited material is sandy and gravelly, with blocks up to about 1.2 m (IDIEM 2013; Fig. 4).

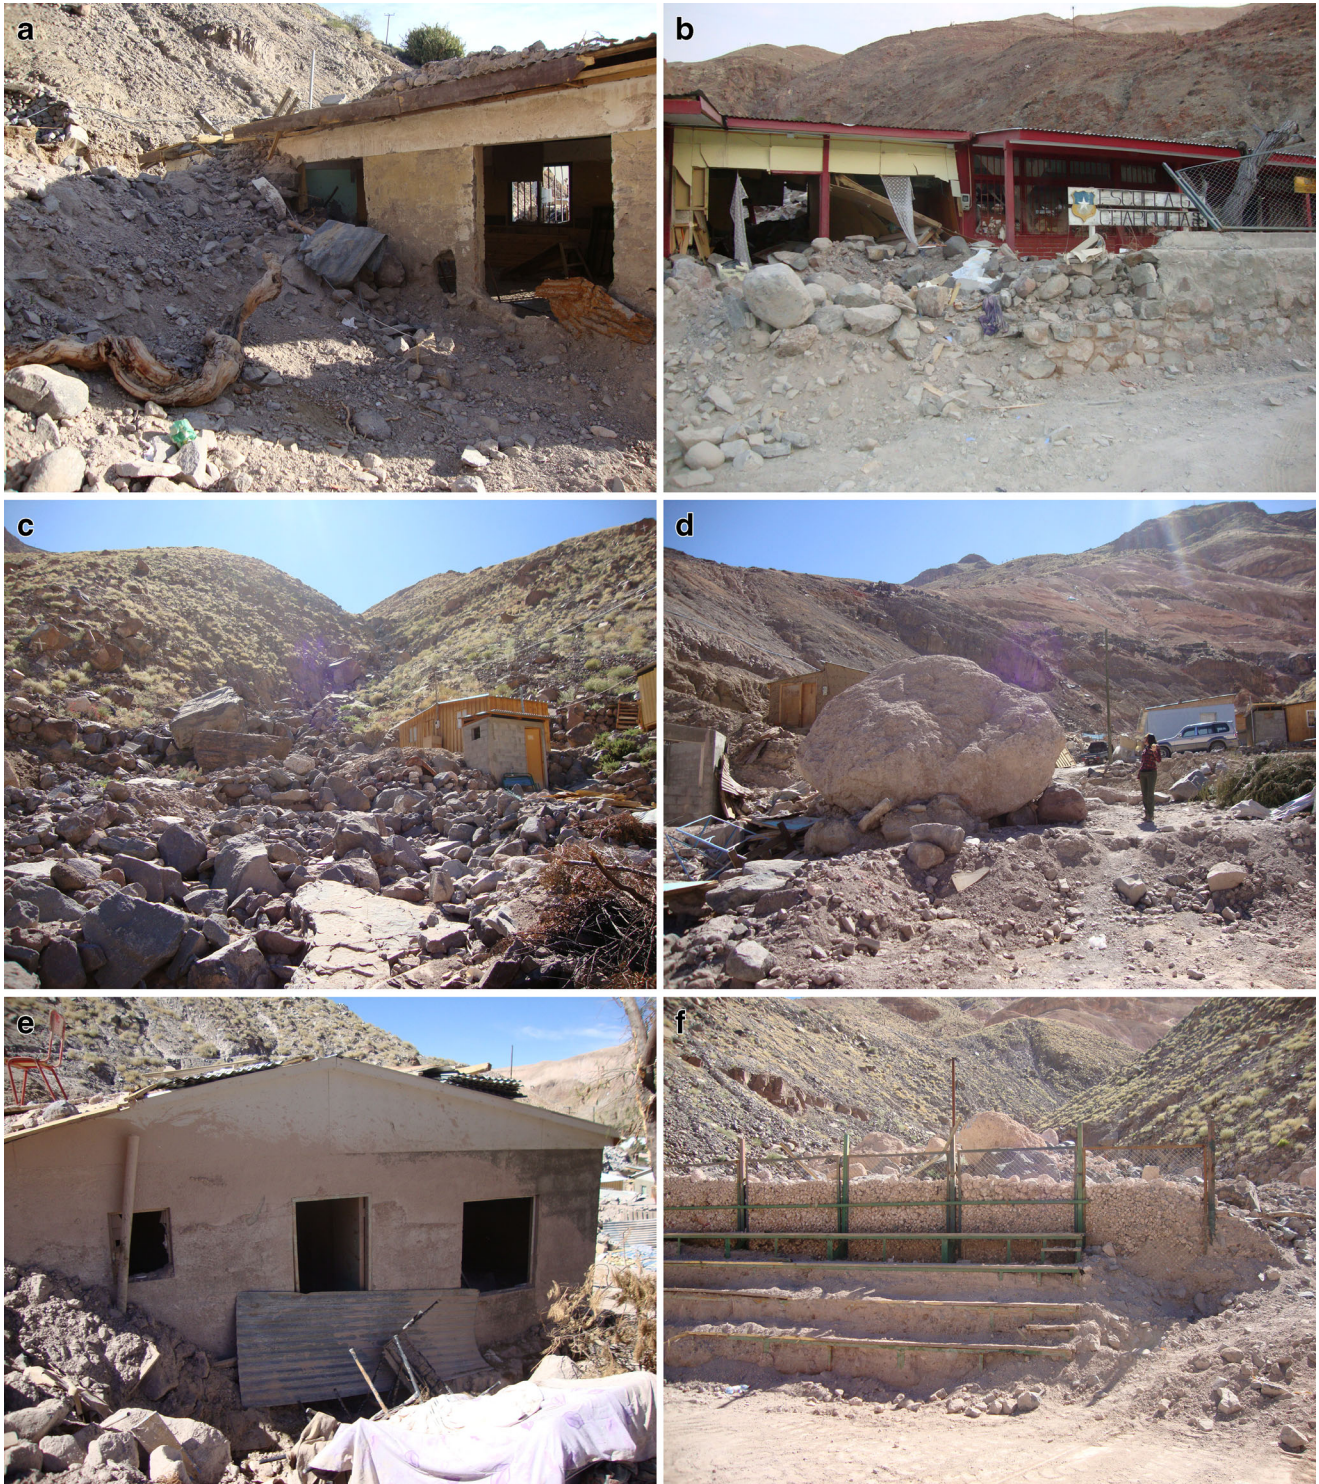
The village of Yala Yala (Fig. 1), downstream Apamilca, was severely affected by a debris flow that directly impacted main village installations such as the adobe church and the surgery, as well as several solid masonry houses, built on an alluvial fan (Fig. 4). The flow reached about 3-m high in the fan apex. Granulometry tests returned that 20 % correspond to blocks over 35 cm, while about 40 % are fragments over 75 mm (IDIEM 2013). As observed in other places, the flows quickly stopped at the end

**Fig. 4** Debris flows in Camiña valley. **a** Debris flow impact on the first upstream house in Yala Yala. Note the flow deposits on the roof; **b** damage by a large flow in Chapiquilta school; **c** Blocky flow deposit in Camiña town; **d** large block over 2 m in diameter in Camiña, the largest found in the urban area; **e** mud splash marks in the same location of the block of (d), height of about 2.5 m. The flow deposit inside the house is 0.5 thick; **f** sports field already cleaned and wire fence in the back that helped to retain the coarse part of a debris flow in the apex of an alluvial fan in the town of Camiña. Location on Fig. 1

The valley main town of Camiña (Fig. 1) located on the northern side of the valley has its downtown built on top of a fluvial terrace, while residential areas are spread on part of the terrace and the rest on four alluvial fans, all of which presented debris flows. The flow material is originated in the volcanic rock valley scarps and in loosen blocks of a large landslide that fall into the gullies and are entrained by the flows. The deposits (Fig. 4) are composed of centimetric to decimetric rock blocks, with a few blocks larger than 1 m, even over 2 m (Fig. 4) and a gravel and sand matrix of variable proportion, as shown by field observations and granulometric tests from test pits (Fig. 5). The depth of alluvial materials from this and older flows in the distal part of the fan reaches 13.5 m according to a borehole (IDIEM 2013). Several houses were destroyed or damaged, and the narrow streets parallel to the fan axis served as a channel for the flow and were eroded, which was observed in several villages. Splash marks in house walls show that flows reached up to 2.5 m in height (Fig. 4).

One interesting feature already observed in Yala Yala and also present in one of the Camiña alluvial fans is the combined effect of small sports field that acts as a slope break that helps to reduce the velocity of the flows and the presence of wire fences that trap most of the coarse sediment (Fig. 4). In Camiña, a large part of the

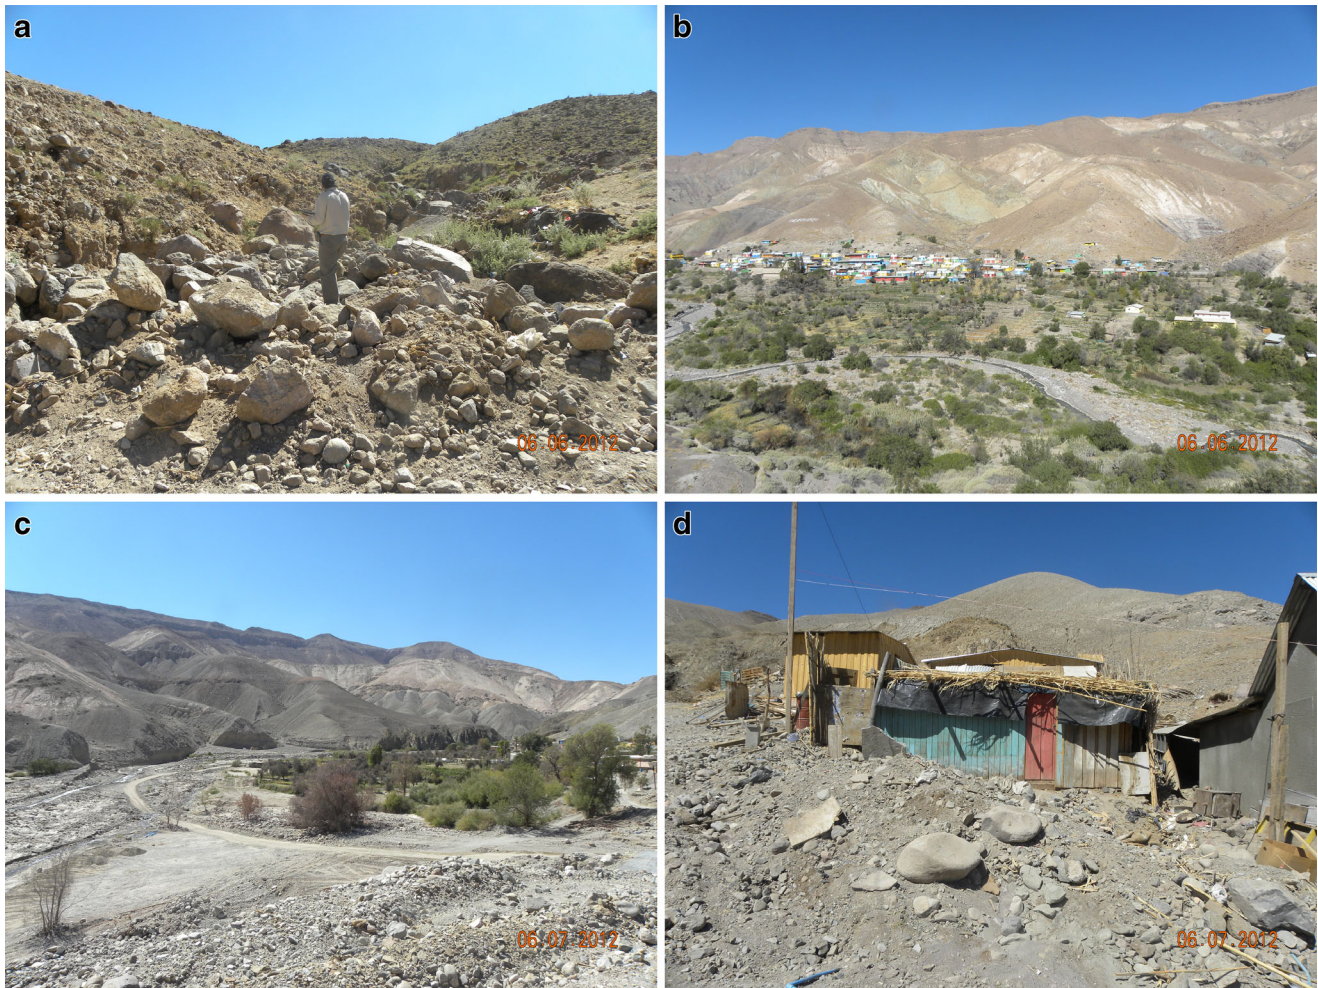
The village of Limacsiña (Fig. 1) is located on top of a megalandslide deposit. Small gullies dissect the slide mass, three of which drain on the town sides before reaching fluvial terraces of the main stream. Coarse-grained material of blocks up to 1 m<sup>3</sup> in a gravelly sandy matrix was remobilized by the flows (Fig. 6). A couple of houses and the access road were damaged by the flows. Deeper and longer are the gullies that drain the southern valley slope draining into the village of Huaviña (Fig. 6). In the western

**Fig. 6** Debris flows in Tarapacá valley. **a** Coarse-grained deposits in Limacsña; **b** panoramic view to the south of Huaviña village; **c** Alluvial plain in Laonzana with signs of flooding erosion and in the foreground debris flow deposits coming from a lateral gully; **d** Damaged houses in the easternmost gully of Laonzana. Location on Fig. 1

The most severely damaged village in the Tarapacá valley was Laonzana (Fig. 1). Four gullies of different size produced debris flows that caused destruction. A small catchment in the centre of the village, similar to the one described in Yala Yala, produced a flow that destroyed a community centre and damaged several houses. Two large gullies on the west cut the access road and destroyed a few houses before converging and producing a large fan, with blocks up to 0.8 m<sup>3</sup>, deposited on the fluvial terrace, which in turn was eroded by the flood coming from upstream in the main valley (Fig. 6). The easternmost gully, a narrow canyon incised in volcanic rocks, produced a finer-grained flow that filled several houses with sandy material (Fig. 6), before running through a street down to the fluvial terrace.

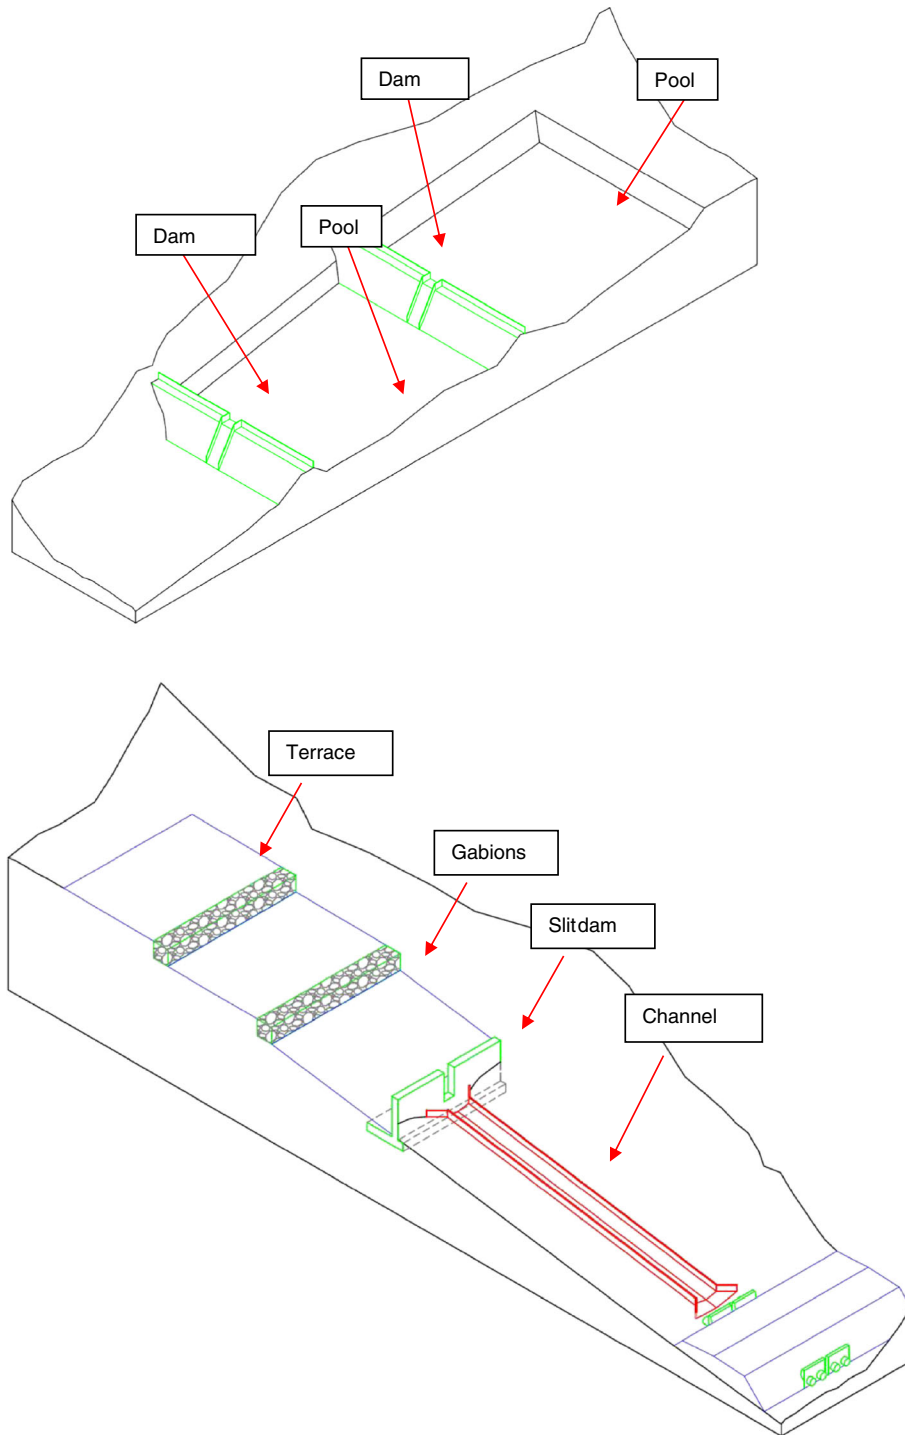
**Fig. 7** Examples of conceptual design of some mitigation measures to be applied in areas affected by the 2012 debris flows (IDIEM 2013)

Having that in mind, the best option to mitigate future catastrophes, which frequency may be even enhanced by global warming, seems to be construction of mitigation structures for debris flow control, along with a proper redesign of the villages. As it was observed, the streets along or parallel to the alluvial fan axes are quite effective to channelize the flows reducing the impact on houses, but they must have a special design to avoid being destroyed and eroded by the flows as it happened this time. Other useful observation is the role of flattened surfaces at the fan apex, which may be used for recreation, that have a positive effect in reducing the coarse sediment load and the flow velocity. Detention of gravel and small blocks by normal wire fences indicate that these types of elements are also useful. Based on those observations, the size of gullies and the hydraulic models of discharge and sediment loads, IDIEM (2013) proposed conceptual engineering solutions that combine elements such as artificial terraces, fences, slit dams, gabions, retaining pools and channels would reduce the level of hazard in the villages (Fig. 7 and 8). These mitigation measures must not only be applied in steep and long lateral gullies, but also in short gullies from small area catchments such as those observed in Yala Yala and Laonzana. Design criteria for these structures are flow grain size and volumetric concentration reduction, energy reduction and channelization (IDIEM 2013). All these measures should be applied along with an urban planning that accounts for this type of hazard, including restrictions in high hazard areas, avoid increases in population density and proper building materials. Finally, design of road gully crossings must be revised to avoid lack of connectivity during and after rainfall events.

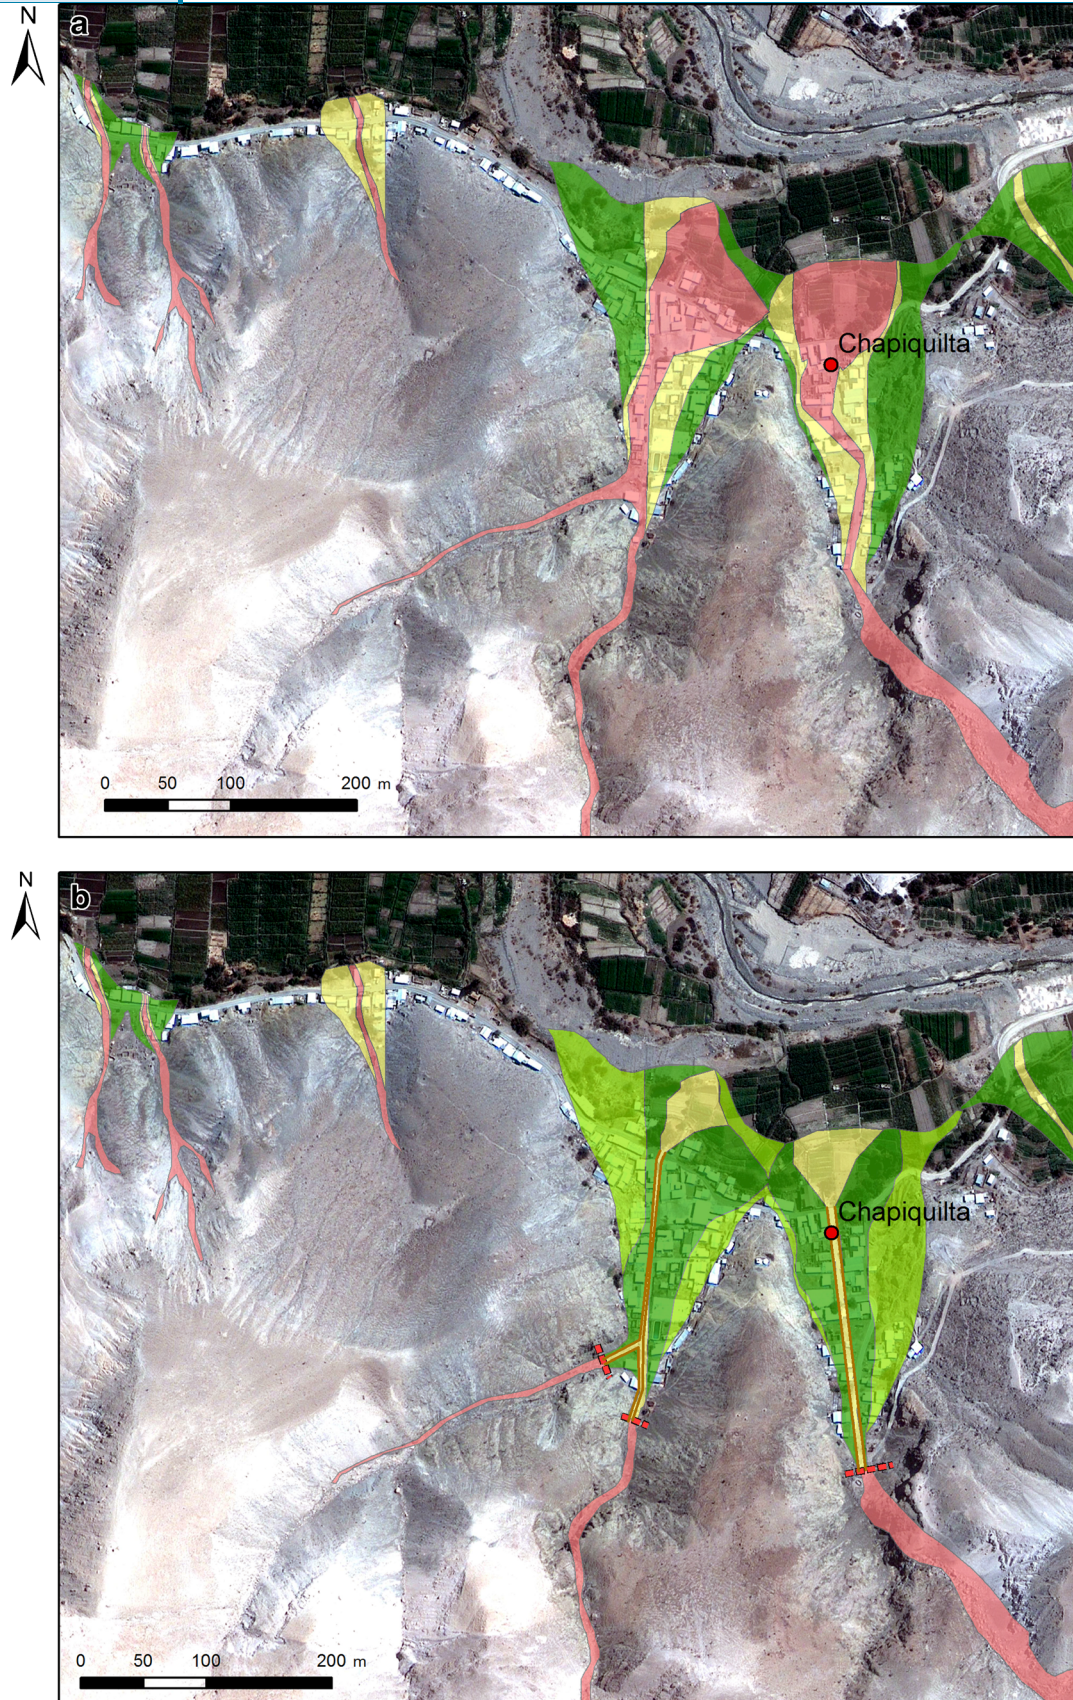
**Fig. 8** Example of debris flows hazard maps without (a) and with structural mitigation measures (b) in the two main gullies in Chapiquilta village. Hazard levels indicated as follows: high (red), medium (yellow), low (dark green) and very low (light green). High hazard degree is based on <100-year return period events. In this case, proposed mitigations solutions are terraces and slit dams in fan apexes and channelized streets (modified after IDIEM 2013)
