The 2014 Earthquake in Iquique, Chile: Comparison between Local Soil Conditions and Observed Damage in the Cities of Iquique and Alto Hospicio

In this study, we present comparisons between the local soil conditions and the observed damage for the 1 April 2014 Iquique earthquake. Four cases in which site effects may have played a predominant role are analyzed: (1) the ZOFRI area, with damage in numerous structures; (2) the port of Iquique, in which one pier suffered large displacements; (3) the Dunas I building complex, where soil-structure interaction may have caused important structural damage; and (4) the city of Alto Hospicio, disturbed by the effects of saline soils. Geophysical characterization of the soils was in agreement with the observed damage in the first three cases, while in Alto Hospicio the earthquake damage cannot be directly related to geophysical characterization. [DOI: 10.1193/111014EQS188M]

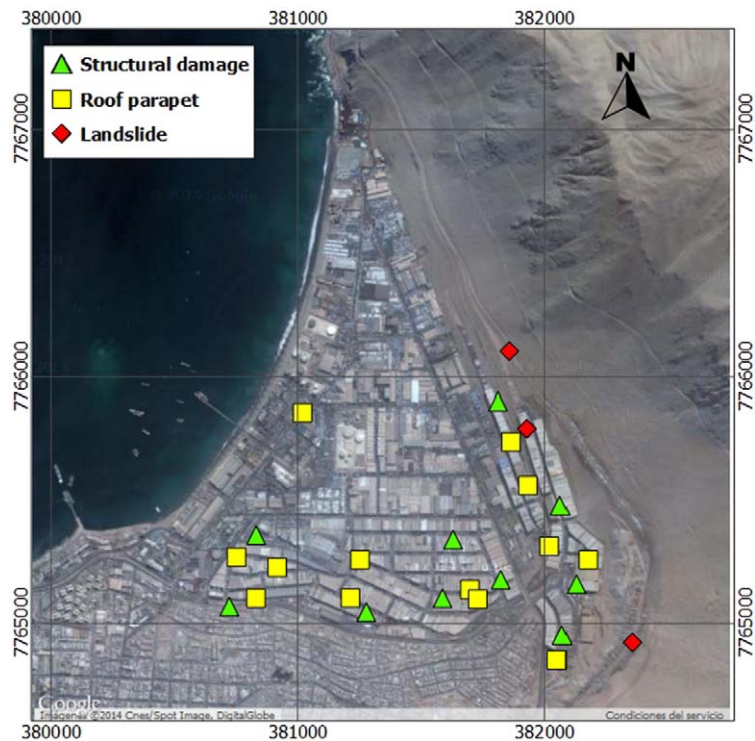
Figure 5. Classification of observed damage in the ZOFRI zone. Each symbol represents a type of damage, as shown in the upper left legend.

The slopes located to the east of the ZOFRI zone have terraces to allow vehicle transit that were built using shallow compaction without any reinforcement or containment system; therefore, the landslides shown in Figure 5 were foreseeable. During the reconnaissance campaign, we measured a maximum horizontal displacement of 1.3 m by adding the opening of the cracks across straight lines parallel to the direction of sliding.

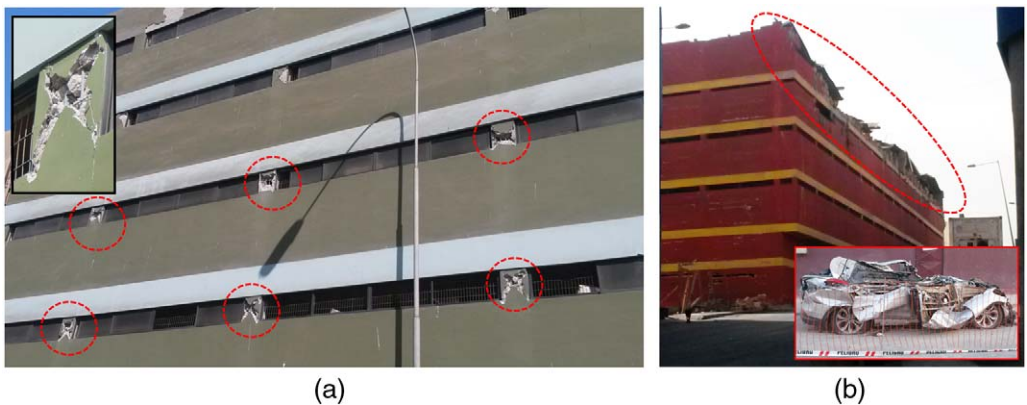
The observed damages in the zone are classified by type in Figure 5. Most of it is concentrated in fallen roof parapets, whereas little structural damage and few landslides were identified in the area. The relative soft soil layer and the topographic effects of the escarpment could increase accelerations in the zone, resulting in larger damage in structural and non-structural components, such as roof parapets (Figure 6b). Most parapets were built using

concrete block with very little steel reinforcement and without any out-of-plane reinforcement; hence, they have extremely low resistance under transversal loading. Even if these elements could be considered as nonstructural, their failure is highly risky for people working in these warehouses. Indeed, the only fatality reported in ZOFRI was crushed by a falling parapet. As depicted in Figure 6a, most of the structural failures were located in short columns.

Figure 6. Examples of observed damage in the ZOFRI warehouses. (a) Short-column structural failure and (b) fallen roof parapet with the result of a crushed car.

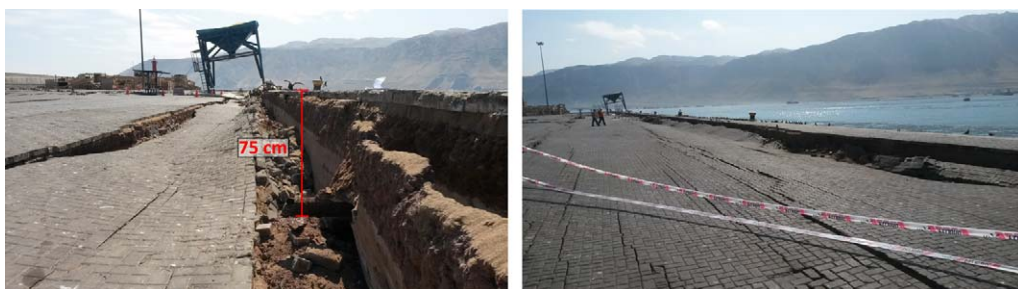
During the damage reconnaissance campaign, we observed that the terminal and eastern pier were practically intact after the earthquake. However, the western pier suffered large differential settlements all along its extension, especially toward the northeastern end, as shown in Figure 8.

The evidence during the reconnaissance campaign suggested that the cracks along the pier were caused by a horizontal displacement of the retaining lateral walls. Using a differential GPS, we measured the changes in elevation along three lines in the pier, as shown in Figure 9, where most of the variations are located to the right side, consistent with the fact that the retaining walls were higher on the left side of the figure. Hence, the variable height of the perimeter walls with a similar cross section could have induced this differentiated lateral displacement under the seismically increased lateral pressures from the fill. Furthermore, the variable thickness along the pier is consistent with the increased displacement toward the end of the pier. Given the poor compaction of the soil and the evidence during the reconnaissance campaign, some partial liquefaction could have taken place, as sand was vented through cracks in the surface of the pier (Rollins et al. 2014). Additionally, according to the Port's administration surveys, lateral spread is still taking place more than a month after the main shock. Detailed studies must be conducted to properly understand the complex mechanisms taking place in this case.

Figure 8. Observed damage in the western pier of the port of Iquique.

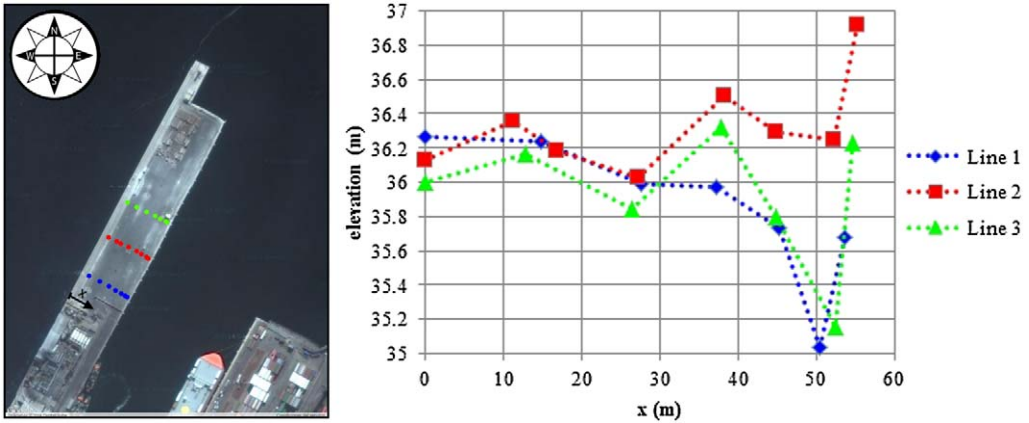
Figure 9. GPS measurements in the port of Iquique after the earthquake.

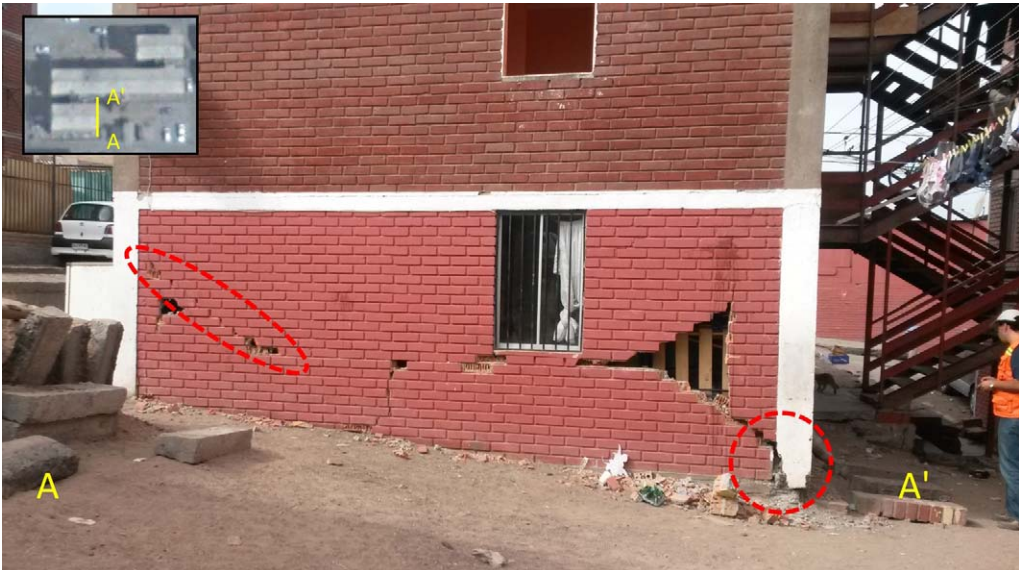
goes up to 4 stories. Based on their different plan dimensions, two types of buildings can be distinguished: type A and type B as illustrated in Figure 11. Both buildings are connected only by a central steel stairs simply supported on masonry walls. The only structural difference between them is their length; however, structural damage was seen only in the shorter buildings type A, in which we observed compressional failures in the columns of the first story and shear failures in the walls (Figure 10). We observed this level of damage in several buildings of the same type.

Figure 10. Observed damage in buildings type A in Dunas I.

Because buildings type B did not suffer any kind of structural damage, we suspect the damage of type A was controlled by a concordance of the resonant frequencies of the soil and the structure. Further studies such as synchronized recording to perform a detailed modal identification will be performed in order to confirm this hypothesis.

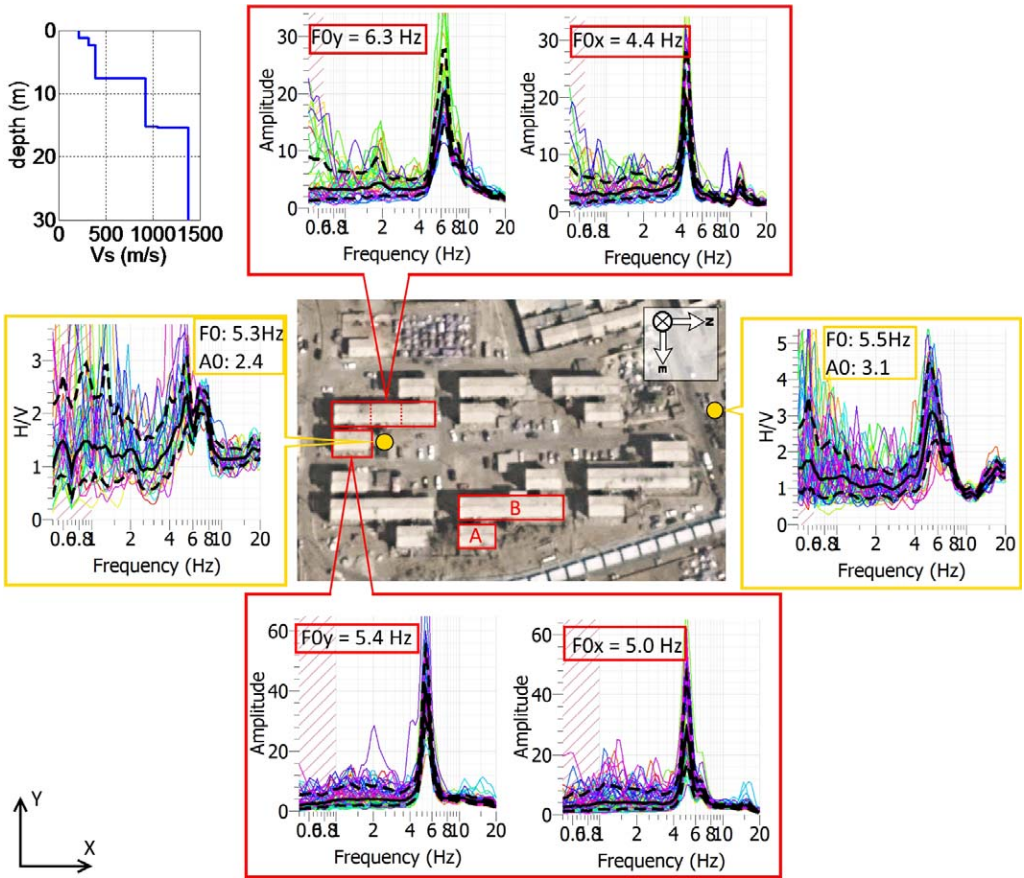
A portable triaxial seismometer was placed on the top floor of each structure making it possible to estimate their post-seismic fundamental frequencies in the X and Y direction using the maximum amplitude of the Fourier spectrum technique. The fundamental frequencies are shown in Figure 11. Furthermore, HVSR was used on the sites to obtain the predominant frequency of the soil, as is depicted in the same figure. Note that, for building type A, the post-seismic fundamental frequency in the Y direction is almost identical to the predominant soil frequency obtained for the building.

Figure 11. Types of structures (A and B) with their respective fundamental frequencies and predominant frequencies of the soil.

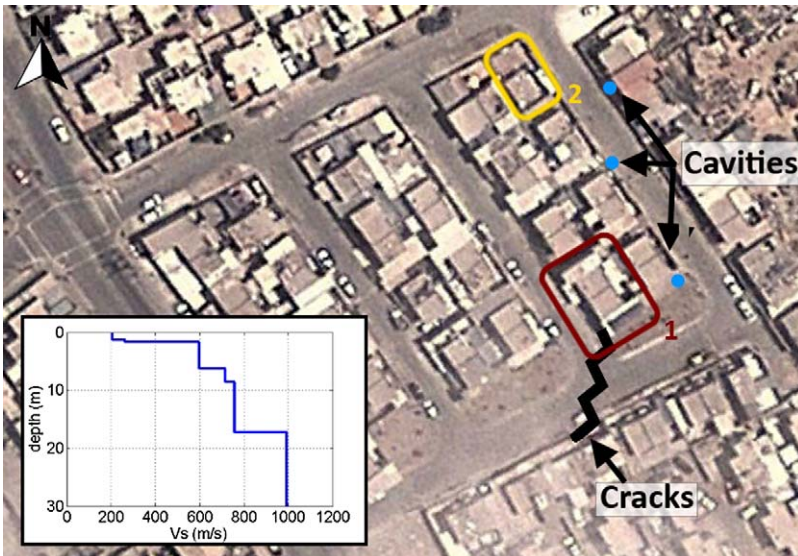
Alto Hospicio is located above the Coastal Range escarpment (Figure 2) at about 550 m above sea level. The soil beneath the city is characterized by rigid gravels with a matrix of halite (also known as rock salt) (Marquardt et al. 2008). Most of the damage in this area was concentrated in masonry houses of up to two stories near the center of the city. This is the case of Santa Eloisa condominium, shown in Figure 12, where several houses were heavily affected by the earthquake.

Figure 12. Map of the observed cases of interest in Santa Eloisa condominium and typical shear wave velocity profile for this area.

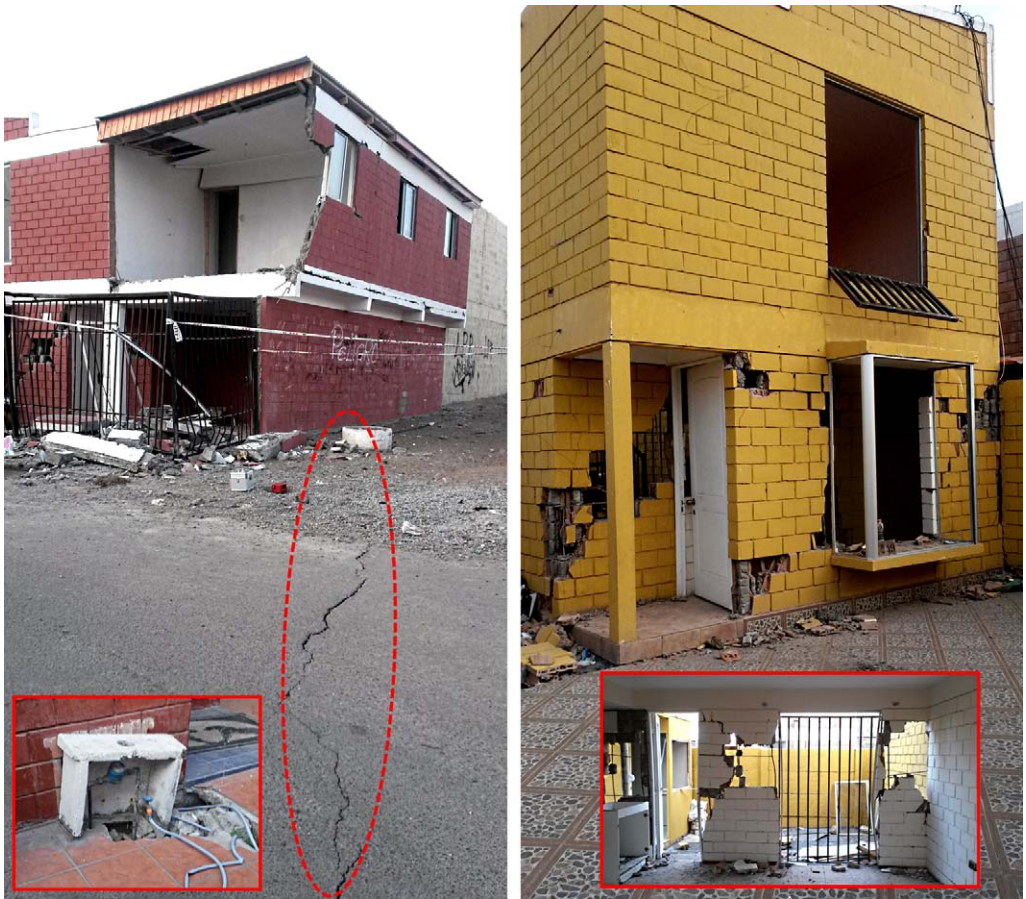
This area is characterized by stiff soils as is shown in Figure 13. Additionally, the strong motion record showed a slight increase compared to the one measured on stiffer soils, from 0.27 g to 0.44 g, as shown in Figure 2. Figure 13 shows the most affected house in the condominium, which shows shear wall failures all along the structure, while Figure 13 presents an example of the post-seismic cracks and cavities detected during the post-earthquake survey. This evidence suggests that partial dissolution of soil salts prior to the shaking may have generated unstable areas (cavities) that were activated during the earthquake, because near the houses, several cavities were identified on the surface, as well as seismically induced cracks on the pavement (Figure 12).

This type of soil effect cannot be associated directly with the dynamic properties of the soil measured by geophysical techniques, but it is an indirect consequence of potential instabilities of this kind of soil triggered by salts dissolution. During the campaign in Alto Hospicio, we found cavities over 5 m deep caused by the rupture of underground pipes. In order to validate this hypothesis in all the cases around the cities, radar measurements will be carried out to identify cavities that are not visible at the surface.

Figure 13. Observed damage for Houses 1 and 2. (a) House 1 shows post-seismic cracks and identified cavities, and (b) House 2 illustrates the most damaged house in Santa Eloisa condominium.
