Geotechnical Aspects of the 2015 M_w 8.3 Illapel Megathrust Earthquake Sequence in Chile

The 2015 Illapel earthquake sequence in Central Chile, occurred along the subduction zone interface in a known seismic gap, with moment magnitudes of M_w 8.3, M_w 7.1, and M_w 7.6. The main event triggered tsunami waves that damaged structures along the coast, while the surface ground motion induced localized liquefaction, settlement of bridge abutments, rockfall, debris flow, and collapse in several adobe structures. Because of the strict seismic codes in Chile, damage to modern engineered infrastructure was limited, although there was widespread tsunami-induced damage to one-story and two-stories residential homes adjacent to the shoreline. Soon after the earthquake, shear wave measurements were performed at selected potentially liquefiable sites to test recent V_S -based liquefaction susceptibility approaches. This paper describes the effects that this earthquake sequence and tsunami had on a number of retaining structures, bridge abutments, and cuts along Chile's main highway (Route 5). Since tsunami waves redistribute coastal and near shore sand along the coast, liquefaction evidence in c

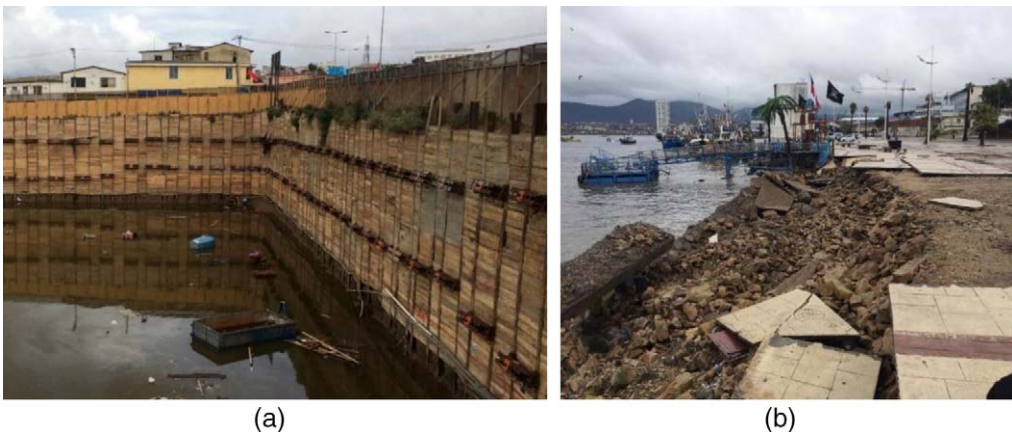
The overall performance of earth retaining structures in the region was satisfactory. Except for one failure, no significant damage was observed on gravity walls and other retaining structures supporting non-liquefiable backfills. Likewise, no evidence of seismically induced earth pressure damage was observed on MSE walls or building basements. Temporary support of excavations also performed well. For instance, in Coquimbo, a ~10 m deep excavation supported on soldier piles and anchors was flooded by the tsunami waves as shown in Figure 7a; however, the ground shaking caused no apparent damage on the retaining system.

A 30 m long section of a 4.5 m high gravity wall adjacent to Coquimbo's port failed by complete overturning, as shown in Figure 7b. The exposed backfill material was a mixture of very angular rock fragments (average size of 15 cm) and coarse beach sand. The measured peak horizontal and vertical accelerations at the nearest station are 0.25 g and 0.18 g respectively, peak ground velocity of 19 cm/s (located 1.9 km south of the site) and significant duration of 59 s; this level of acceleration is generally not sufficient to mobilize the shear strength of the retained material (Geraïli Mikola et al. 2016), and thus, the likely cause of failure is the combined effect of hydrodynamic forces induced by the repeated tsunami waves and the ground shaking. Similar patterns of damage to quay walls and breakwaters

Figure 7. (a) Flooded excavation in Coquimbo (29.958°S, 71.338°W). No damage observed on the soldier piles and anchors; (b) failure of gravity walls at Coquimbo's waterfront (29.951°S, 71.336°W).

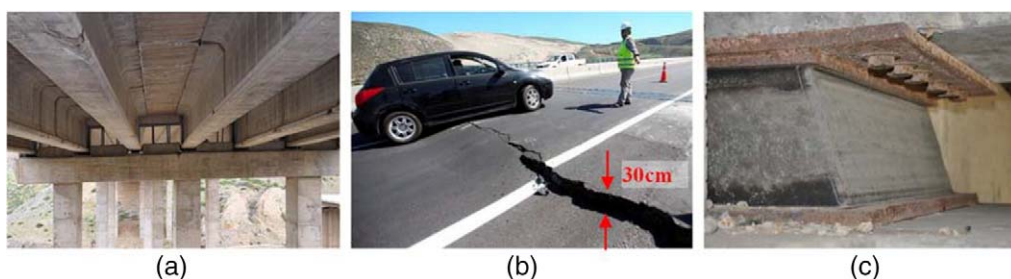
El Teniente Bridge, located on the Quaternary marine terraces adjacent to Teniente Bay, is a five span reinforced concrete (RC) structure consisting of two spans 38.5 m long, and three spans 39.5 m long. The superstructure is made of a 0.2 m thick concrete slab and seven prestressed girders simply supported on neoprene bearing pads, a structural configuration commonly used in Chilean bridges (Moroni et al. 2008). The end abutments and the four intermediate piers are supported on ten piles 18 m in length, and 1.5 m in diameter. The ground motion caused a settlement in the south abutment of ~ 30 cm and a horizontal displacement of ~ 7 cm, leaving a residual deformation on the neoprene pads and large cracks in the approach pavement, as shown in Figure 8; the estimated PGA for rock is 0.25 g. Emergency ramps were built and the traffic flow was restored soon after.

Figure 8. (a) Concrete girders and piers of El Teniente bridge, (b) south approach before temporary repairs, (c) deformed neoprene bearings on the south abutment. (30.995°S , 71.631°W).

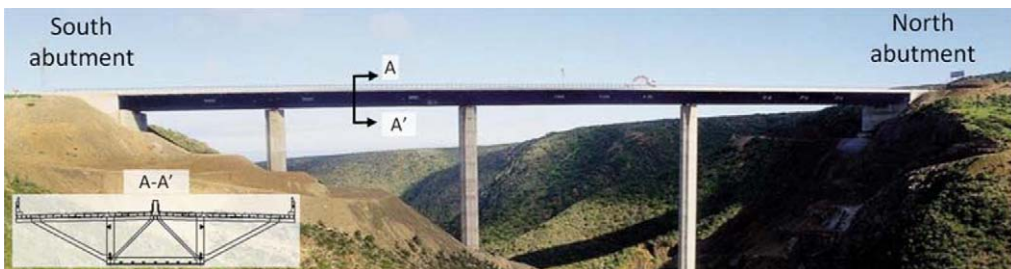
Other bridges inspected showed only slight damage or no damage at all. For instance, the Amolanas Viaduct in Route 5, one of the tallest bridges in South America, underwent no structural or geotechnical damage. The viaduct has a total length of 268 m and four spans (40, 60, 80, and 88 m), Figure 9; the deck consists of a continuous steel box supported on three RC piers of height 22.3 m, 49.1 m and 95.6 m, and is equipped with friction isolators and viscous dampers. The foundations are supported on folded layers of sedimentary rocks, and sandstone conglomerate with excellent bearing capacity. The southern and northern slopes are reinforced with rock bolts (González Rodríguez 2008).

Figure 9. Amolanas Viaduct, no damage observed (31.174°S, 71.608°W).

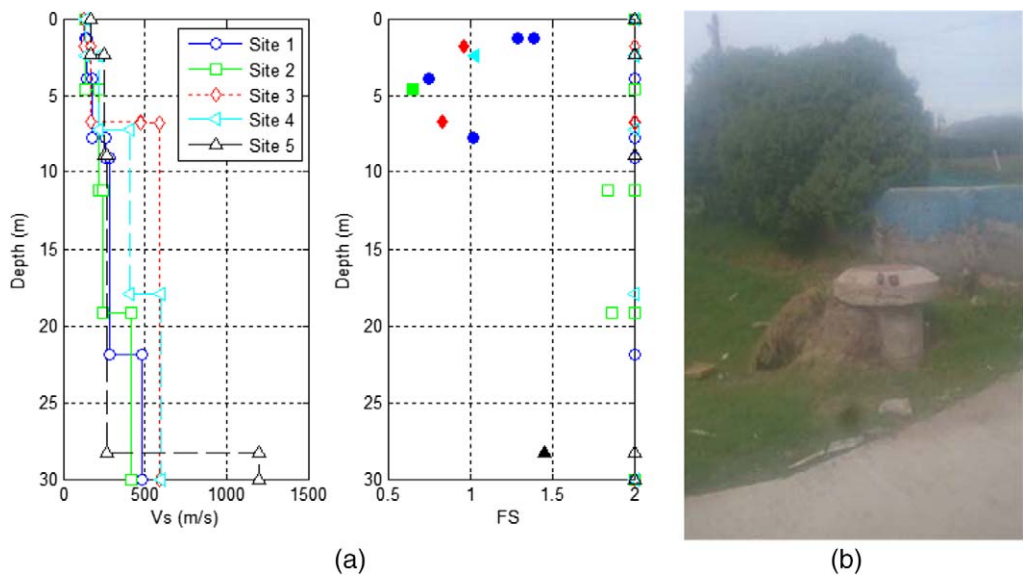
Figure 10. (a) Measured shear wave profiles and factors of safety from liquefaction triggering analysis, and (b) field photograph of Los Pescadores street sewer portal (Site 4) after a number of M_w 6+ aftershocks (29.951°S, 71.295°W).

Liquefaction Site 4 – Near Coast in La Serena with Lateral Spreading and Sewer Pipes Uplift (29.951°S, 71.295°W)

This site exhibited clear evidence of liquefaction and lateral spreading of a ~600 m long strip parallel to the coast in La Serena. Here, deformation was evident with liquefaction and lateral-spreading-induced floating of concrete sewer services (i.e., flotation, raised sewer portals and raised pipes), vertical subsidence noted with cracked ground, normal (downward) faulted blocks of soil, cracks within nearby roads and tilted power poles (Figure 10b). The V_S -based liquefaction susceptibility analysis indicated that the critical layer was at a depth of 2.5 m. The first observations here were taken one week after the earthquake. The sites were revisited one week later (week of October 5, 2015) at which time they showed continued deformation (i.e., subsidence, likely due to numerous $M_w > 6$ aftershocks during this one-week period).

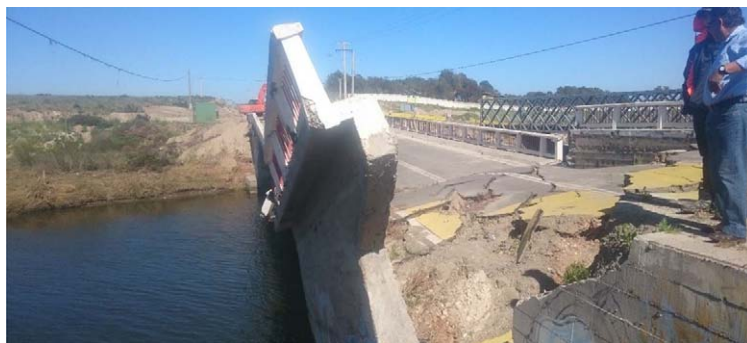
The old Tongoy Bridge of route D-420 is a two lane RC bridge built in the 1960s located in the north access of Tongoy Bay. This bridge was closed permanently on 2012 due to lack of maintenance and a significant settlement in the north abutment. After the 2015 earthquakes, the north abutment continued deforming and accumulated a settlement of over 1.5 m, as shown in Figure 11. The V_S -based susceptibility analysis did not predict liquefaction at this site.

Figure 11. Field photograph looking south of the D-420 bridge. Northern end of the bridge has a vertical step where it failed during the earthquake. People shown for scale (30.261°S, 71.481°W).

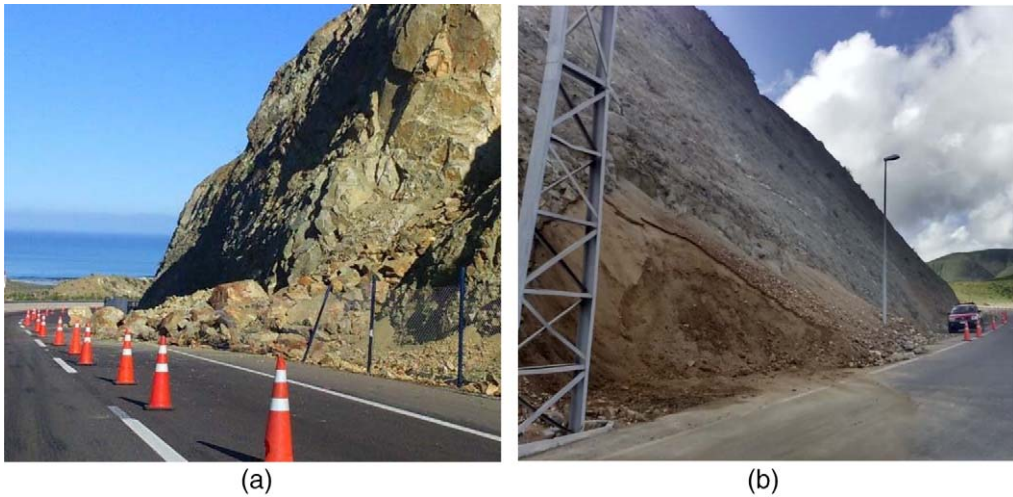
Figure 12. Rockfalls on Route 5: (a) northbound lane at km 334 (31.004°S , 71.624°W), mitigation fences were destroyed, both lanes were closed after the earthquake and one lane remained closed for at least 10 days; and (b) southbound lane at km 280 (31.444°S , 71.564°W), one lane was blocked following the earthquake.

Numerous topples or slumps were observed in over-steepened road cuts through weathered igneous rocks and sediments, even where fences or other mitigation measures were in place. Oftentimes, these over-steepened cut slopes had estimated inclinations of 4:1 (V:H) or steeper, and estimated heights between 5 m to 30 m. In some locations, rockfall occurred along bedding planes, however most rockfall occurred from cliffs composed of highly fractured (i.e., jointed) and weathered igneous rocks, which failed due to strong ground motion. No rockfall or slope stability issues were noted along the flatter sections along Route 5.

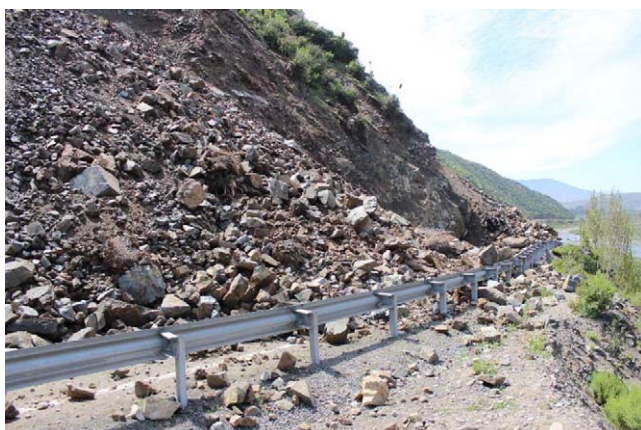
In addition to Route 5, several inland roads in the region were visited, including asphalted routes D-55, D-71, D-81, D-85, and dirt Routes D-75 and D-951 which run along the Choapa River. These roads cross hilly terrain and the east-west fluvial transverse valleys in the region. In some areas these roads run parallel to nearly vertical cliffs, and the earthquakes caused widespread damage to steep cut-slopes of sedimentary rocks and weathered igneous rocks, temporarily blocking traffic on one or two lanes, as shown in Figure 13.

Figure 13. Traffic discontinued on Route D-75 as a result of rockfalls. Estimated volume > 200 m³ (31.5855°S, 71.4674°W).

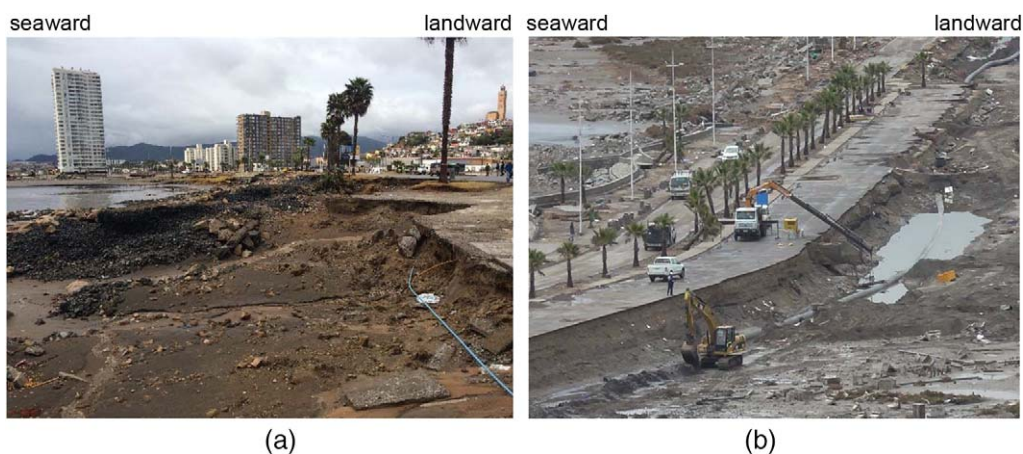
Figure 15. (a) Sand and rock fills in Coquimbo's shoreline washed away by tsunami waves (29.956°S, 71.336°W), and (b) tsunami erosion and scour along Avenida Costanera, Coquimbo (29.961°S, 71.328°W).

Tsunami waves caused severe damage to Coquimbo's waterfront. The measured inundation depth in the bay was over 4.5 m and extended over a distance of ~500 m from the coast in some areas (GEER 2015). As a result, several lightweight structures were washed away, lifelines were interrupted, and the inundation zone was left with several tons of tsunami debris (including fishing boats that were carried onshore). Along Avenida Costanera (Coquimbo's coastline road), several residential buildings were flooded, and the sand and rock fill along the road were heavily eroded and occasionally washed away by the tsunami waves (Figure 15).
