REVISITING PAST REFINERY ACCIDENTS FROM A HUMAN RELIABILITY ANALYSIS PERSPECTIVE: THE BP TEXAS CITY AND THE CHEVRON RICHMOND ACCIDENTS

Marilia Abílio Ramos,¹* Enrique López Droguett,² Ali Mosleh,³ Márcio das Chagas Moura⁴ and Marcelo Ramos Martins⁵

Can. J. Chem. Eng. 95:2293-2305, 2017

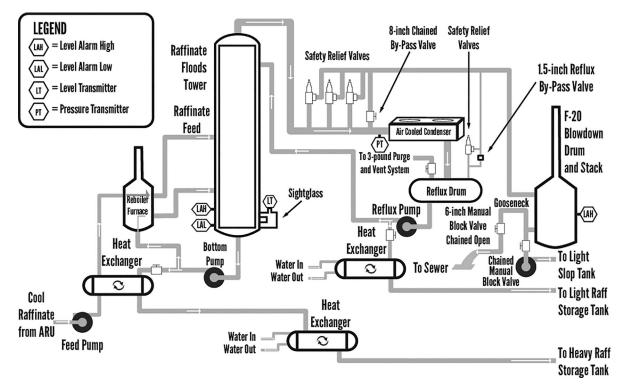
Although it was mentioned on the startup procedures that, during the startup, the level should be established at a 50 % transmitter reading, it was not unusual for the operators to fill the bottom of the tower until 99 %. They would do this to avoid the liquid level of the tower dropping, which had happened in past startups, and thus avoid damaging any equipment. After filling the tower, the operators stopped the startup, by closing the tower feed and shutting off the bottom pumps. Even though startup procedures instructed to put the tower level control valve on "automatic" and set as 50 % after a level was reached in the tower, it continued in the "closed" position.

Figure 2. Raffinate Section of BP Texas City Refinery Isomerization Section.^[31]

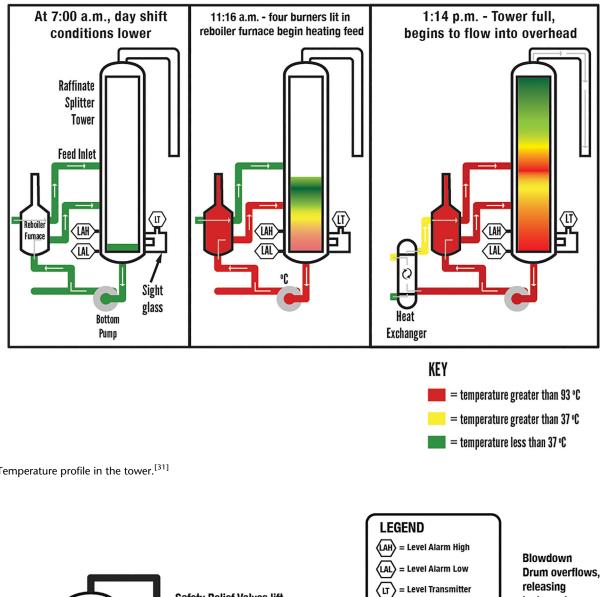
By the time of the accident, most of the column was heating at a fast pace and just a cold layer of liquid remained at the top. The entire column then approached the boiling point of the liquid, and the vapour bubbles, which initially were rising and condensing after contact with the liquid, began to accumulate. This caused an increase in volume from vaporization. Consequently, the liquid in the column top began to overflow into the vapour line.

Figure 3. Temperature profile in the tower.^[31]

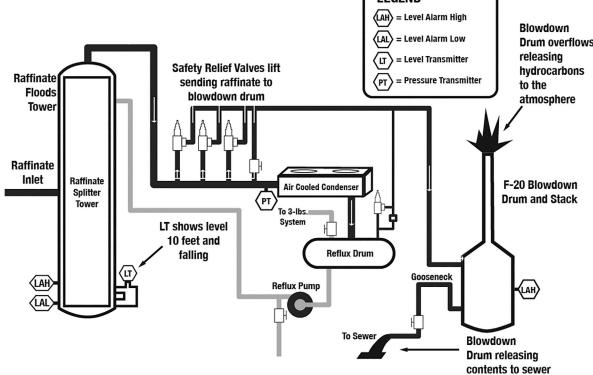
The safety relief valves opened as a result of the increase of the hydrostatic head in the line and the tower pressure, and let liquid raffinate into the raffinate splitter disposal header collection system. The crew was concerned by the high pressure, and noticed that the blowdown drum's high-level alarm had not sounded. However, they still thought that the cause of the overpressure was lack of reflux or a buildup of noncondensible gases.

Given the events abovementioned, the crew fully opened the level control valve to heavy raffinate storage and shut off the fuel gas to the furnace from the satellite control room. Thus, the amount of material decreased, the pressure to dropped and the safety relief valves closed, after approximately 196 500 litres of flammable liquid flowed into the collection header–and discharged into the blowdown drum. The blowdown system filled, leading flammable liquid to discharge to the atmosphere from its stack as a geyser and falling to the ground (Figure 4).

Figure 4. Tower is overfilled and sends hydrocarbons to blowdown drum, which overflows.^[31]

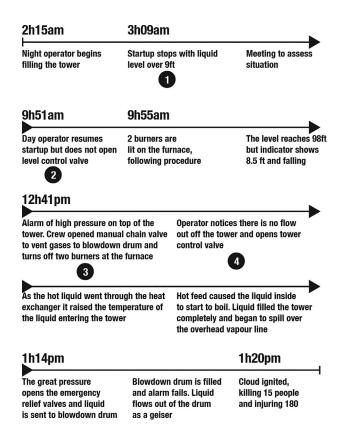
Based on the description above it is possible to build a timeline of the accident, focusing on the operators' actions and their interaction with the plant, in order to identify the Human Failure Events. The timeline of the accident (Figure 5), highlighting the operators' actions, shows four HFE that can be seen as major contributors to the accident (numbers 1–4):

Event 4: Operators open the control valve with the liquid already too hot. The liquid from the bottom of the tower exchanged heat with the feed of the tower. This caused the rise of the temperature of the feed entering the tower, which led to a high pressure over the emergency valves, which opened and let liquid into the blowdown drum.

Figure 5. Timeline of BP Texas City Accident on March 23, 2005.

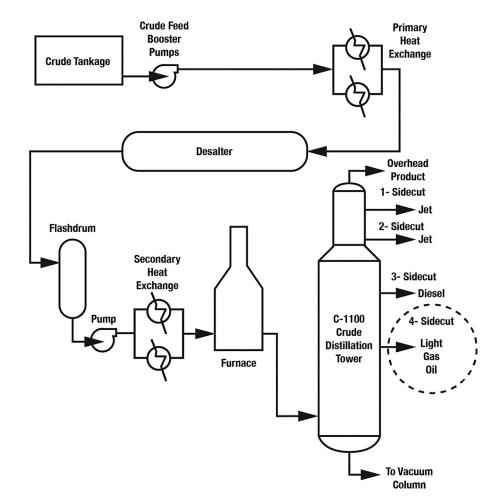
This accident took place on August 6, 2012. A catastrophic rupture of the 4th sidecut of the distillation tower in the Crude Unit (Figure 6), a 132-cm long, 20-cm diameter carbon steel pipe, released flammable hydrocarbon process fluid. The line operated at a temperature near 337 °C and had an operating pressure of approximately 379 kPa (gauge) at the rupture location. The hydrocarbon fluid partially vaporized into a large vapour cloud that surrounded 19 Chevron employees and ignited. All the employees escaped. The ignition of the cloud and subsequent burning of the hydrocarbon process fluid caused a large plume of particulates and vapour to travel across the Richmond, California area. Almost 15 000 people from the adjacent area had to look for medical treatment due to the release.^[33]

The technical cause of the accident was sulphidation corrosion of the piping. However, a deeper analysis of the accident reveals that human error played an important role. In the 4th sidecut of the column, light gas oil exits the column to be further refined and processed. This sidecut was not isolated by valves; thus, if a leak occurred in this pipe, an operator could not actually block this section to repair it while the unit was operating.

Figure 6. Chevron Richmond refinery Crude Unit atmospheric column and upstream process equipment.^[33]

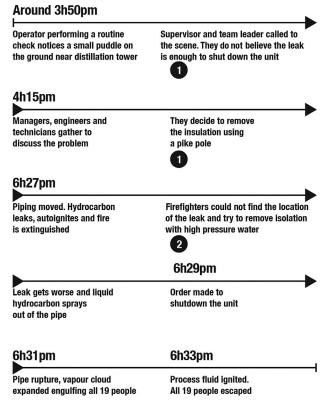
The main events during the accident can be seen in Figure 7, where Items 1 and 2 indicate the main human events in the timelines are related to a crew failure mode. Note this timeline focuses on the operators' actions and their interaction with the plant.

Event 1: The head operator misdiagnoses the state of the plant, believing that the leak is not big enough to shut down the unit. The strategy chosen is to remove the insulation by using a pike pole. This actually made the leak worse, since the pipeline walls were already too thin due to corrosion.

Figure 7. Timeline of the Chevron Richmond accident on August 2, 2012.
