# Inspection of Seismic Damage and Conservation Conditions in Modern School Buildings in Chile

Claudia Torres<sup>1(✉)</sup> and Pablo Rojas<sup>2</sup>

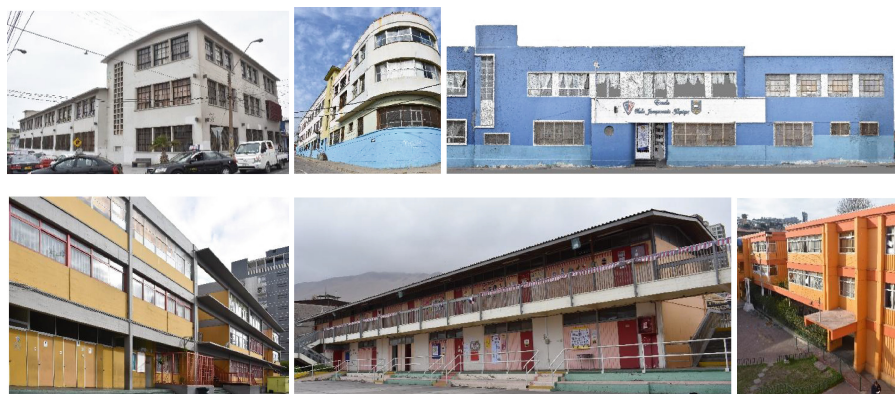
**Fig. 1.** Samples of the educational establishment examined. Top row: Eduardo Frei School (Arica), República del Salvador School (Valparaíso), Paula Jaraquemada School (Iquique). Bottom row: Ljubica Domic School (Antofagasta), Flor del Inca School (Iquique), Instituto Superior de Comercio (Valparaíso).

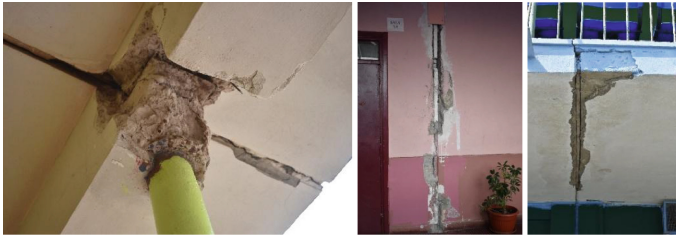
**Fig. 3.** Faults in expansion joints in all buildings in the sample

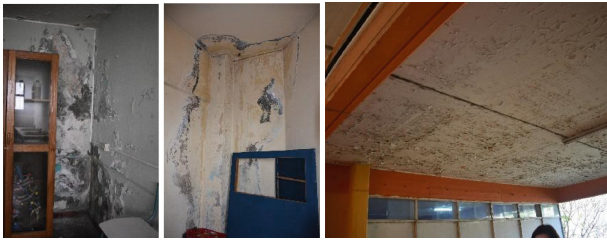
**Fig. 4.** Stains, efflorescence and peeling paint because of humidity. Absorption by capillarity in retaining walls (Arica) and rainfall leakage (Valparaiso), environmental humidity from morning fog (Antofagasta).

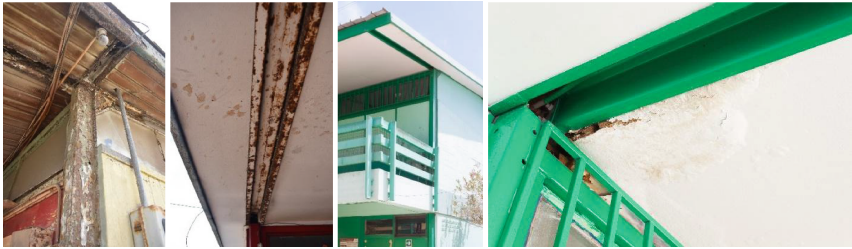
Fig. 5. Corrosive processes in metallic structures with different protection levels (paint).
