ANALYSIS OF FAILURES AND DEGRADATION MODES OF SMALL SCALE  
DOMESTIC/FARM PHOTOVOLTAIC POWER PLANTS IN RURAL COMMUNITIES  
OF THE ATACAMA DESERT

TESIS PARA OPTAR AL GRADO DE  
MAGÍSTER EN CIENCIAS DE LA INGENIERÍA, MENCIÓN ELÉCTRICA

PIA JAVIERA VASQUEZ RIVERA

SANTIAGO DE CHILE  
2020

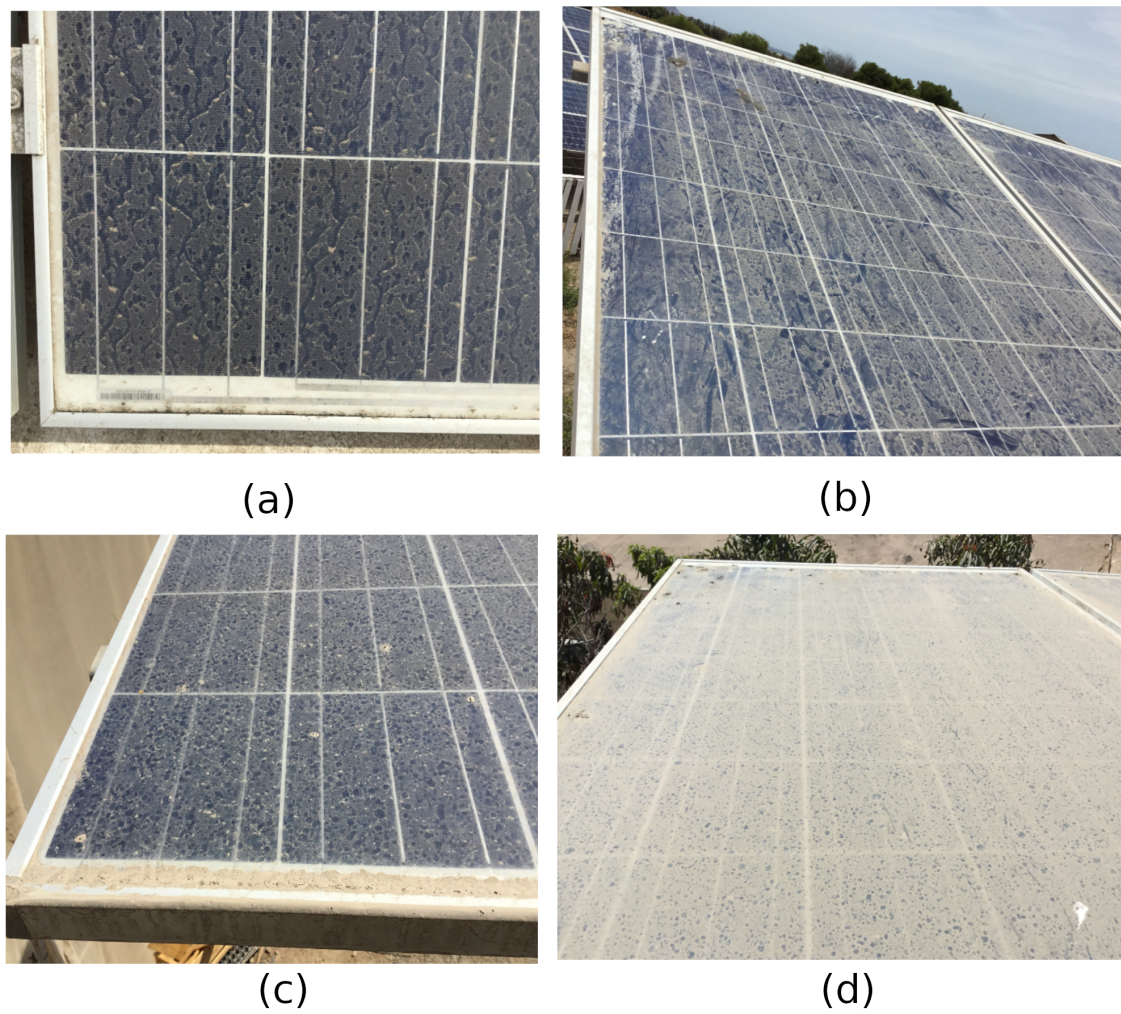
Figure 3.5: Heavily soiled modules in (a) coastal zone, (b) coastal zone inside city, (c) and (d) inner valley.

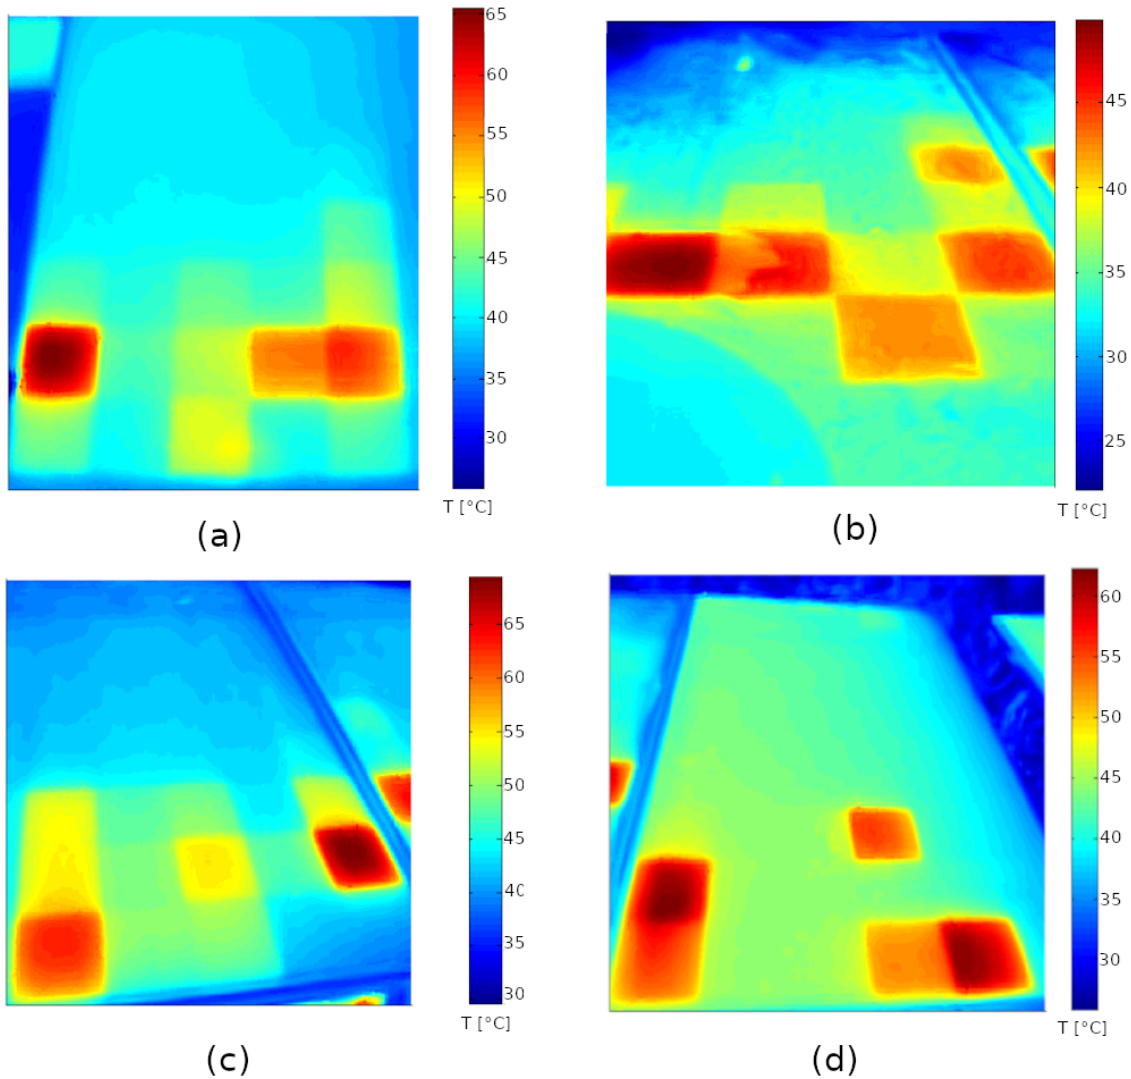
Regarding to the thermal signatures of heavily soiled modules, the common feature found in all modules was an approximately even temperature profile over the surface (temperature variations no higher than  $3^{\circ}\text{C}$  between cells within a module). Despite individual thermal patterns of hot cells that were more probable to be associated to other failures (like shading by drops or objects, micro-cracks or shunts). Temperature variations  $< 10^{\circ}\text{C}$  of cells within modules correspond to patchwork thermal patterns (random distribution of cells with different temperatures, but no differences higher than  $10^{\circ}\text{C}$  between each other) that can be associated to electrical current mismatch.

Figure 3.6: Thermal images of heavily soiled modules operating in (a) coastal zone, (b) city, (c) and (d) inner valley

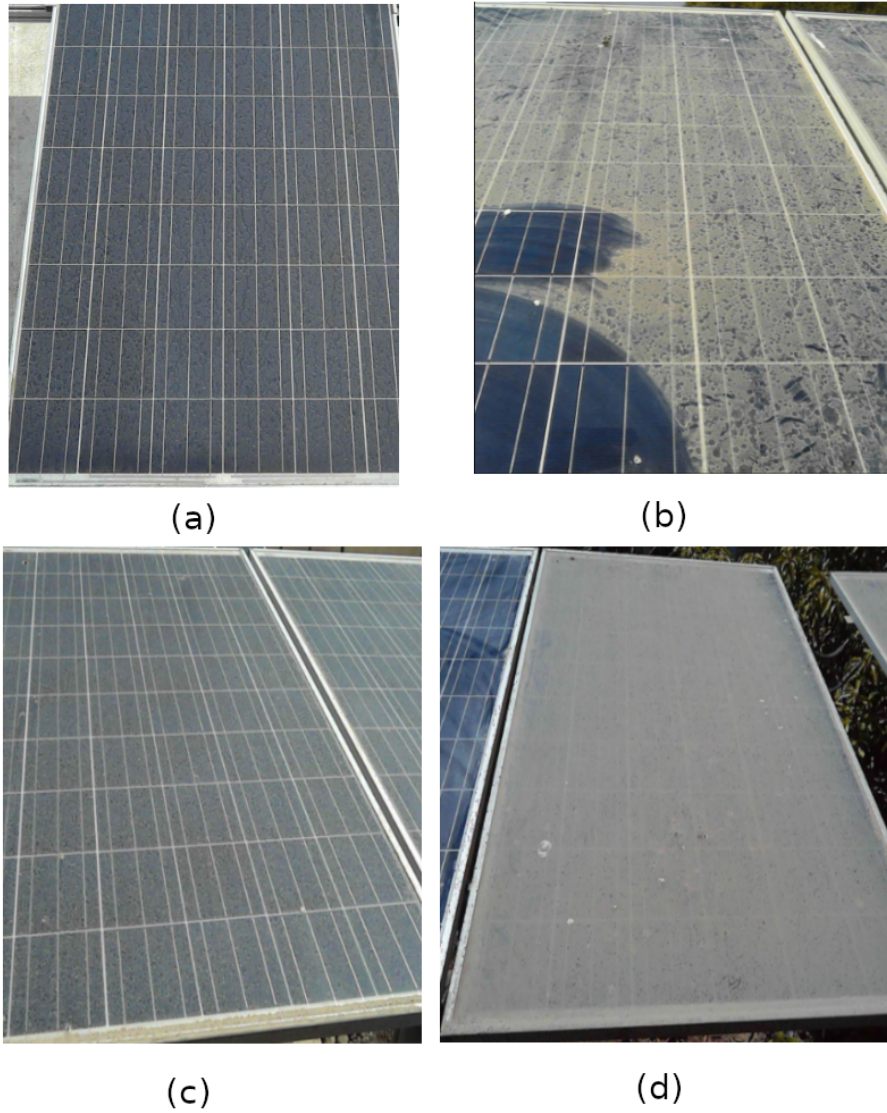
Figure 3.7: Visual images of heavily soiled modules operating in (a) coastal zone, (b) city, (c) and (d) inner valley

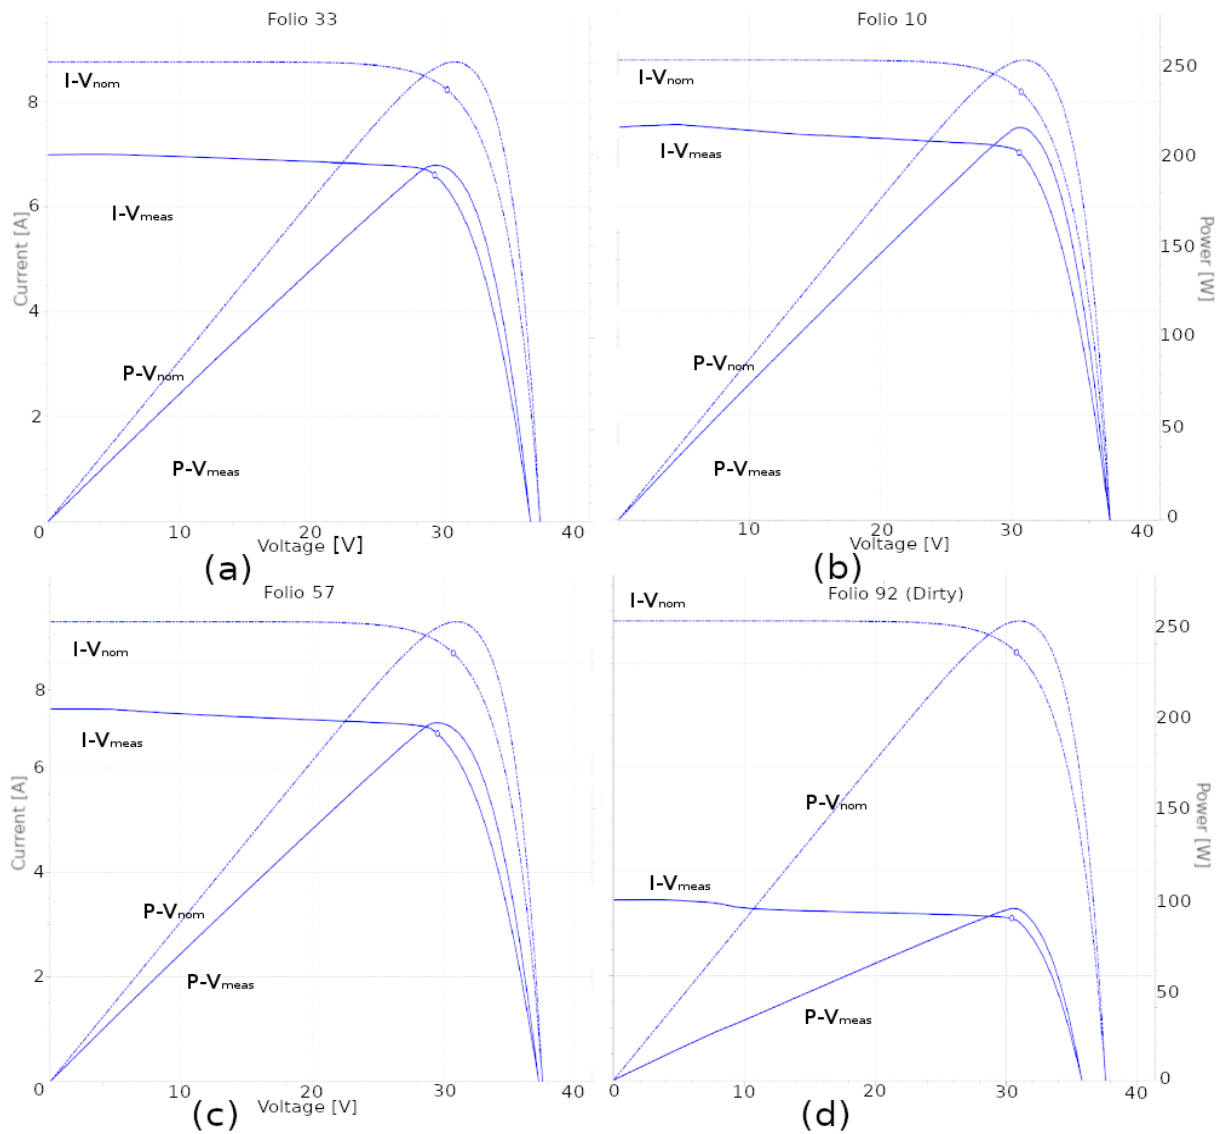
The effect of heavy soiling on the electrical parameters of the affected modules can be associated to a reduction in  $I_{sc}$ . This is because of the screening effect of soiling layers over the surface of the module, which prevents the arrival of photons on the active surface. As shown in Figure 3.8, modules of the three zones (coast, coastal city, and inner valley) are affected by a severe reduction of  $I_{sc}$  and a less significant reduction of  $V_{oc}$ . Since  $P_{mpp} = I_{mpp} V_{mpp}$ , a reduction in maximum power point is significant due to the high reduction in the Short Circuit Current. Average values of reduction on the electrical parameters are shown in Table 3.3. It can be seen that, as expected, the largest reduction of  $I_{sc}$  and thus  $P_{mpp}$  was found in the most heavily soiled modules (pattern s4) located in the inner valley. The second highest drop was found on the other set of modules of the inner valley (pattern s3) followed by the coastal-based modules (s1) and the less affected modules were those located in coastal city (s2). This effect can be due to the homogeneous distribution of soiling of patterns s1, s3 and

Figure 3.8: I-V characteristics of heavily soiled modules ( $I-V_{meas}$ ,  $P-V_{meas}$ ) operating in: (a) coastal zone, (b) city, (c) and (d) inner valley (solid line) compared with nominal values at STC ( $I-V_{nom}$ ,  $P-V_{nom}$ ).

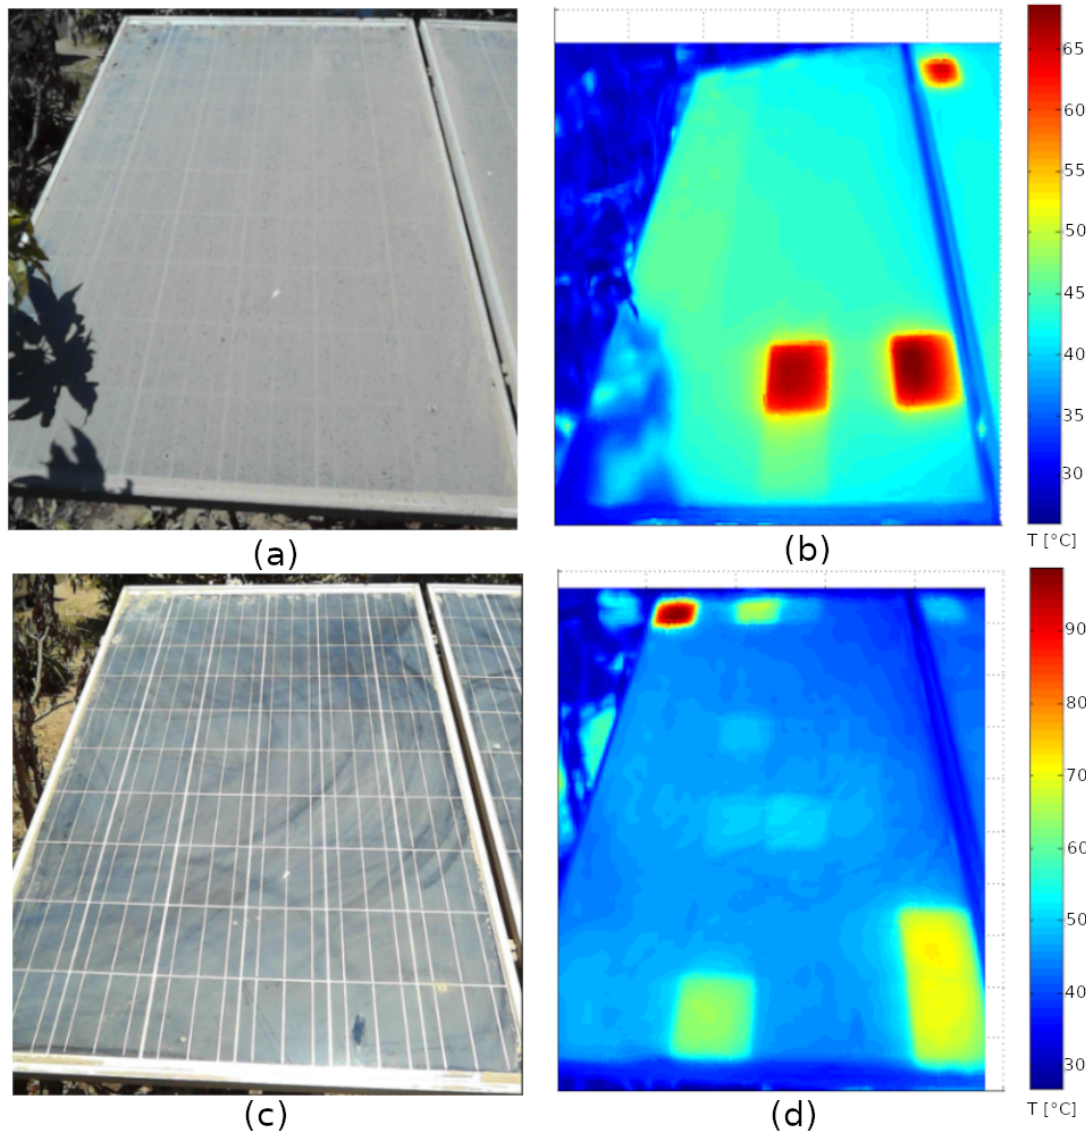
Figure 3.9: Visual and thermal images of a heavily soiled module (F90) from zone C (a), (b) before and (c), (d) after cleaning.

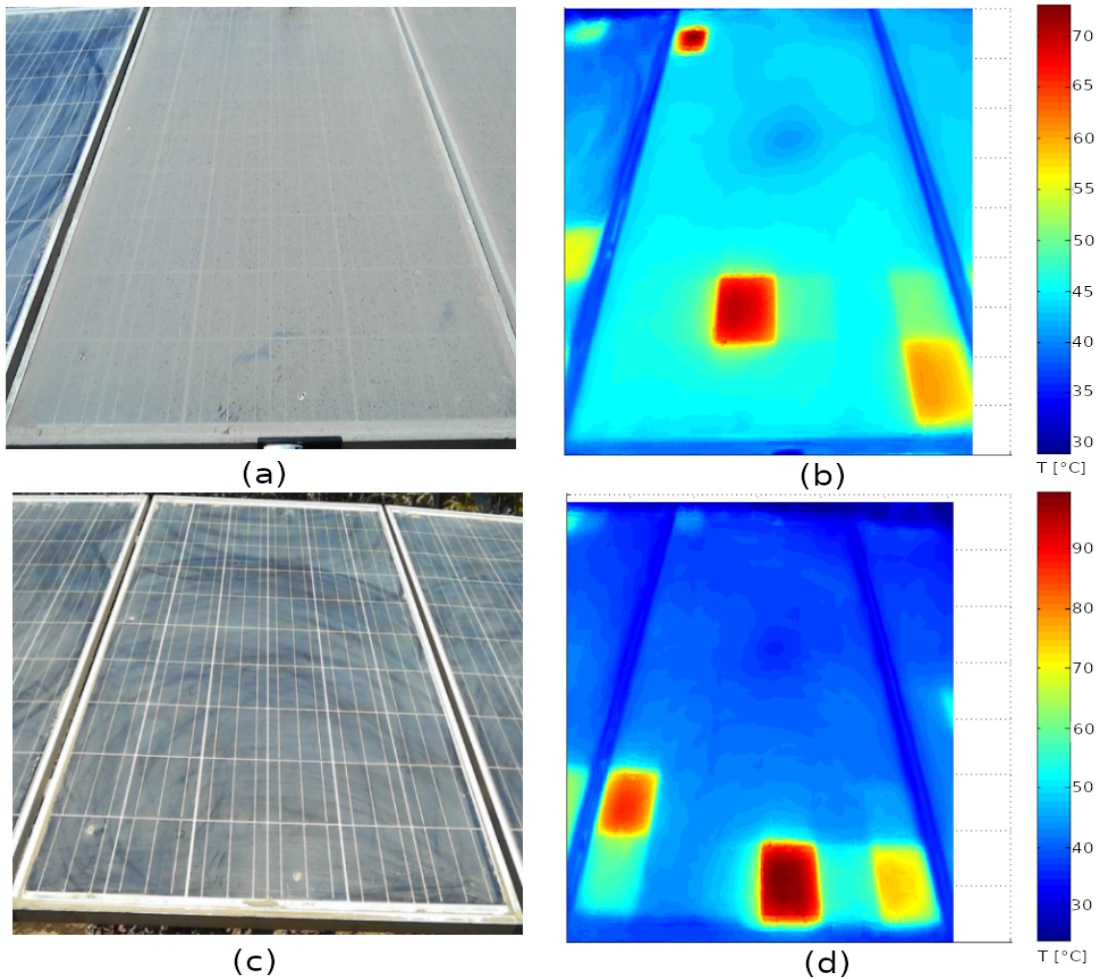
Figure 3.10: Visual and thermal images of a heavily soiled module (F91) from zone C (a), (b) before and (c), (d) after cleaning.

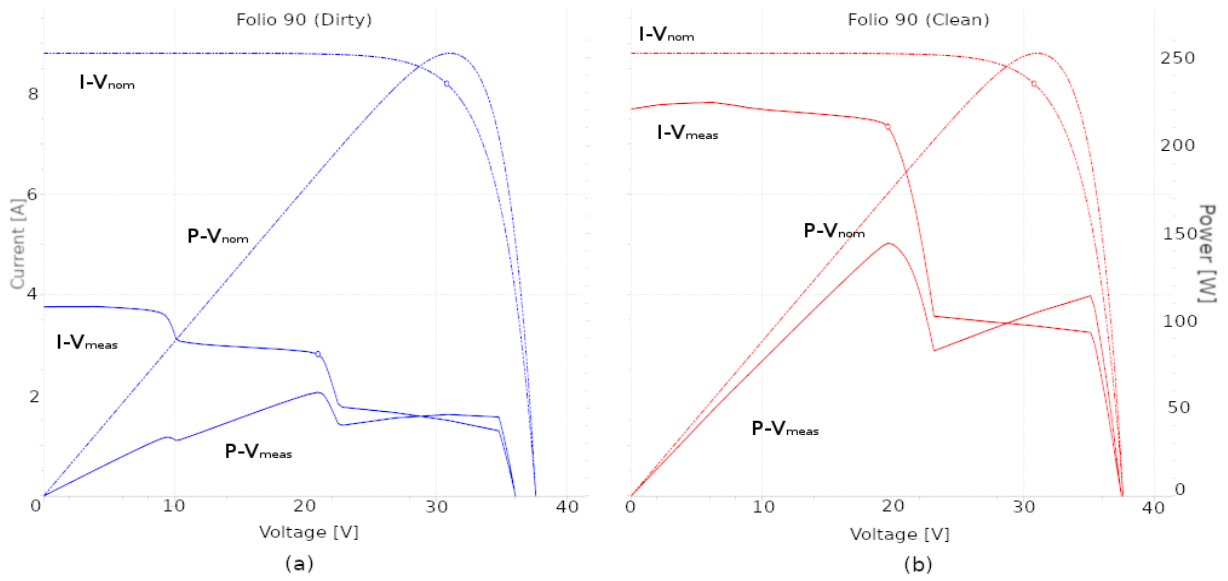
Figure 3.11: I-V and P-V characteristics of heavily soiled module (a) before and (b) after cleaning (F90).

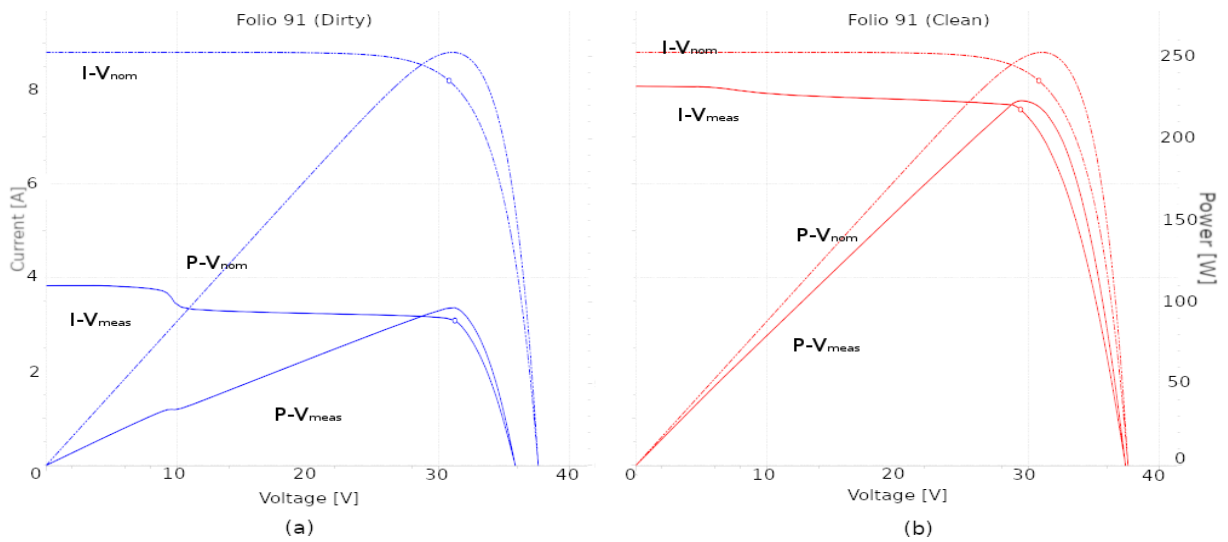
Figure 3.12: I-V and P-V characteristics of heavily soiled module (a) before and (b) after cleaning (F91).

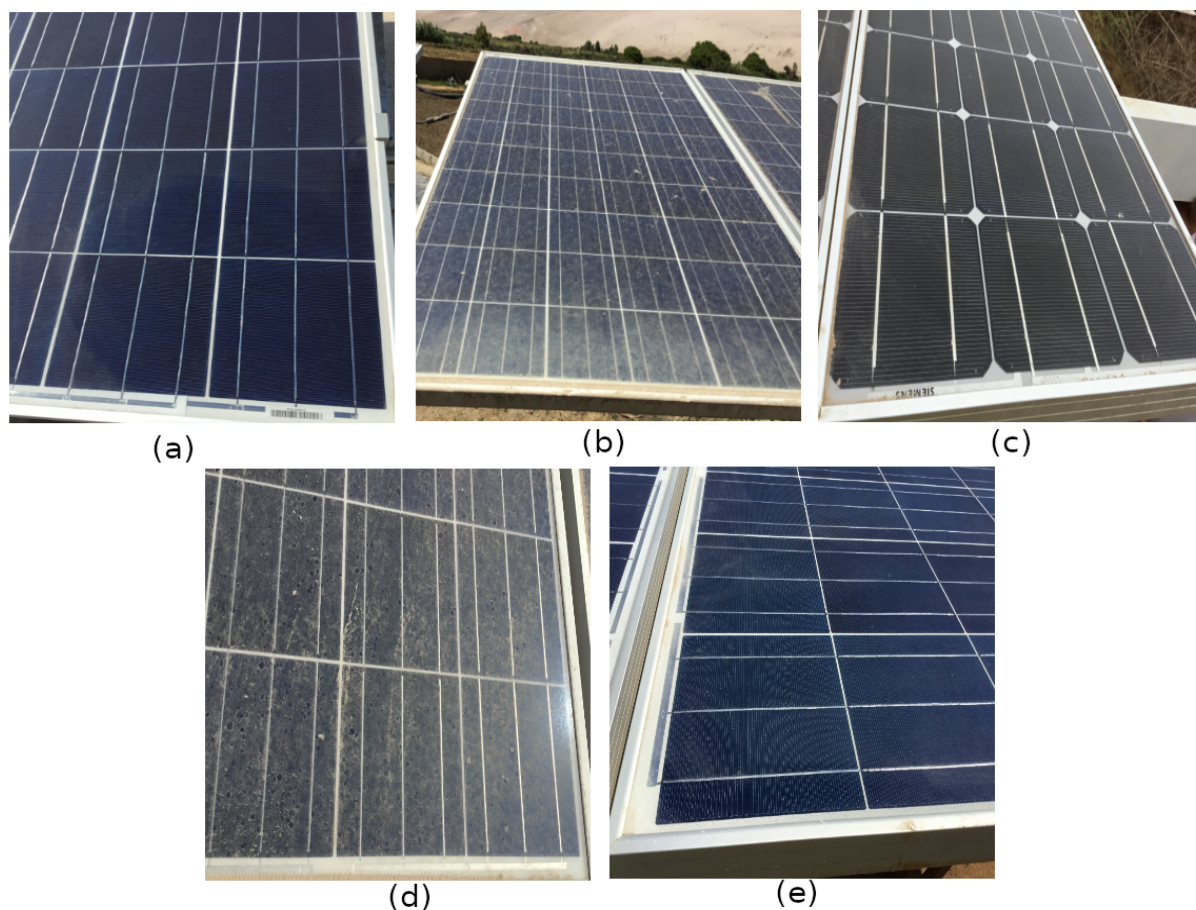
Figure 3.13: Close visual inspection of lightly soiled modules operating in (a) city zone, (b), (c), (d) inner valley, and (e) inner coast.

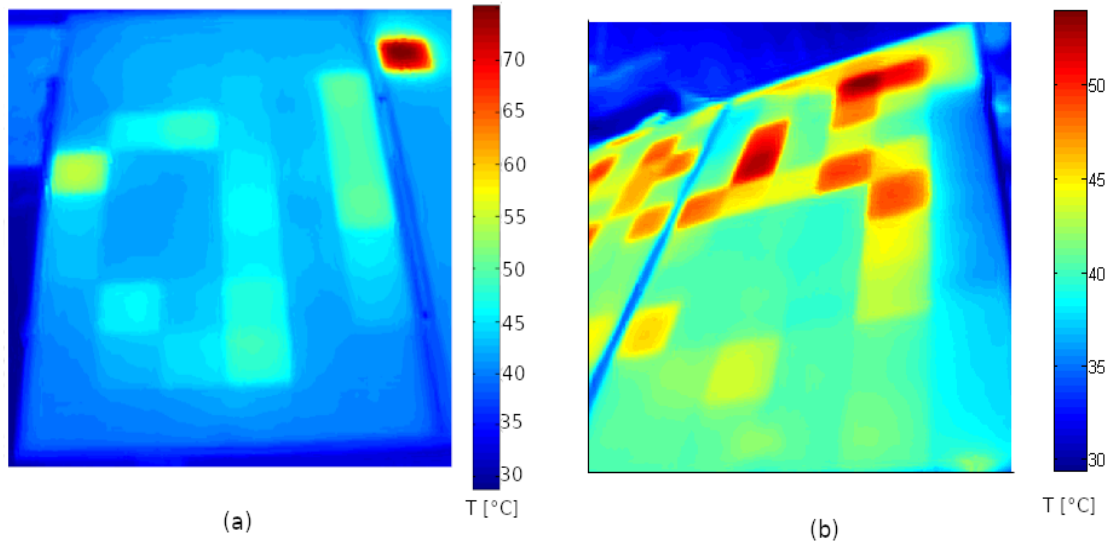
Figure 3.14: Thermal profiles of lightly soiled modules located in (a) city and (b) inner coast zones.

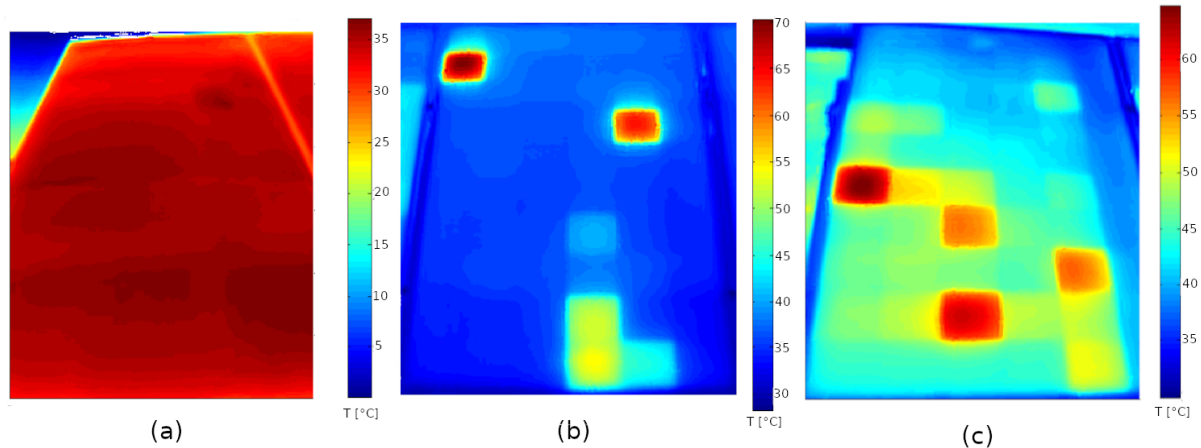
Figure 3.15: Thermal profiles of lightly soiled modules of zone B (a) uniform temperature distribution, (b) uniform temperature distribution with single/few hot cells and (c) modules with hotter cells at the bottom.

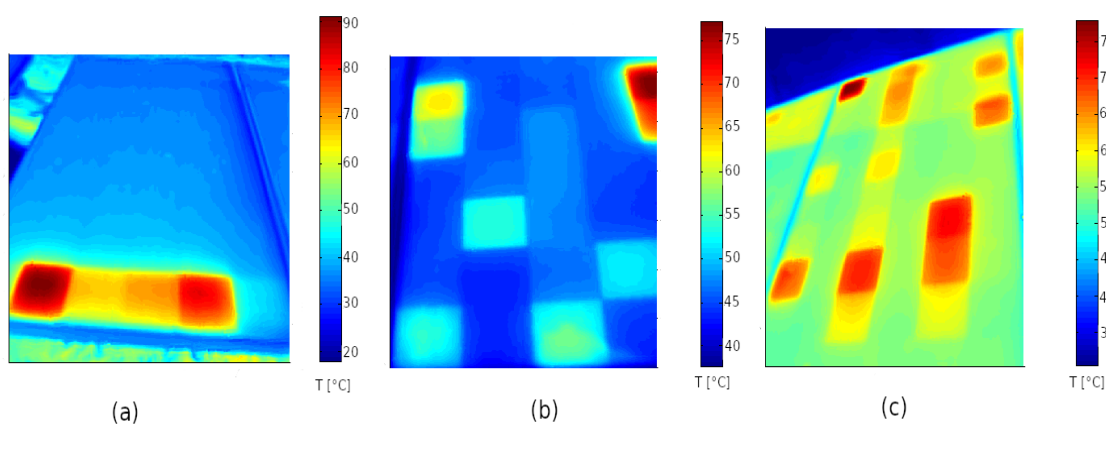
Figure 3.16: Characteristic thermal profiles found in lightly soiled modules located in inner valley zone.

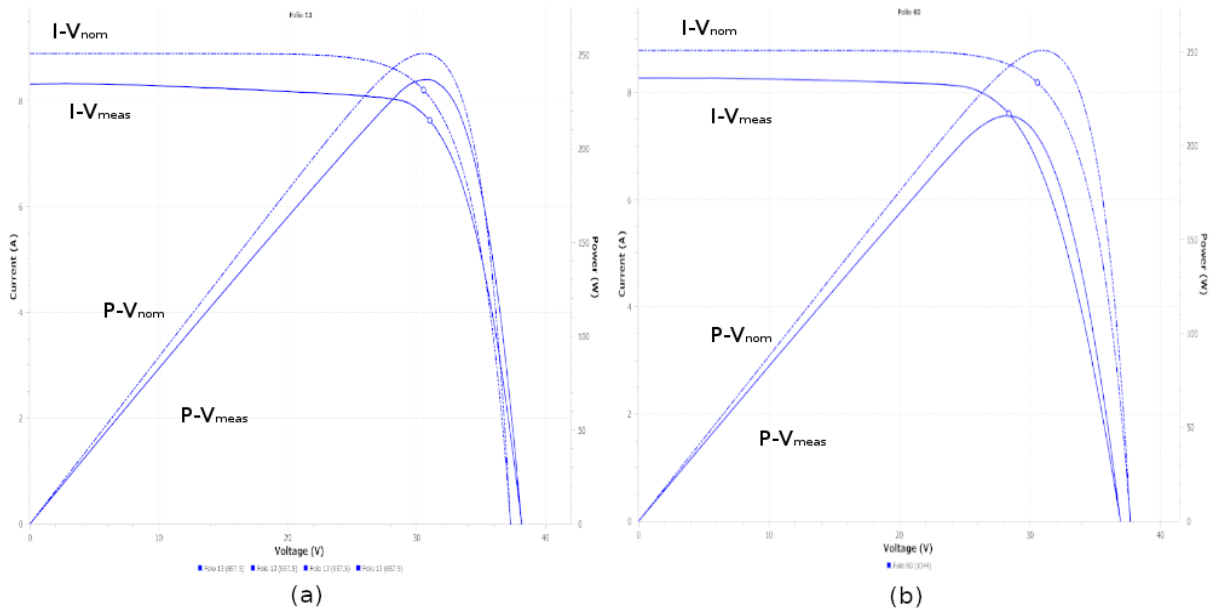
Figure 3.17: I-V and P-V characteristics of lightly soiled modules located in (a) city and (b) inner coast zones (solid line) compared with nominal values at STC (dotted line).

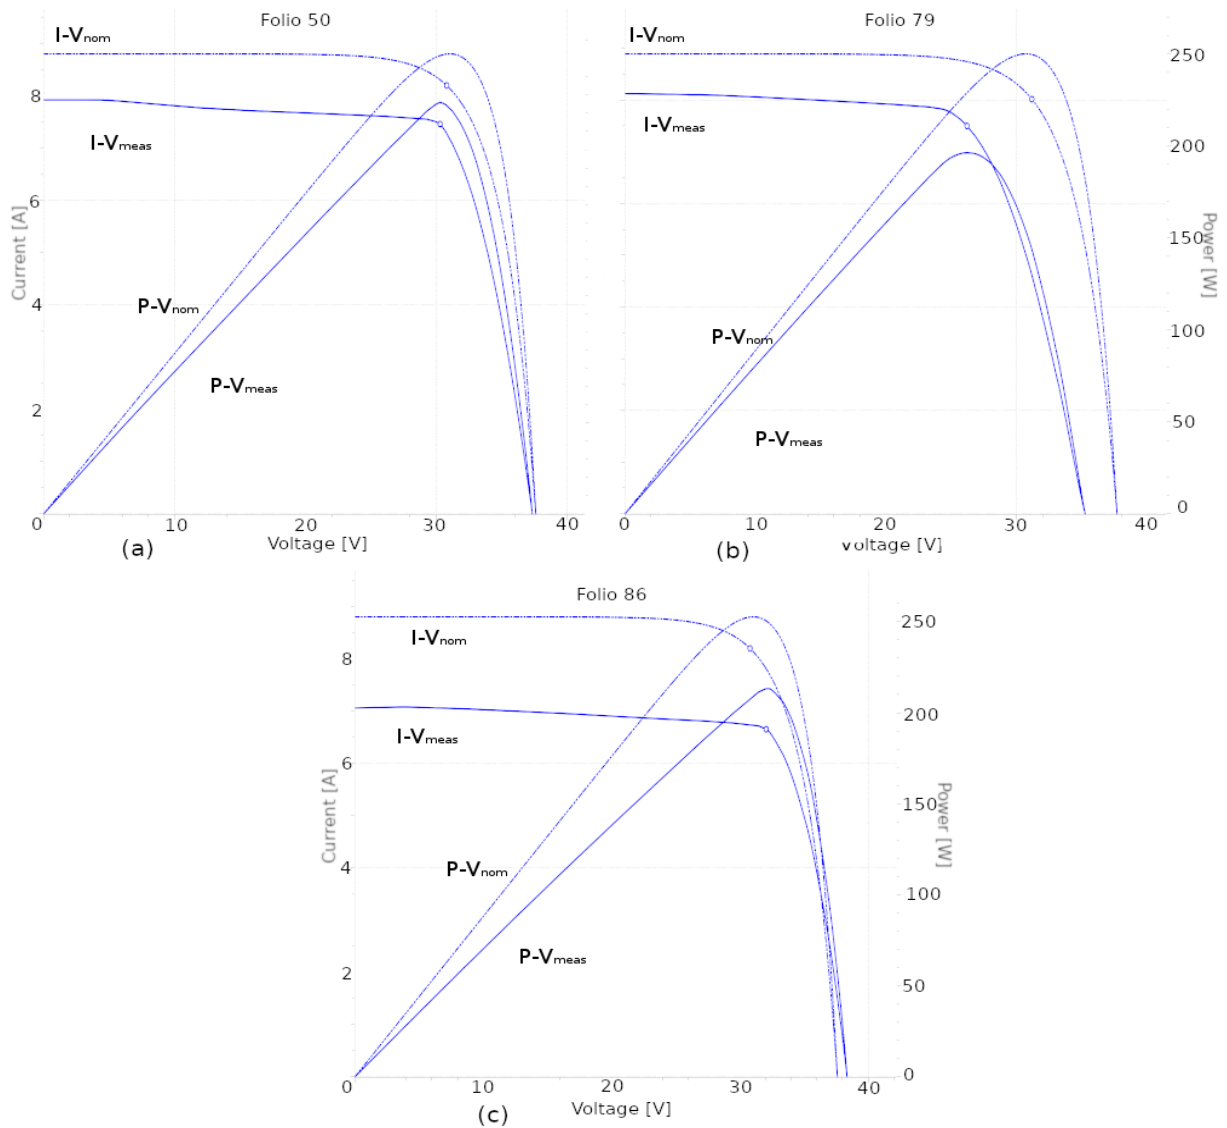
Figure 3.18: I-V characteristics of lightly soiled modules located in inner valley zone (solid line) compared with nominal values at STC (dotted line).

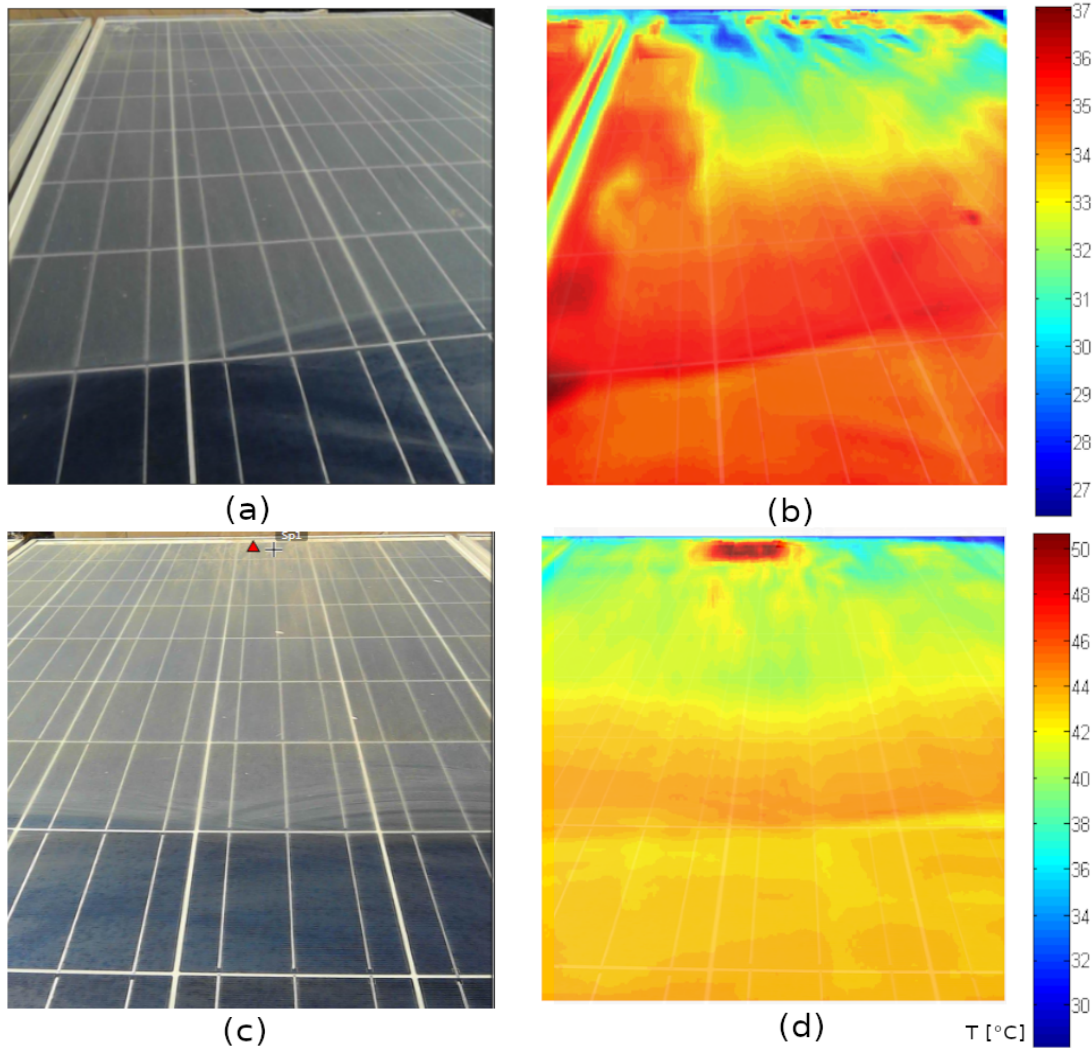
Figure 3.19: (a) (c) Visual inspection and (b) (d) thermal images of extensive milky discoloration found in two modules.

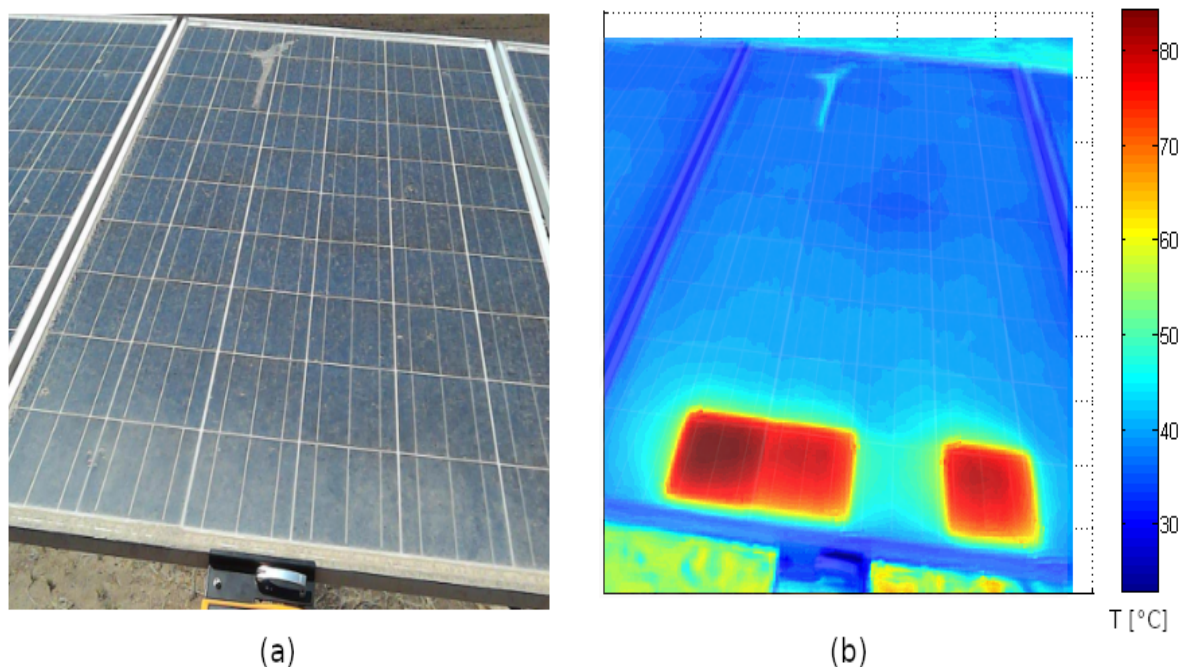
Figure 3.20: (a) Visual inspection and (b) thermal image of a module with milky discoloration localized in the bottom cells, combined with light homogeneous soiling.

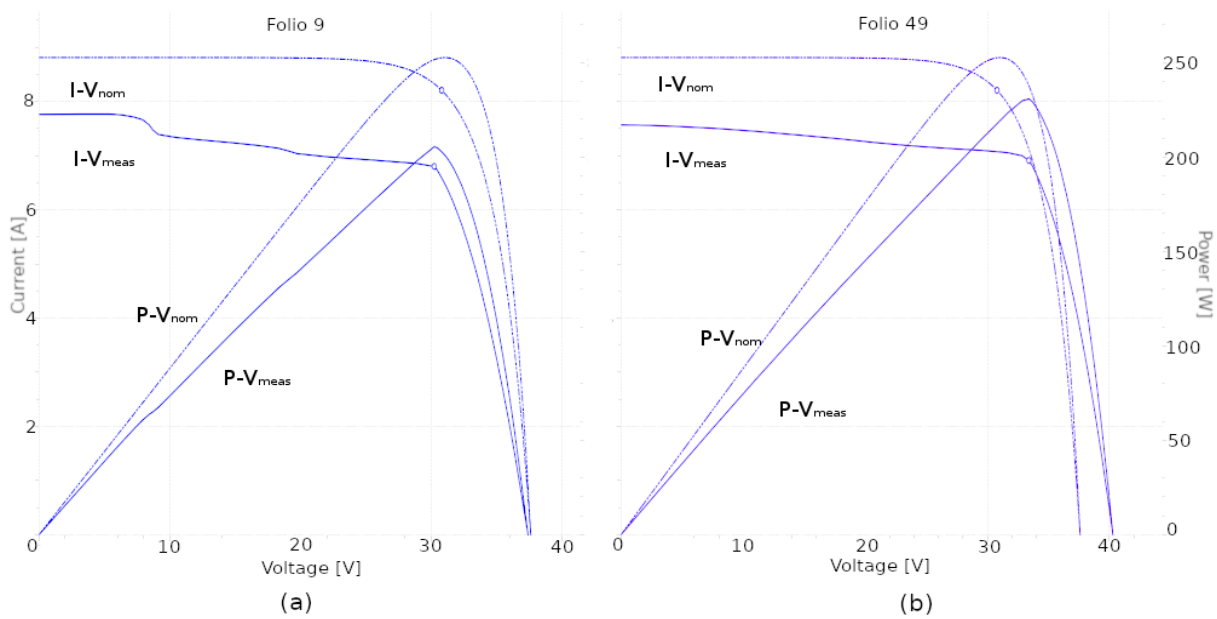
Figure 3.21: I-V/P-V characteristics of modules with milky discoloration (a) extensive, (b) localized in bottom cells.

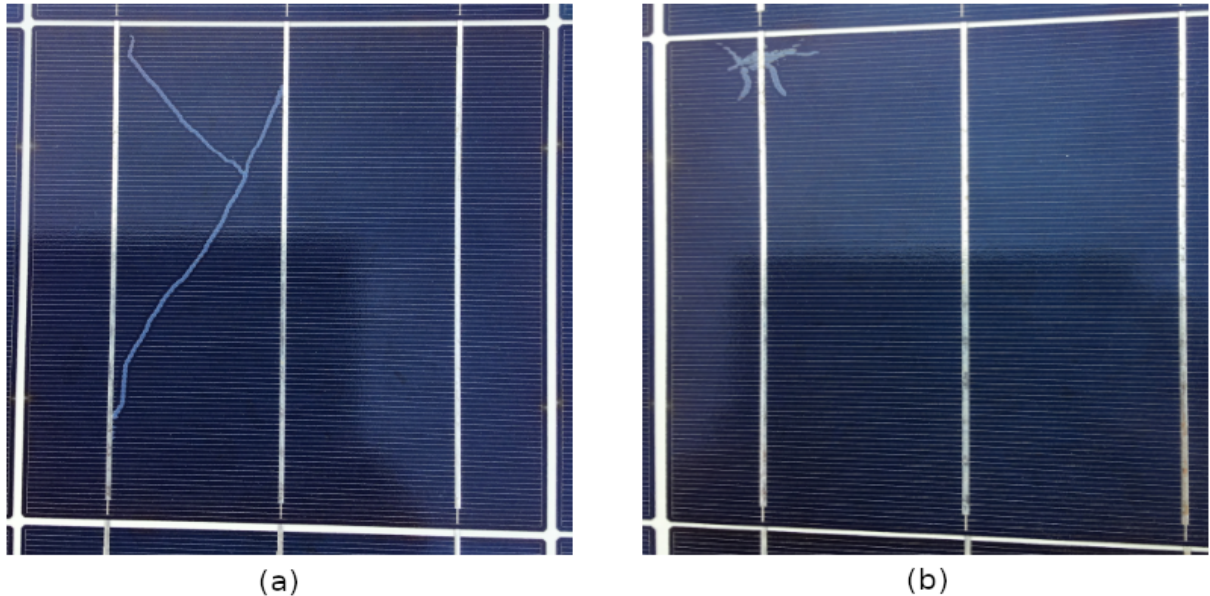
Figure 3.22: Visual inspection of module F35 showing localized delamination (a) over cells and gridlines and (b) around busbar.

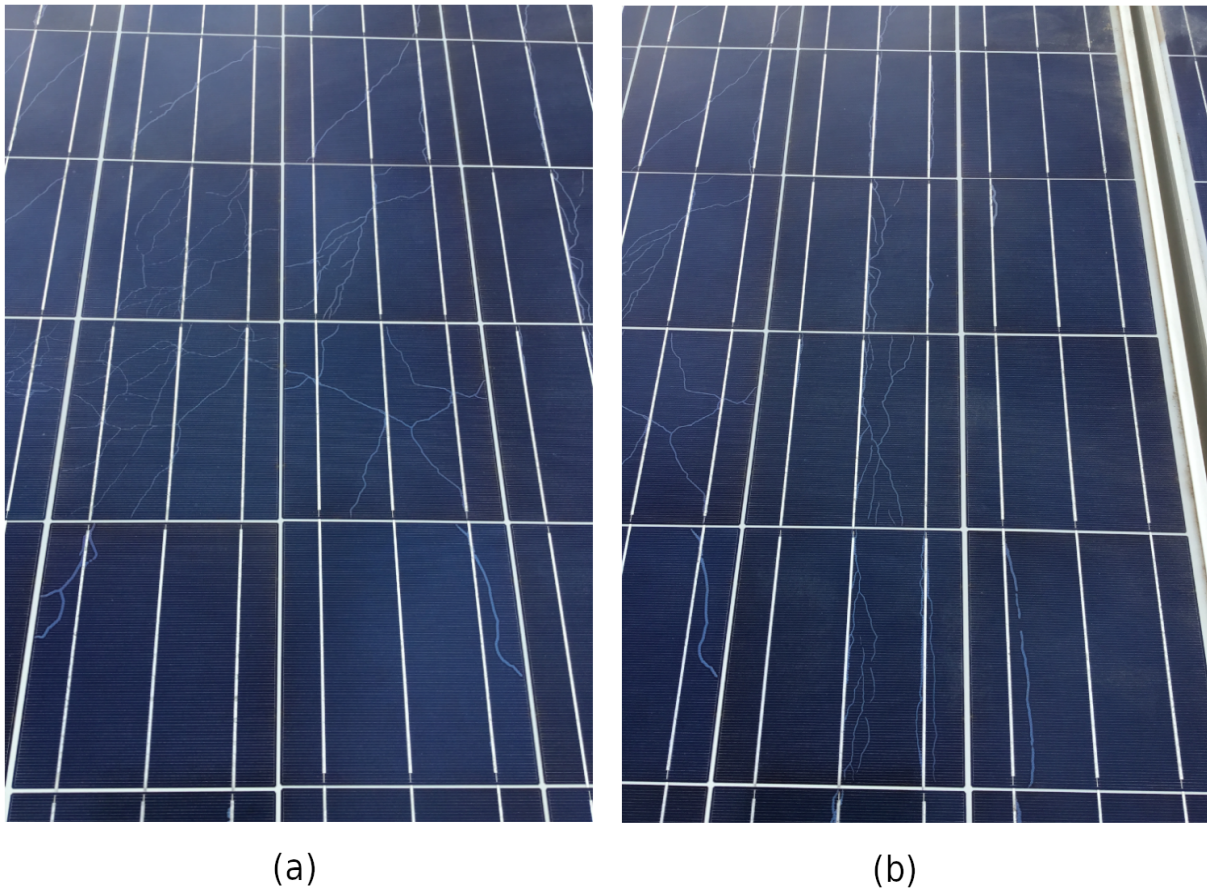
Figure 3.23: Visual inspection of a module with extensive delamination (a) over cells and (b) around busbars.

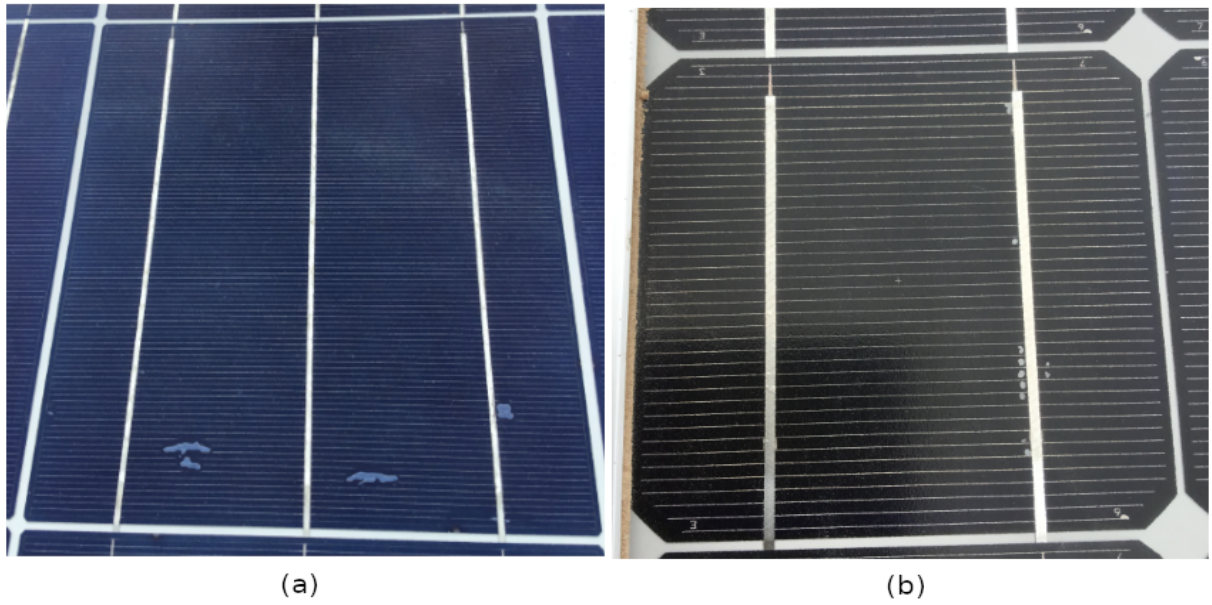
Figure 3.24: Visual inspection of delaminated cells of two modules around gridlines (a) and busbars (b).

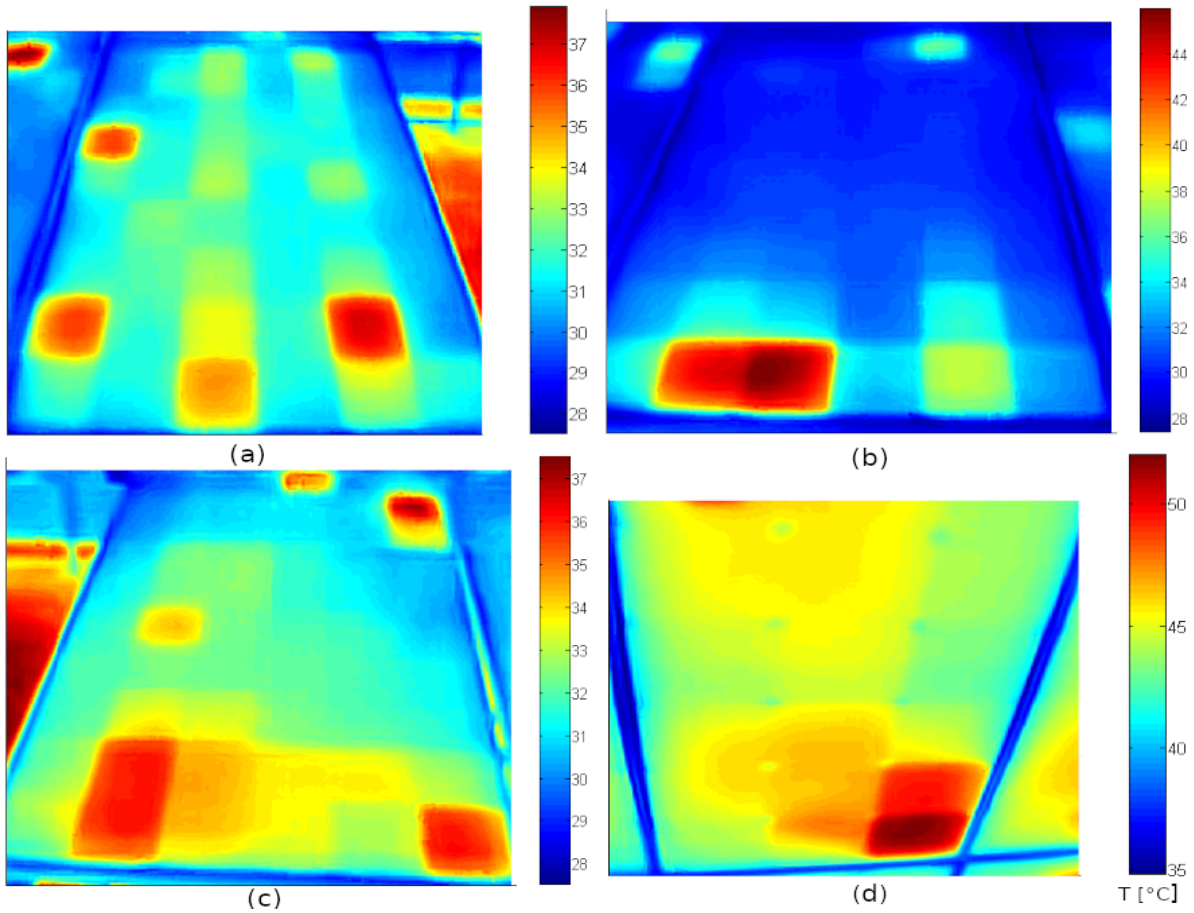
Figure 3.25: Thermal images of delaminated modules.

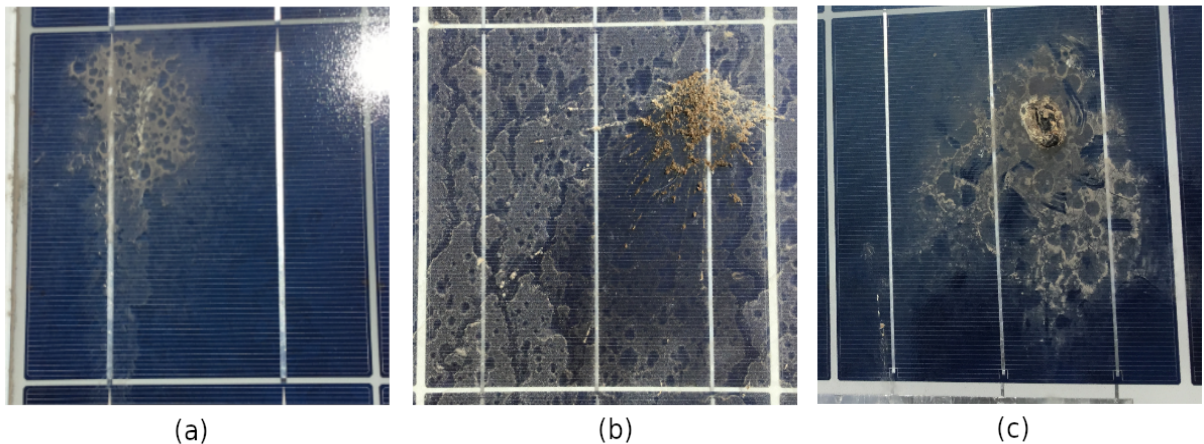
Figure 3.26: Visual inspection of cells with (a) localized dust deposition, (b) mud drop and (c) bird drop.

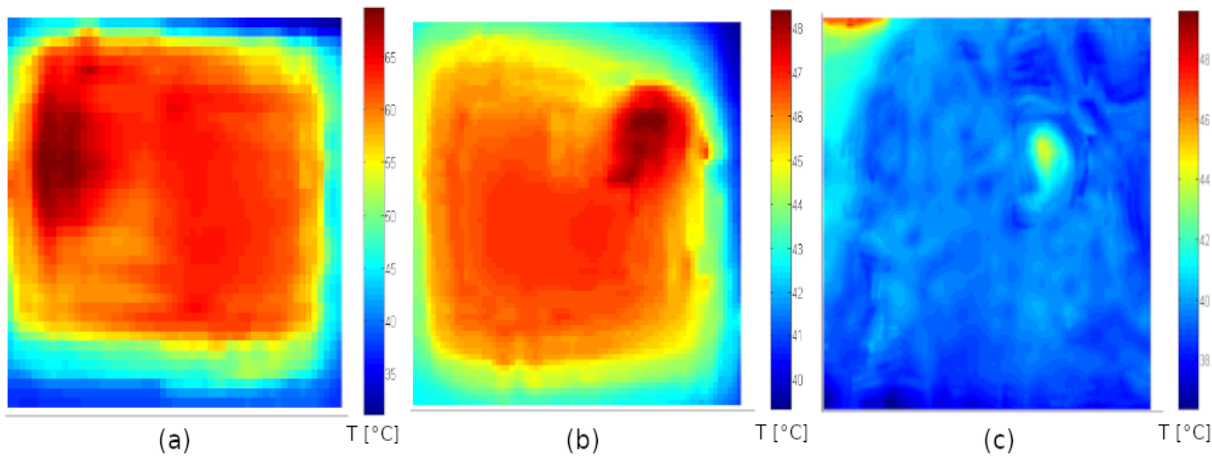
Figure 3.27: Close up of thermal images of cells with (a) localized dust deposition, (b) mud drop and (c) bird drop.

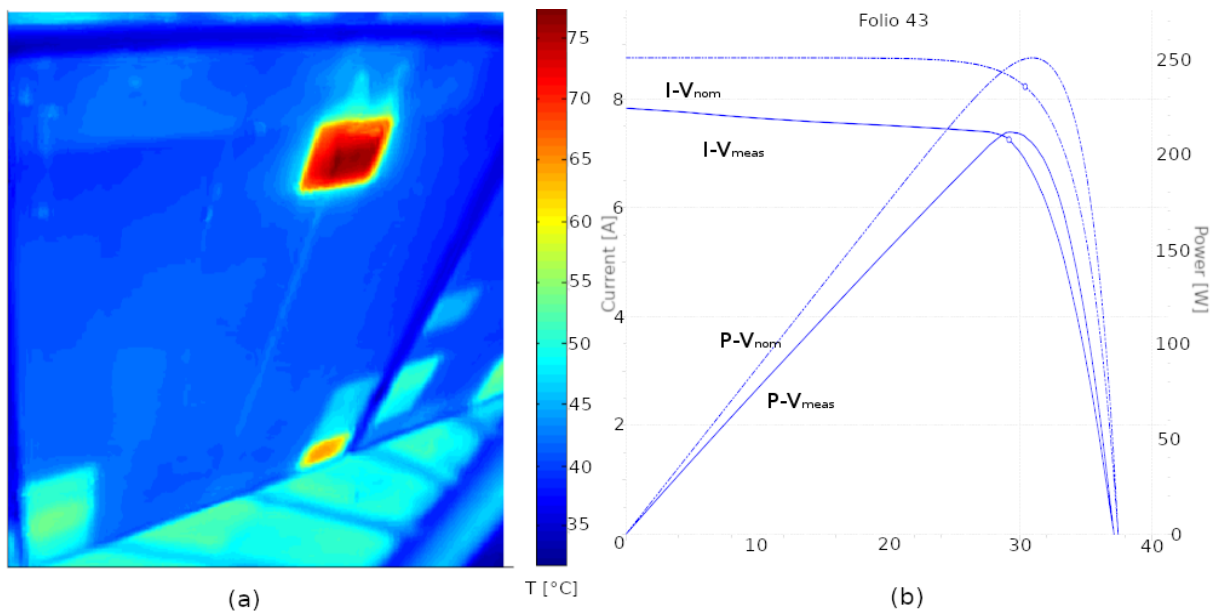
Figure 3.28: (a) Thermal image and (b) I-V/P-V characteristics of a module with partial shading caused by a thick bird drop.
