ANALYSIS OF FAILURES AND DEGRADATION MODES OF SMALL SCALE  
DOMESTIC/FARM PHOTOVOLTAIC POWER PLANTS IN RURAL COMMUNITIES  
OF THE ATACAMA DESERT

TESIS PARA OPTAR AL GRADO DE  
MAGÍSTER EN CIENCIAS DE LA INGENIERÍA, MENCIÓN ELÉCTRICA

PIA JAVIERA VASQUEZ RIVERA

SANTIAGO DE CHILE  
2020

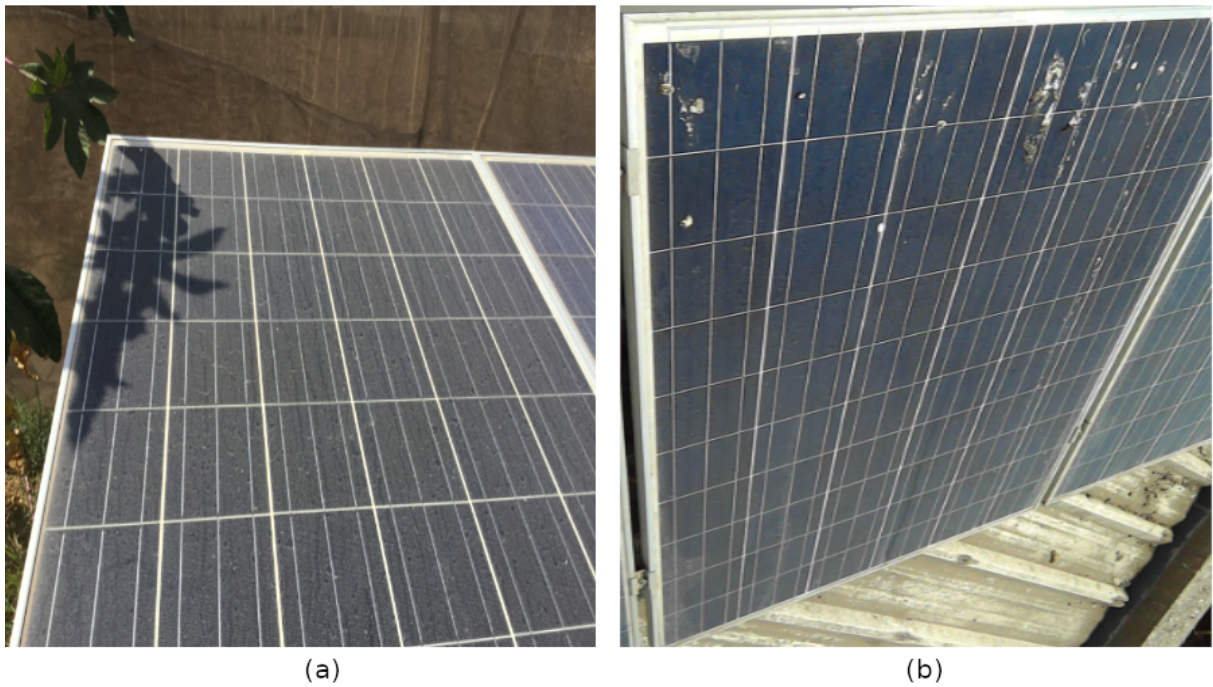
Figure 3.29: Visual inspection of modules with partial shading caused by (a) a plant and (b) a thick bird drop combined with dust deposition.

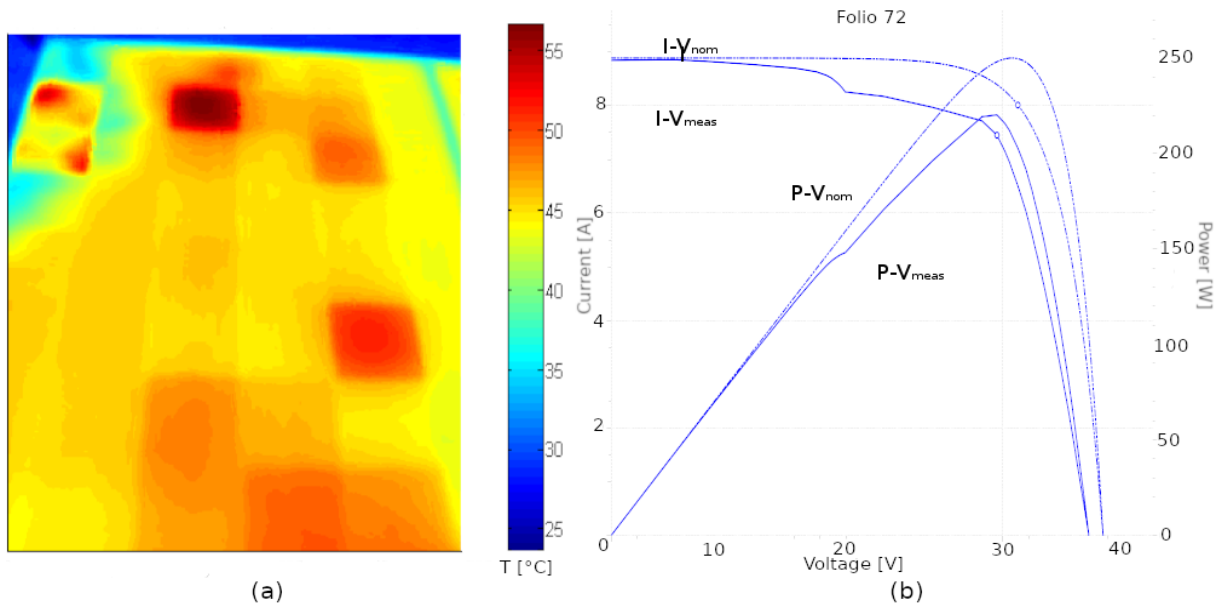
Figure 3.30: (a) Thermal image and (b) I-V/P-V characteristics of partially shaded module by a tree.

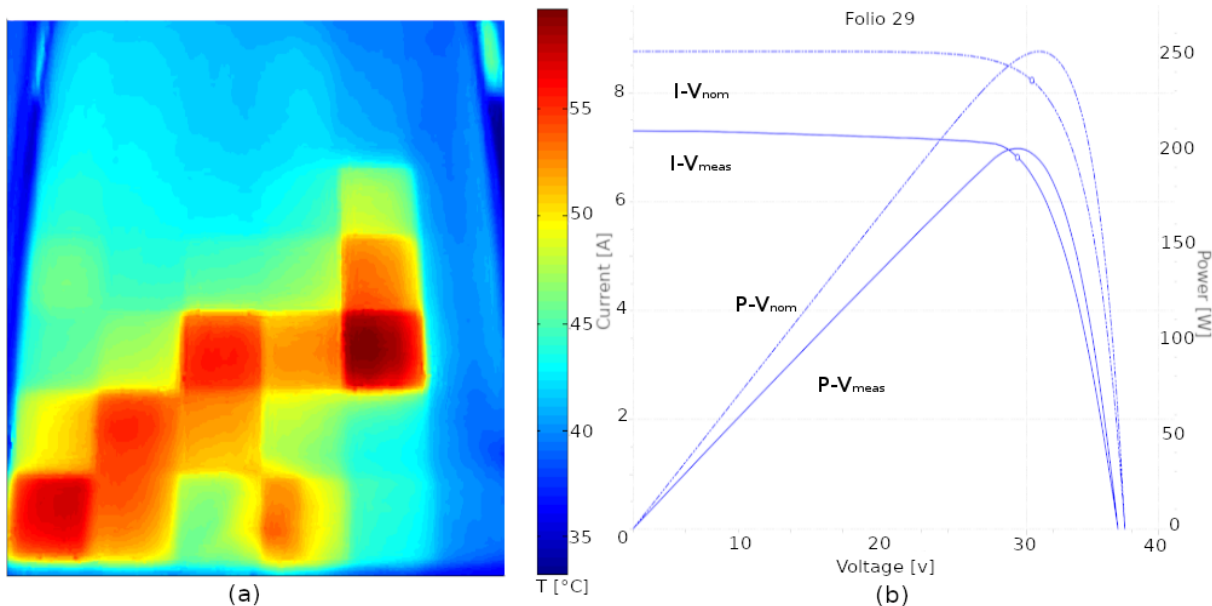
Figure 3.34: (a) Thermal image and (b) I-V/P-V characteristics of a module with one bottom cell half heated.

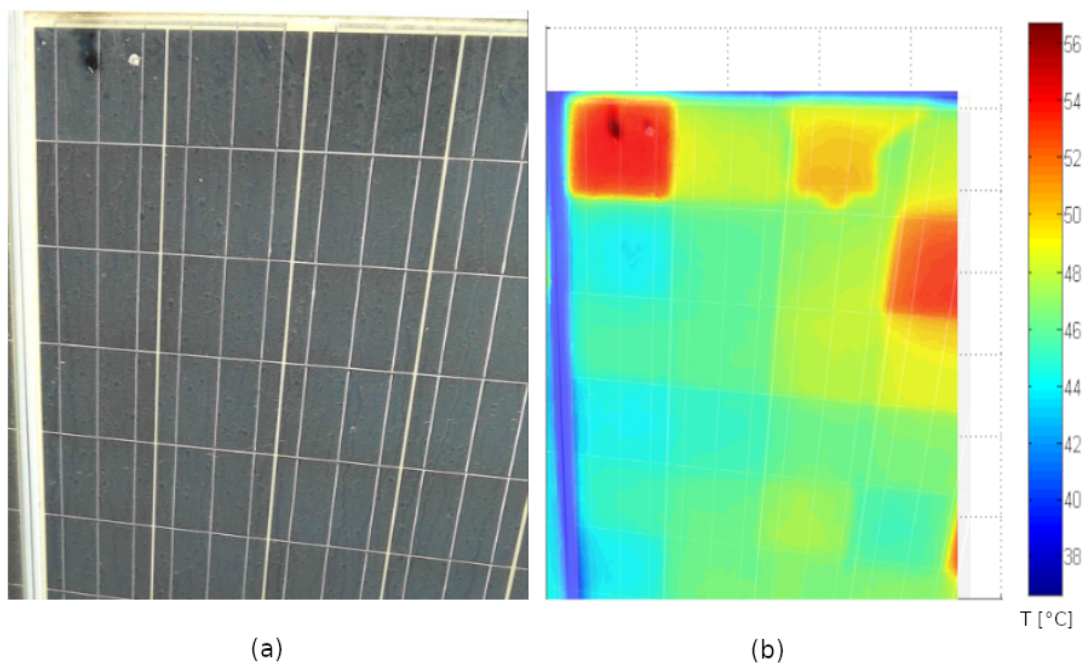
Figure 3.35: (a) visual inspection and (b) thermal image of module with a drop in cell R1C1 and a presumed fracture in cell R1C3.

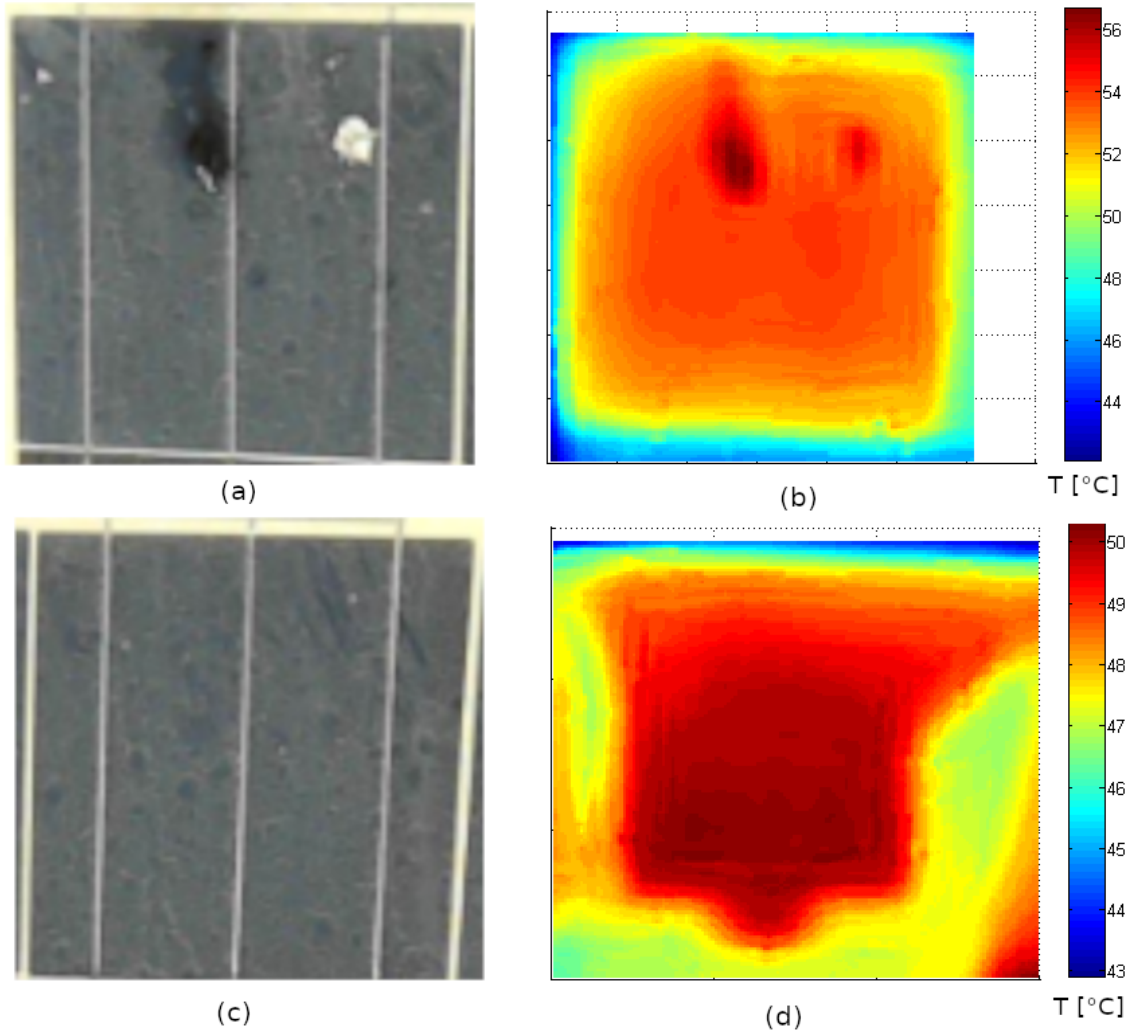
Figure 3.36: (a), (c) visual inspection and (b), (d) thermal image of a dropped and a presumably fractured cell.

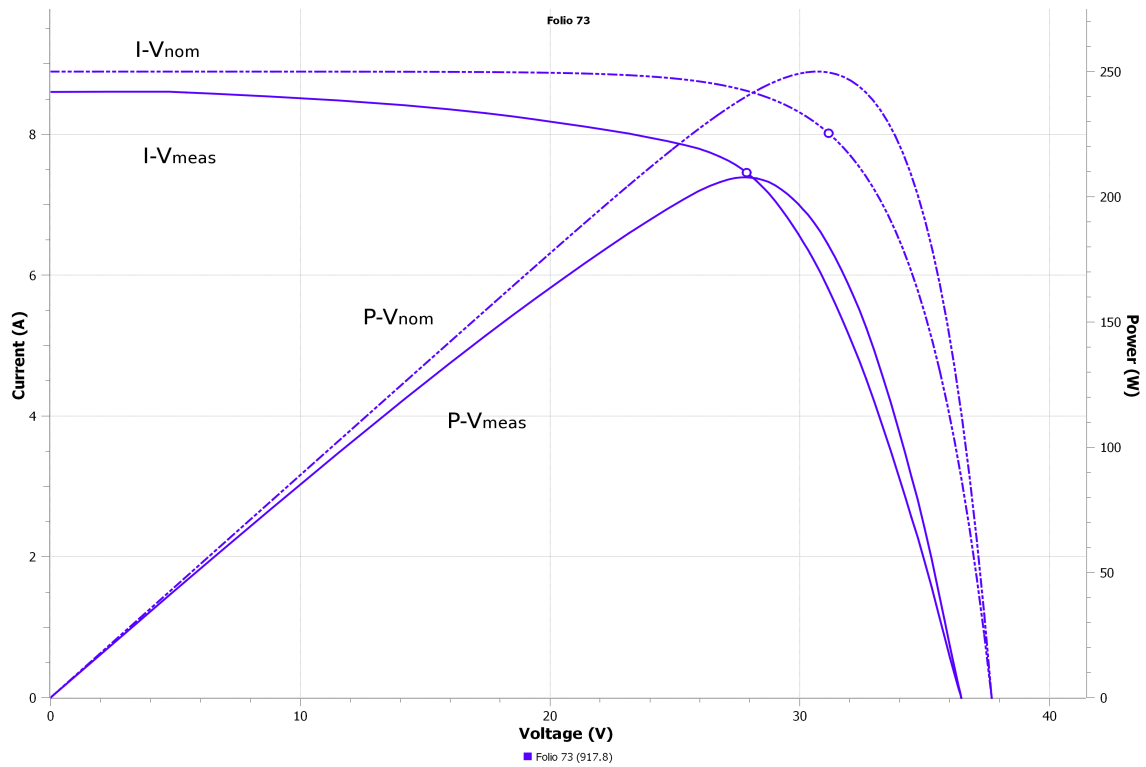
Figure 3.37: I-V/P-V characteristics of a module with a thick drop on one cell (R1C1) and a presumably fractured cell (R1C3).
