## Performance of the Torre Bosquemar and Olas buildings in San Pedro de la Paz and the Pedro de Valdivia building in Concepción in the 27 February 2010 offshore Maule, Chile earthquake

### SUMMARY

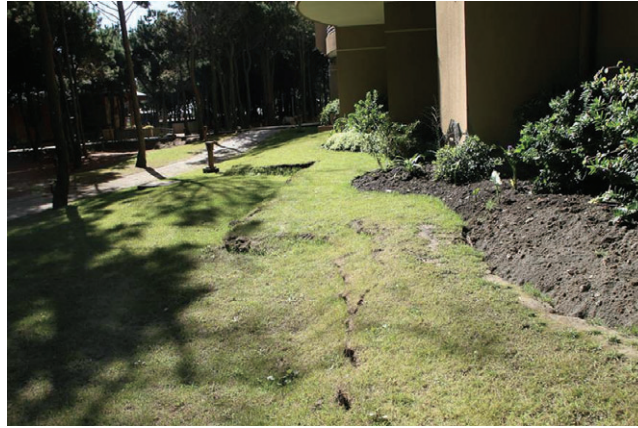
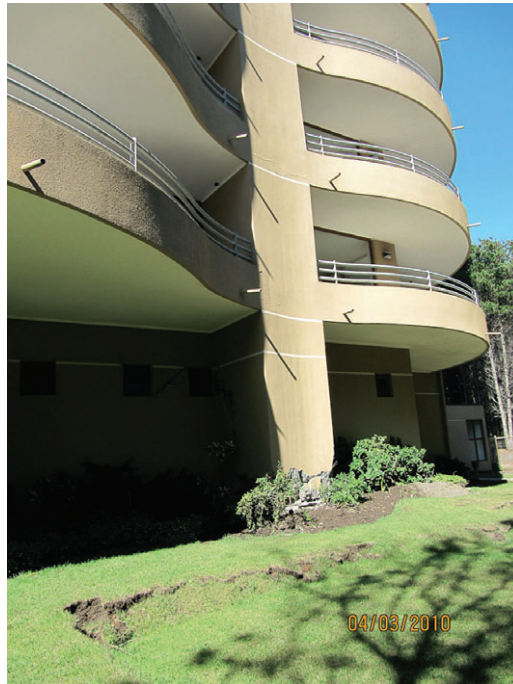
Figure 5. Soil depression along ocean-facing side.

Damage was visible along the exterior of the structure in a variety of locations. The first item of interest is the very noticeable depression in the soil along a large portion of the ground along the ocean-facing side of the tower as shown in Figures 5 and 6. This type of depression occurred at multiple locations around the exterior soil of the structure. These depressions were most likely caused by either settlement of poor backfill compaction against the basement walls or rocking of the building at the foundation level.

Figure 6. Soil depression.

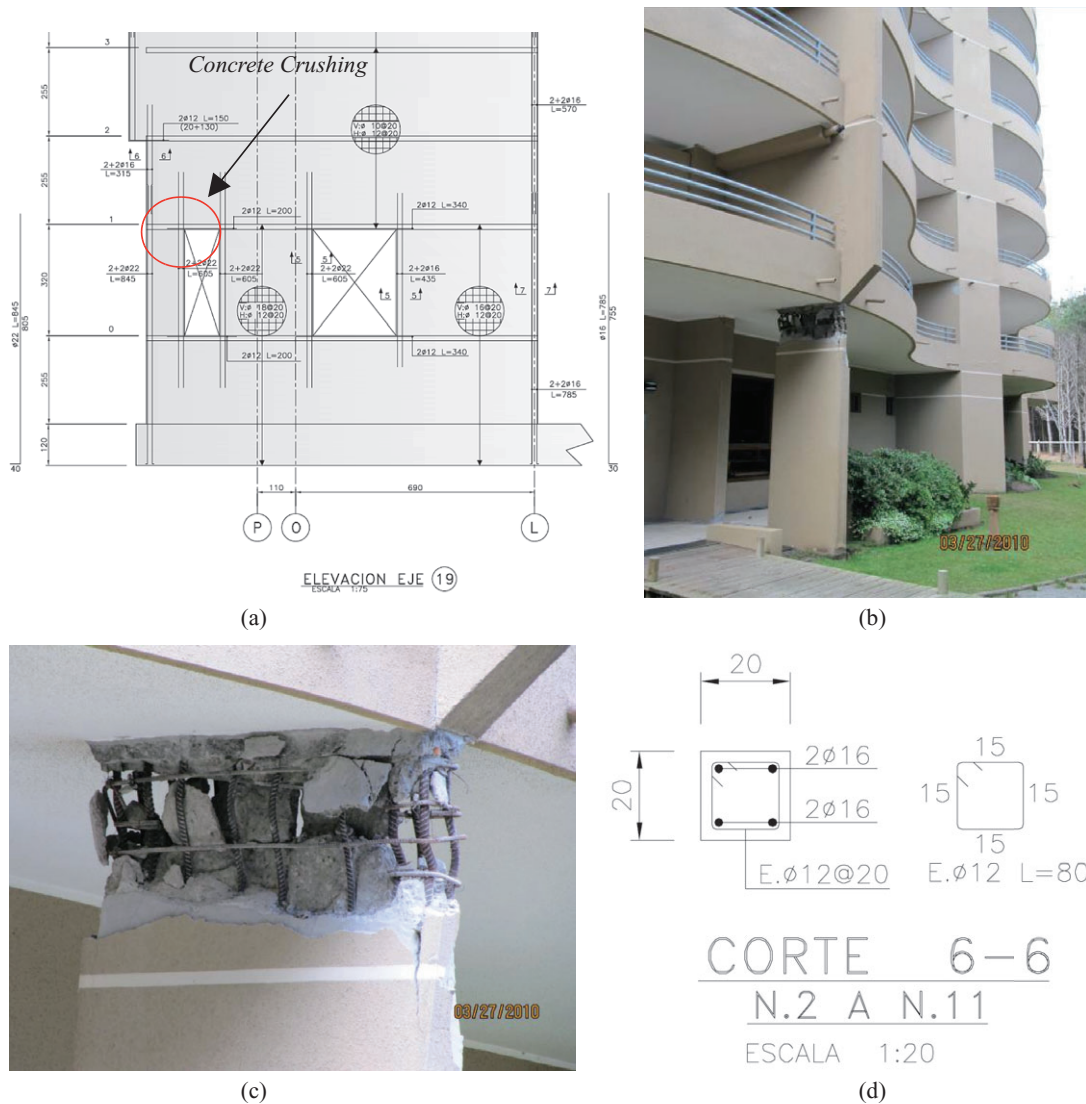
One of the main recurring themes of damage in buildings during this particular seismic event was thin walls with moderate to no boundary confinement steel seeing flexural/compression crushing, oftentimes focused in areas with vertical discontinuities. This type of damage was prevalent at Bosquemar as well, which had 20-cm (7.87 in.) walls, typical throughout the entire structure. Referencing Figures 7 and 8, this type of damage is first noticeable at the ocean-side exterior along gridline 19 that bisects the structure along the transverse direction. The shear wall along this gridline is continuous with no openings from gridline L to the extreme edge of the structure for the entire height of the structure (see Figure 7) other than openings that occur at floor 1 level as shown in the elevation of line 19 as shown in Figure 9(a). One of these openings at floor 1 is very close to the edge of the shear wall, which likely saw very high compressive stresses from the overturning of the shear wall above. This resulted in concrete crushing, shown from afar in Figure 9(b), with a closer view in Figure 9(c). The detail for the boundary confinement at this location, shown in Figure 9(d), was

similar to those throughout the structure. The crushing at this location resulted in significant buckling of the longitudinal bars as well as a noticeable out-of-plane offset between the top and bottom of the crushed zone.

Figure 9. (a) Elevation of lower floors along line 19; (b) concrete crushing along line 19; (c) closer view of crushing at top of wall; (d) boundary confinement details at line 19.

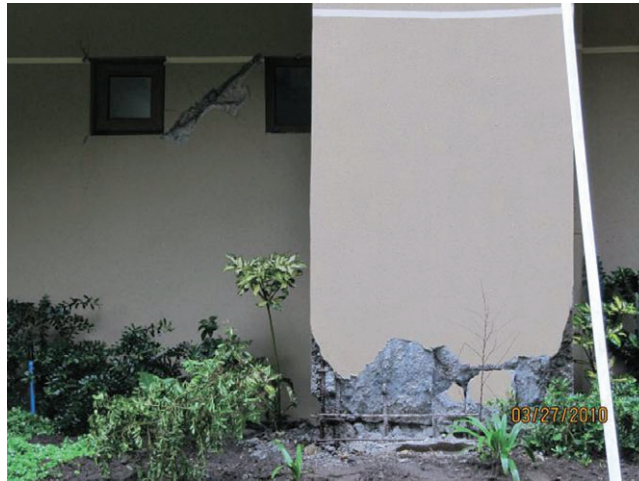
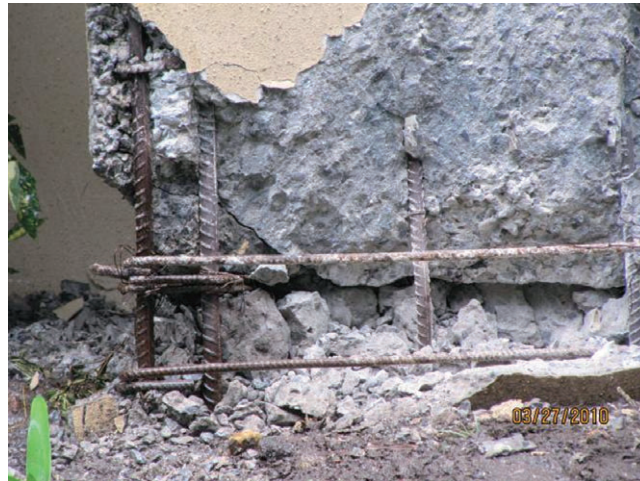
Further along this same exterior edge of the building, significant crushing was found along the curved shear wall near gridline O between lines 4 and 5. As shown in Figures 10 and 11, there was significant spalling of concrete at the bottom of the wall. Although the crushed shear wall itself is relatively short in length and most likely did not attract a large amount of in-plane loading, it is used as a flange by transverse walls along both lines 4 and 5. Given that no enlarged boundary elements were used, it appears that the overturning forces from the two perpendicular walls may have had a significant contribution to the crushing stresses in this wall.

Figure 10. Crushing at exterior wall between lines 4 and 5.

Figure 11. Close up view of concrete crushing and rebar between Lines 4 and 5.

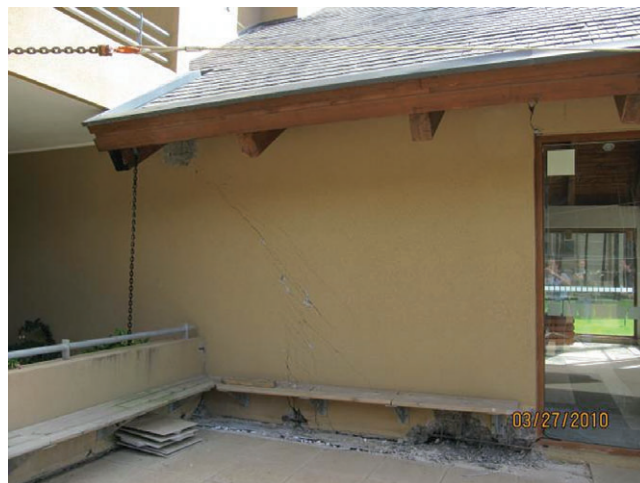
Another location of significant damage occurred along the entrance side of the structure, facing inland. Significant cracking was seen along both walls of the entrance lobby as shown in Figures 12 and 13. Referencing Figure 7, these walls span along gridlines 15 and 22 from line K to D above the first floor. However, at the first floor, these walls extend out from the front face of the tower as seen in Figure 8, creating a vertical discontinuity and an outrigger effect.

The elevation along gridline 15 (Figure 14) reveals that an opening exists directly under the diagonal cracking. While the extended wall acted similar to an outrigger and attracted large demands from the walls above, there is not a suitable load path down the through the structure for these large demands. This results in the concrete crushing shown at the edge of the ground level wall near the opening (Figure 15) as this crushing is occurring at the only location where there is another concrete wall underneath that is able to continue the load path down to the foundation.

Figure 12. First floor wall along gridline 15.

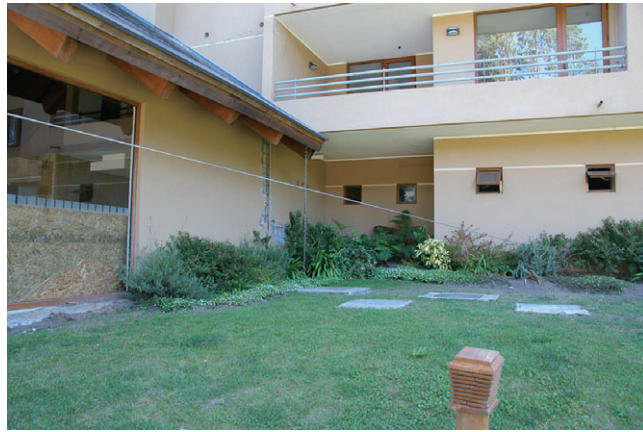
The elevation along the other wall of the entrance lobby (along line 22) is identical to line 15 with the exception that there is no opening in the floor below. Because of this, the load path does not need to span over an opening in the lower level as it does along line 15, as described earlier. On the other hand, along line 22, it appears that the overturning demands from the floors above create flexural/compressive stresses that are too great, thus creating the large vertical crack that can be seen at the interface of where the elongated wall extends outwards from the typical length walls in Figure 13.

Figure 13. First floor wall along gridline 22.

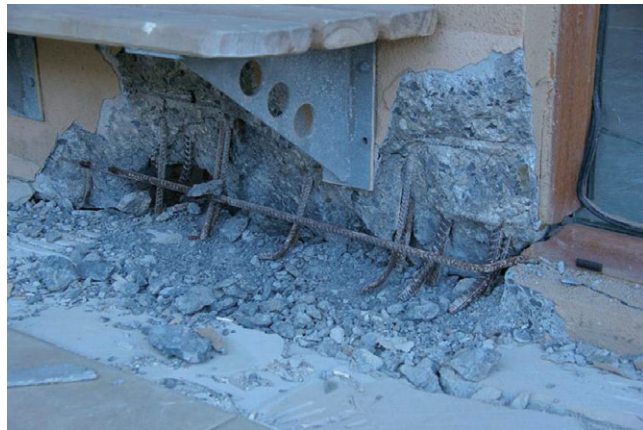
Figure 15. Concrete crushing at edge of 'outrigger wall' along gridline 15.

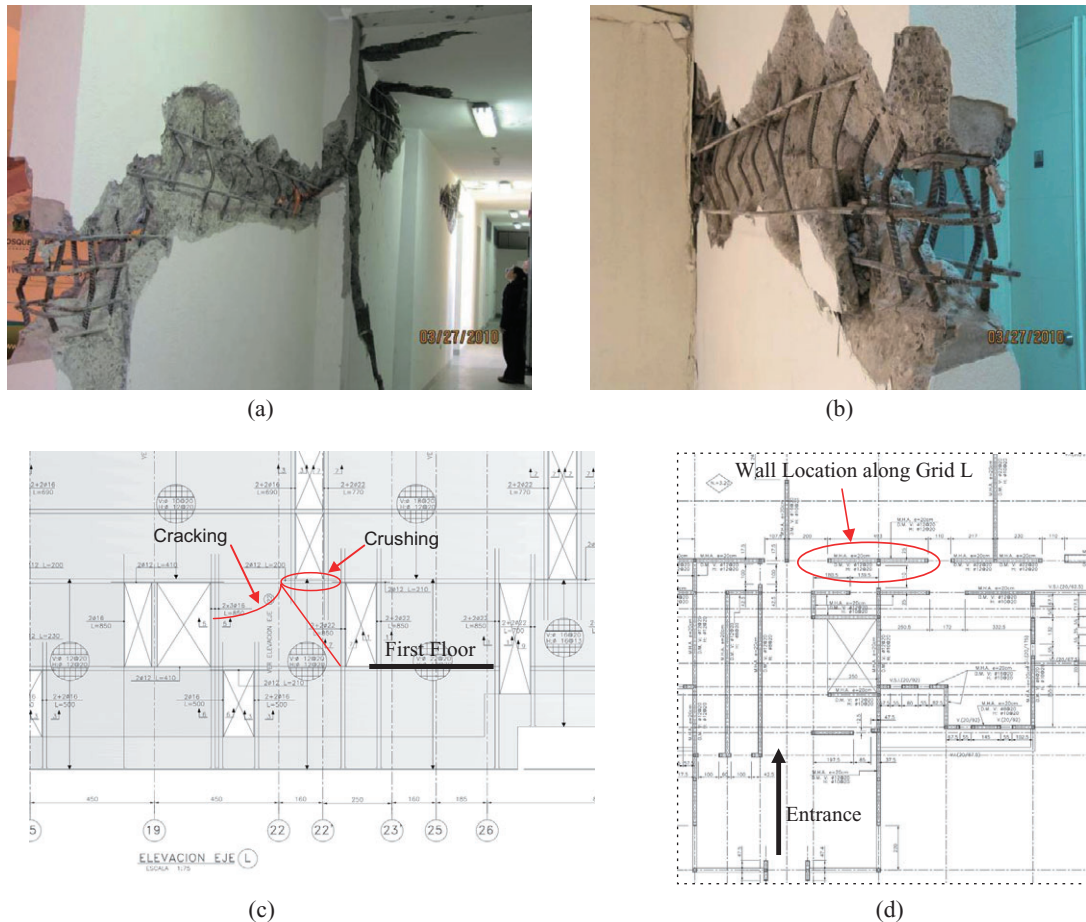
One of the more substantial cases of concrete crushing that resulted in the rupture of vertical bars was within an interior wall shown in Figure 16. This damage occurred at the first floor along line L on the wall centred along line 22 (refer to Figure 8). The large crack turns horizontal, with noticeable vertical bar buckling along its entire length until the edge, where both the vertical bars as well as the transverse bars confining them were ruptured as shown in Figure 16(b).

Reviewing the elevation of this location, this damage seems to be the result of vertical discontinuities within the shear walls combined with the thin wall thickness and lack of confinement. Crushing occurred at the top of the wall where there was likely high compressive stresses caused by the flexural overturning of two different walls from above (See Figure 16(c)). The opening at the first floor between lines 22' and 23 focuses the majority of the compressive stress from the wall above to travel through the wall centred along line 22. Yet, given the opening at the basement level, between lines 19 and 22, there is another discontinuity in the vertical shear wall, and thus, the cracking ends up horizontal at this end of the wall.

Figure 16. (a) View of cracking/crushing looking down the hallway; (b) close-up view of bar rupturing; (c) elevation of location; (d) cropped plan of location (first floor).

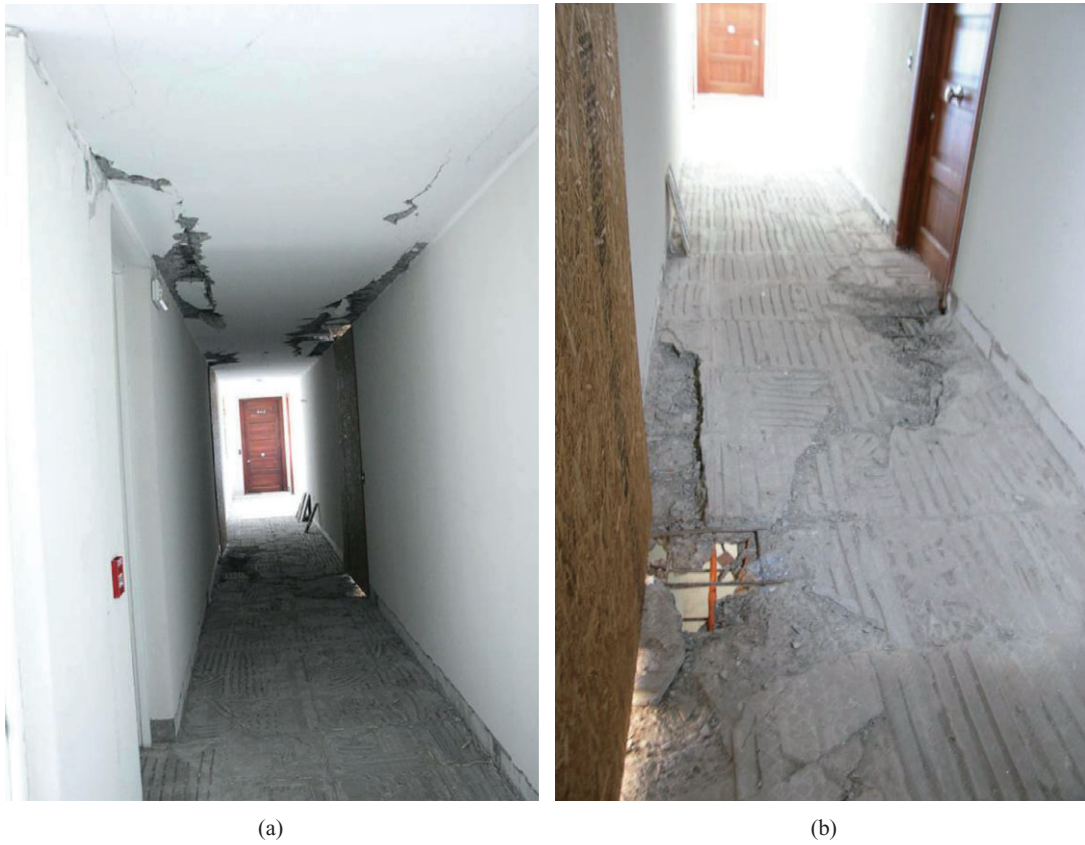
The majority of damage observed in the typical upper floors was in the slab itself. This occurred in slabs acting as coupling beams across door openings as well as in slabs acting as coupling elements between parallel walls. Both of these types of actions were very noticeable along the main corridor of the tower between the closely spaced walls along gridlines K and L for multiple floors along the height of the tower.

Figure 17(a) shows the typical types of slab coupling damage that was observed in the upper floors. The closet cracking in the image along the ceiling slab shows clear coupling between the parallel walls (gridline K on the left side, with gridline L on the right). At the doorway on the right side of the picture, daylight is able to be seen above and below the door where coupling beam-type action within the slab has crushed most of the concrete. In some locations, there was also diagonal cracking that developed between staggered openings within the two walls along the corridor as shown in Figure 17(b).

Although certain locations did see extra reinforcement, typical slab reinforcement through these corridors was 8 cm diameter bars at 20 cm on centre, or approximately no. 3's at 8 in. on centre. This type of damage was noted in other buildings in Chile during the event as well and results not only in substantial required repairs but can also jam doors.

Figure 17. Slab coupling damage.

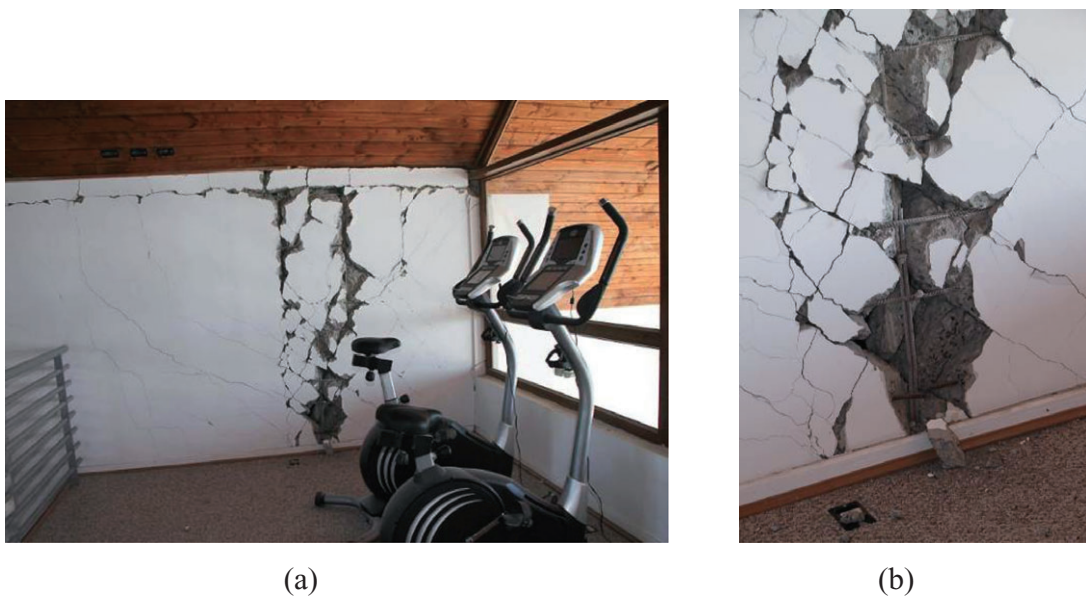
The most substantial wall cracking observed in the upper floors came at the top of the structure in the gymnasium area as shown in Figure 18(a). This was another case of a vertical discontinuity in a shear wall. The location of the damaged wall is shown in plan and elevation in Figure 19. The portion of wall that is damaged does not continue to any of the lower floors below the gymnasium level but

Figure 18. (a) Large cracks at gridline 15; (b) lap splice concrete spalling.

is restrained by the wall along line L, which most likely caused large shearing demands through this short length of wall, resulting in the severe vertical cracking only over a limited section of the wall shown in the image. The bottom of the wall, where the largest amount of concrete spalling occurred, was a lap splice location as shown in Figure 18(b).

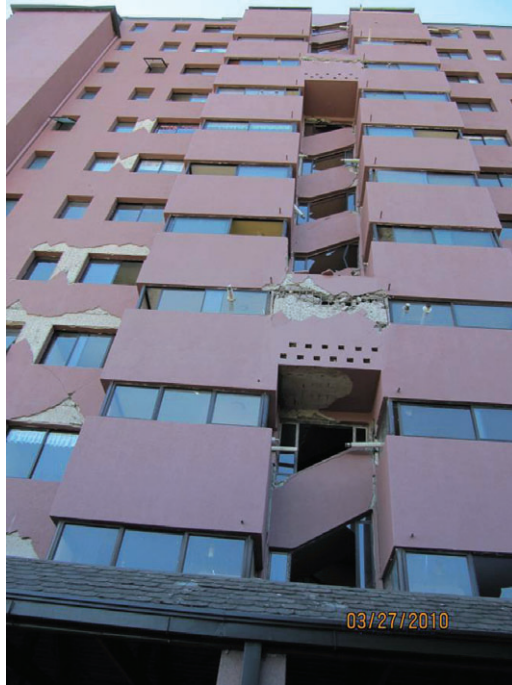
Figure 20 shows the stairwell between two shear walls along the height of the structure. The slanted windows along the stairways resulted in concrete elements that during the seismic event acted as braces between the two walls that they connected to on each end. In addition, areas at about the one-quarter and three-quarters height along the stairway were used for water and power systems. As shown in the image, these locations behaved as short columns and failed in shear. These are clear examples of architectural elements not originally intended to have a structural purpose adopting roles in the lateral system. This therefore results in an alteration of presumed manner in which the lateral system will behave as well as a high probability of damage to the elements in question.

Figure 20. Diagonal stairwell elements along height.

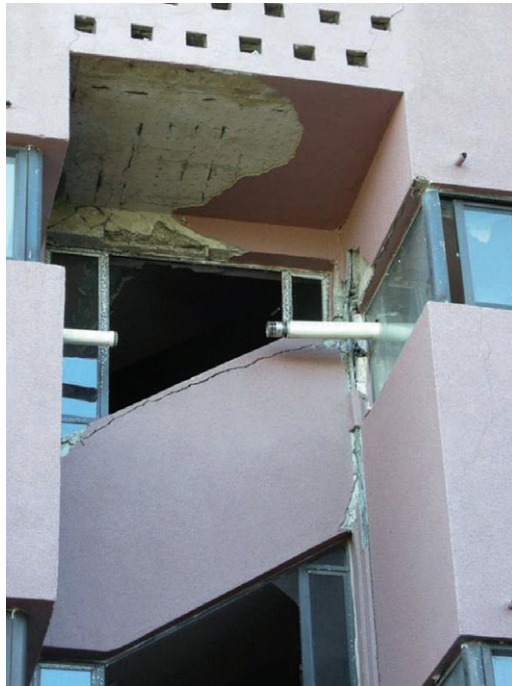
Figure 21 shows the exterior damage that occurred at the ends of the stairwells where the concrete was acting as a sloping non-ductile coupling beam. The interior of the stairwells revealed excessive crushing and spalling of concrete at each edge of the slanted window openings (Figure 22). It also reveals that although the walls on each of the stairwell were detailed with boundary confinement, these boundary zones occur within the span of the stairwell and not within the portion of the wall that is restrained within the structures diaphragm (see plan view in Figure 23).

Figure 21. Damage at ends of stairwell.

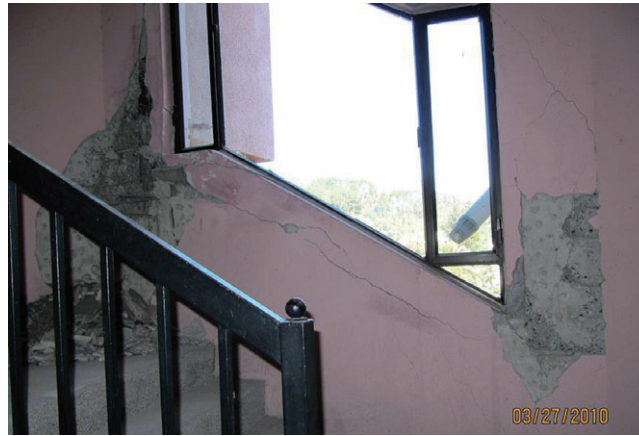
Figure 22. Interior view from stairwell.

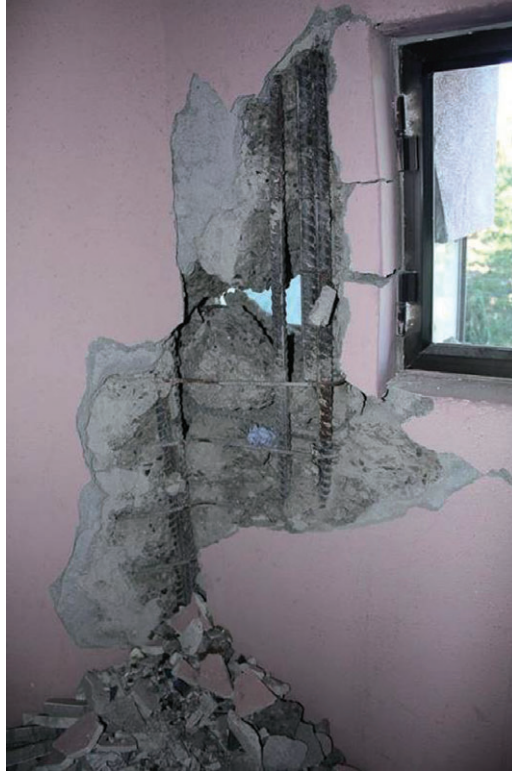
In addition, these boundary zones are located approximately 6 in. from the edge of the slanted window openings as shown in Figure 24, leaving this amount of concrete to crush and spall. It can also be seen that the slanting concrete sections along the exterior edges of the stairwells were not originally detailed to act as coupling or to behave in a ductile manner. Therefore, these end up behaving as non-ductile coupling beams during the earthquake.

Figure 24. Close-up of interior damage at an edge of the stairwell.

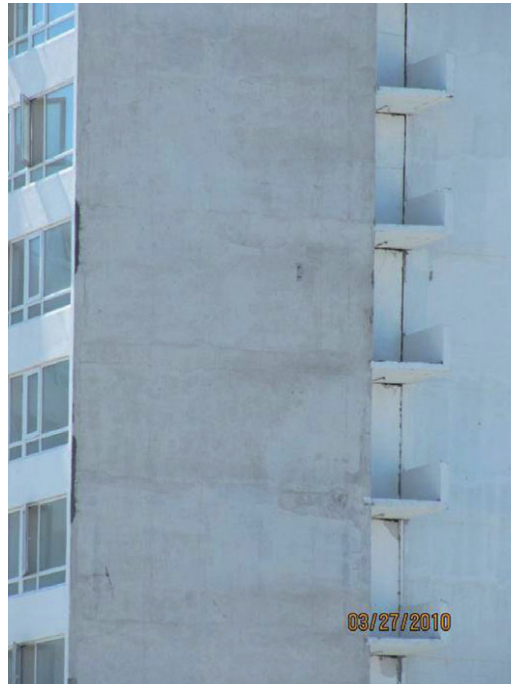
The Olas building in San Pedro de La Paz was unoccupied during the seismic event. The building is actually two separate structures with a sloping profile along a curving plan. Only limited information could be collected from the observation but two important items were discovered. The first was cracking along the far edge of the structure, which is able to be seen in Figures 25 and 26. It appears as though some cracks may have already been covered or painted over by the time the pictures were taken one month after the earthquake. Figure 27 shows the same end of the building just after the earthquake. In addition, there was evidence of the two closely spaced structures pounding against each other during the earthquake as shown in Figure 28.

Figure 26. Close view of cracking at extreme edge with repairs made.

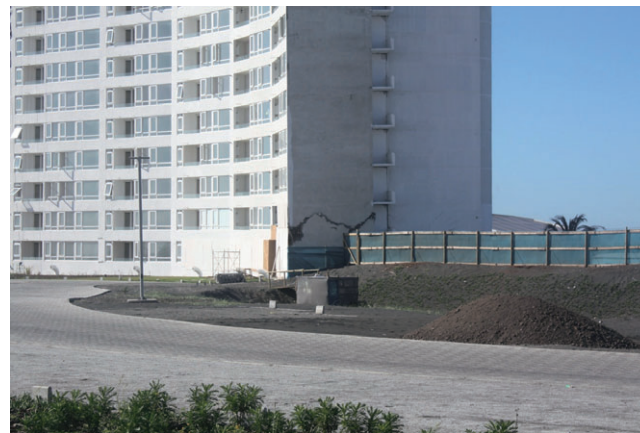
Figure 27. View of damage of end walls after earthquake and before repairs.

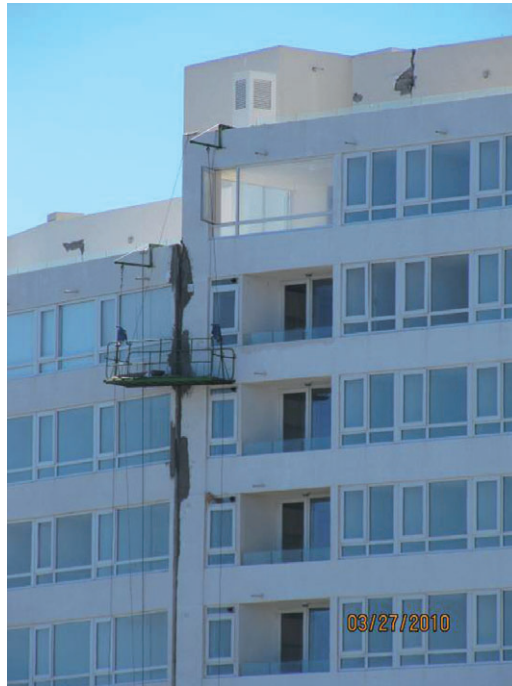
Figure 28. Evidence of pouncing.

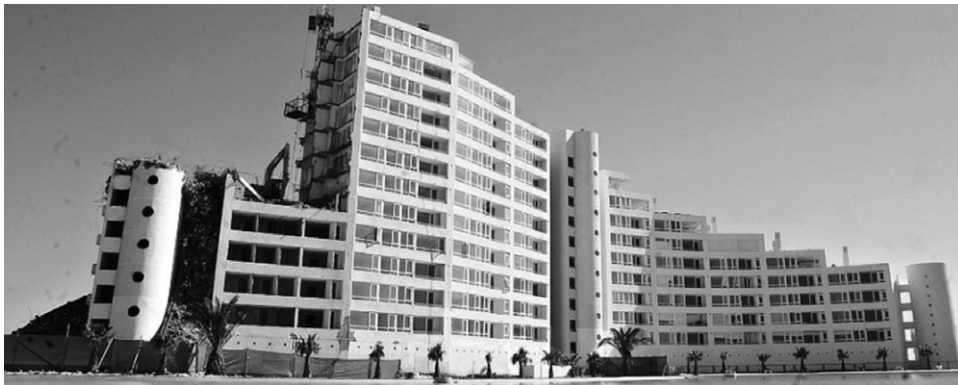
Current information dictates that the earthquake caused far greater damage than the exterior images revealed. As of August 2010, a large portion of the taller end of the structure has been under demolition, cited as part of repairs to the structure for the damage caused (see Figure 29). Although the demolition is extensive, it is suggested that the demolished section will be reconstructed, and the building will be completed and opened (per the *Concepción Journal*).

Figure 29. Demolition work caused by damage from earthquake, as of August 2010 (source: <http://i857.photobucket.com/albums/ab134/roogenial2/olasim.jpg>).
