## Performance of tall buildings in Santiago, Chile during the 27 February 2010 offshore Maule, Chile earthquake

### SUMMARY

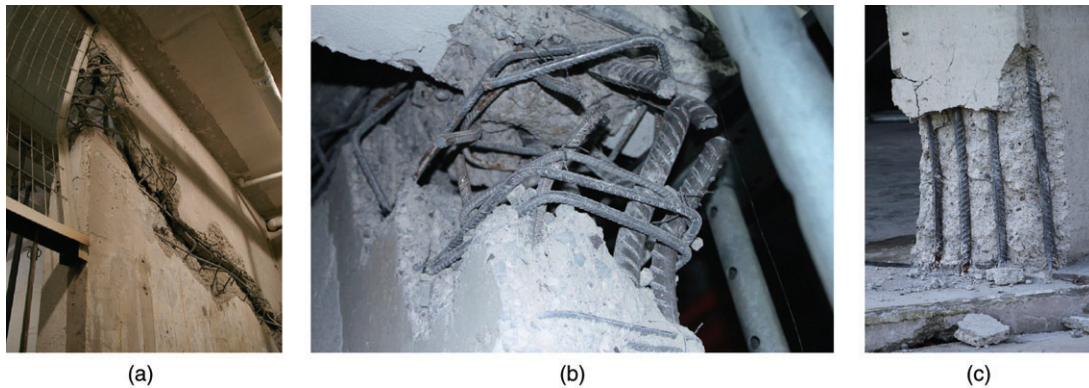
Two types of damages were observed repeatedly in the damaged buildings inspected by our team in Santiago, as well as other cities. First, the predominant mode of failure appeared to be the tension-compression failure of the shear walls at the ground floor or the floor immediately below the ground level (see Figure 7a), and second and closely related, the tearing of main bars at the extreme ends of walls at the location of failure, particularly when the main bars were bent (see Figure 7b). It is possible that the tearing of these bars is related to low-cycle fatigue caused by the numerous cycles of loading and unloading caused by the long duration of the strong ground motion during this earthquake.

Figure 6. Location of damaged buildings in Santiago visited by our team. (a) Typical tension-compression failure of the wall (El Parque building). (b) Tearing of main bars at the wall failure zone near the end of the wall; transverse ties typically had only 90° hooks (Sol Oriente building). (c) Lack or shortage of transverse reinforcement and/or inadequate confinement (Empresarial Complex).

Figure 7. Typical failures.

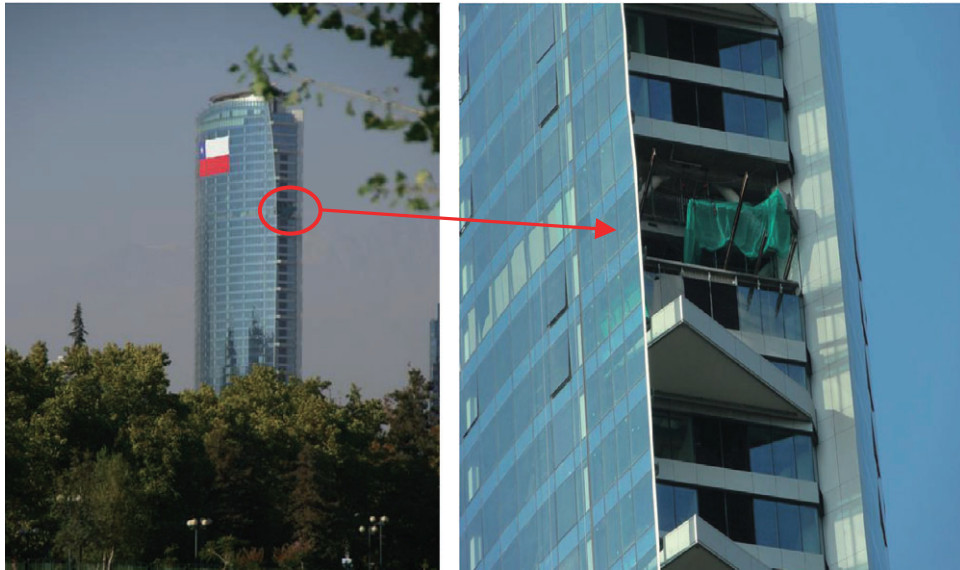
structural damage. The non-structural damage was limited to partial separation of a cladding piece at about 40 floors above the ground (Figure 8). The structural system of the tower consists of precast floor panels with cast-in-place topping and concrete columns and walls (Figure 9). The lateral system is augmented by a passive energy dissipating device located at the two narrow ends of the building and connected to the floors above and below with large pipe section braces (Figure 10). No damage to the basement walls and subterranean floors were observed in any of the seven subterranean floors (Figure 11).

Figure 8. The Titanium Tower, local cladding damage.

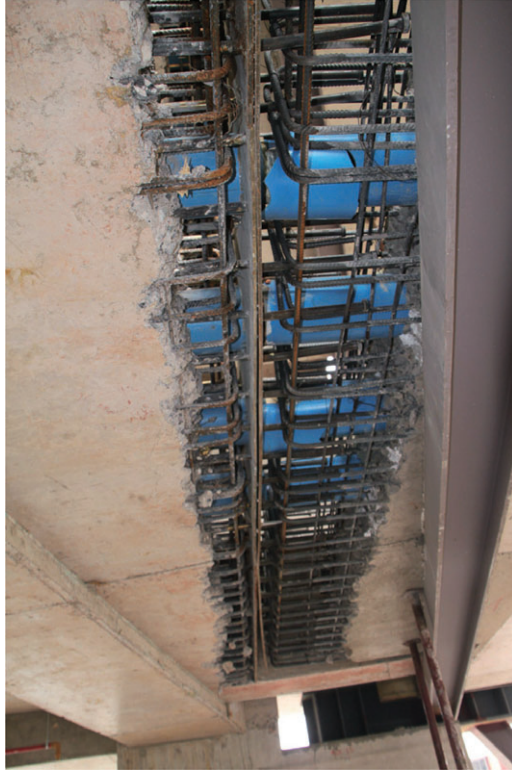
This is a reinforced concrete building with a post-tensioned system deployed for the bridges connecting the two wings. Although a large gap and isolation bearings were placed to protect the bridge from the adverse effects of the relative movement of the two wings (Figure 14), it appears that the likelihood of buildings moving towards each other was not properly contemplated either during design or implementation. As a result, during the earthquake, there was relative movement of the wings and damage was observed at the bridge–wing interfaces (Figure 15).

Figure 15. Damage to bridge due to relative movement of the wings.

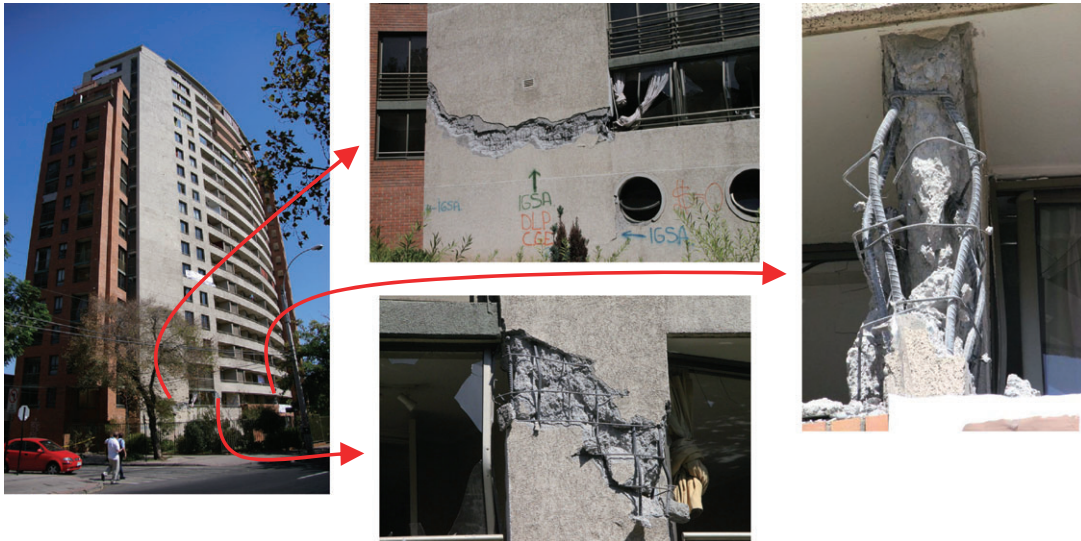
The Central Park building is a 19-storey reinforced concrete shear wall building. Above the ground level, the building suffered tension-compression failure of one of the exterior walls, a column and a transverse wall, all at the second floor above the ground (see Figure 17). The significant buckling of the transverse wall main bars revealed lack of seismic hoops, small diameter of the transverse reinforcement and the large distances between transverse reinforcement bars provided. The transverse reinforcement typically only had 90° hooks. In combination, this apparently caused the transverse reinforcement incapable of providing adequate bracing for the main bars, resulting in their buckling.

Figure 17. Aboveground damage.

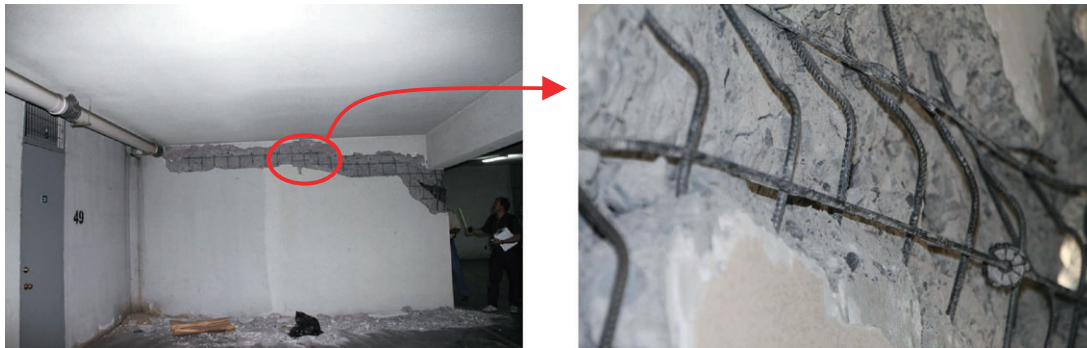
The damage observed in the subterranean parking areas (Figure 18) was very typical of the damage observed in many buildings in Chile. That is tension-compression failure of the wall, which was probably instigated by high axial forces at the extreme ends of the wall, where lack of adequate bracing for the main bars and confinement apparently caused failure in this zone, which then propagated along the length of the wall.

Figure 18. Typical below ground damage at the Central Park building.

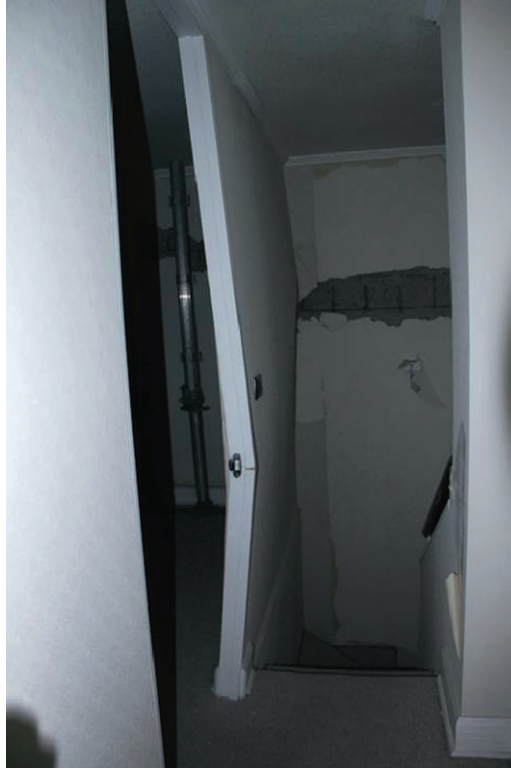
At the time of our visit, the damaged building was out of plumb and the roof was leaning by about 24 cm with respect to the ground. The shortening of the floor-to-floor height was clearly visible on the second floor of the building (Figure 21). The damage similar to what was explained in Section 2.5 at the subterranean floors was observed at other walls, as well for the same probable reasons explained previously (Figure 22). Extensive shoring in the lower levels was implemented to prevent the building from leaning further to the side (Figure 23).

Figure 21. Shortening of floor height causing buckling of non-structural panel.

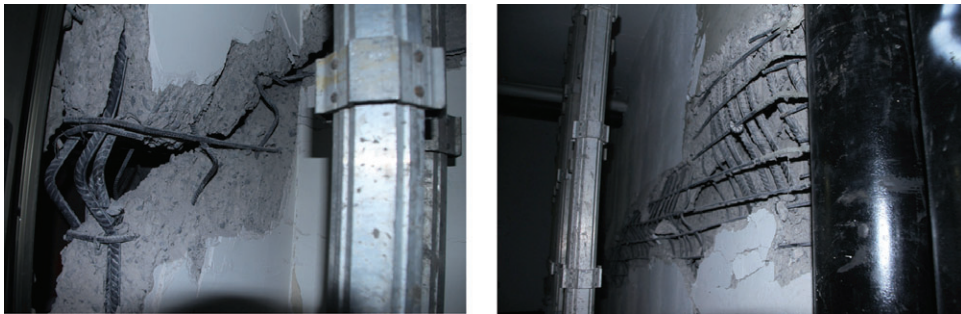
Figure 22. Typical wall damage (note lack of seismic hooks and buckling of main bars).
