Performance of tall buildings in Concepción during the 27 February 2010 moment magnitude 8.8 offshore Maule, Chile earthquake

SUMMARY

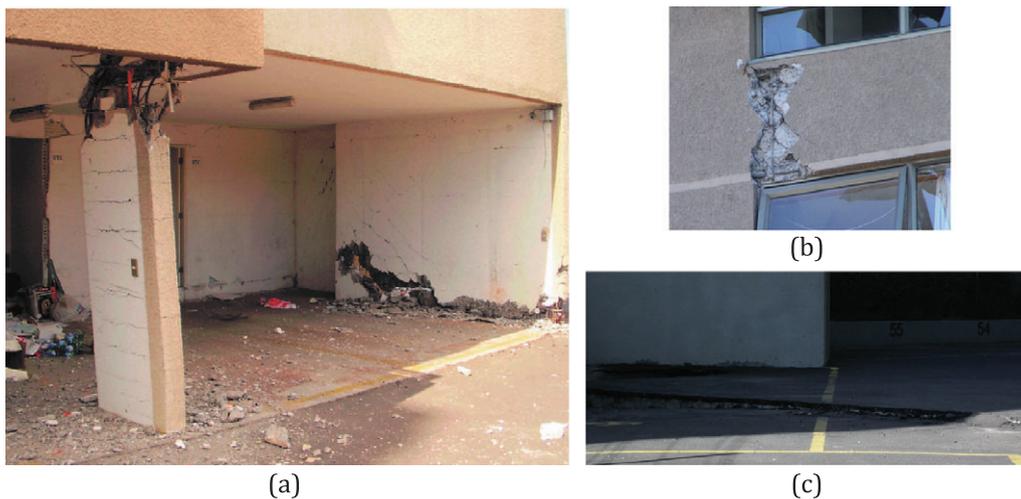
There was evidence of some soil compaction problems of backfill settlement around the building basement (Figure 12c) and there was failure in tension and compression of the walls (piers) in the

Figure 12. (a) Tension failure in pier and crushing failure in concrete (El Sur, 2010), (b) failure of beam (c) soil backfill settlement in parking area.

end and corner walls of the building (Figure 12a) as no confinement in the boundary elements was observed; also some diaphragm cracking were observed.

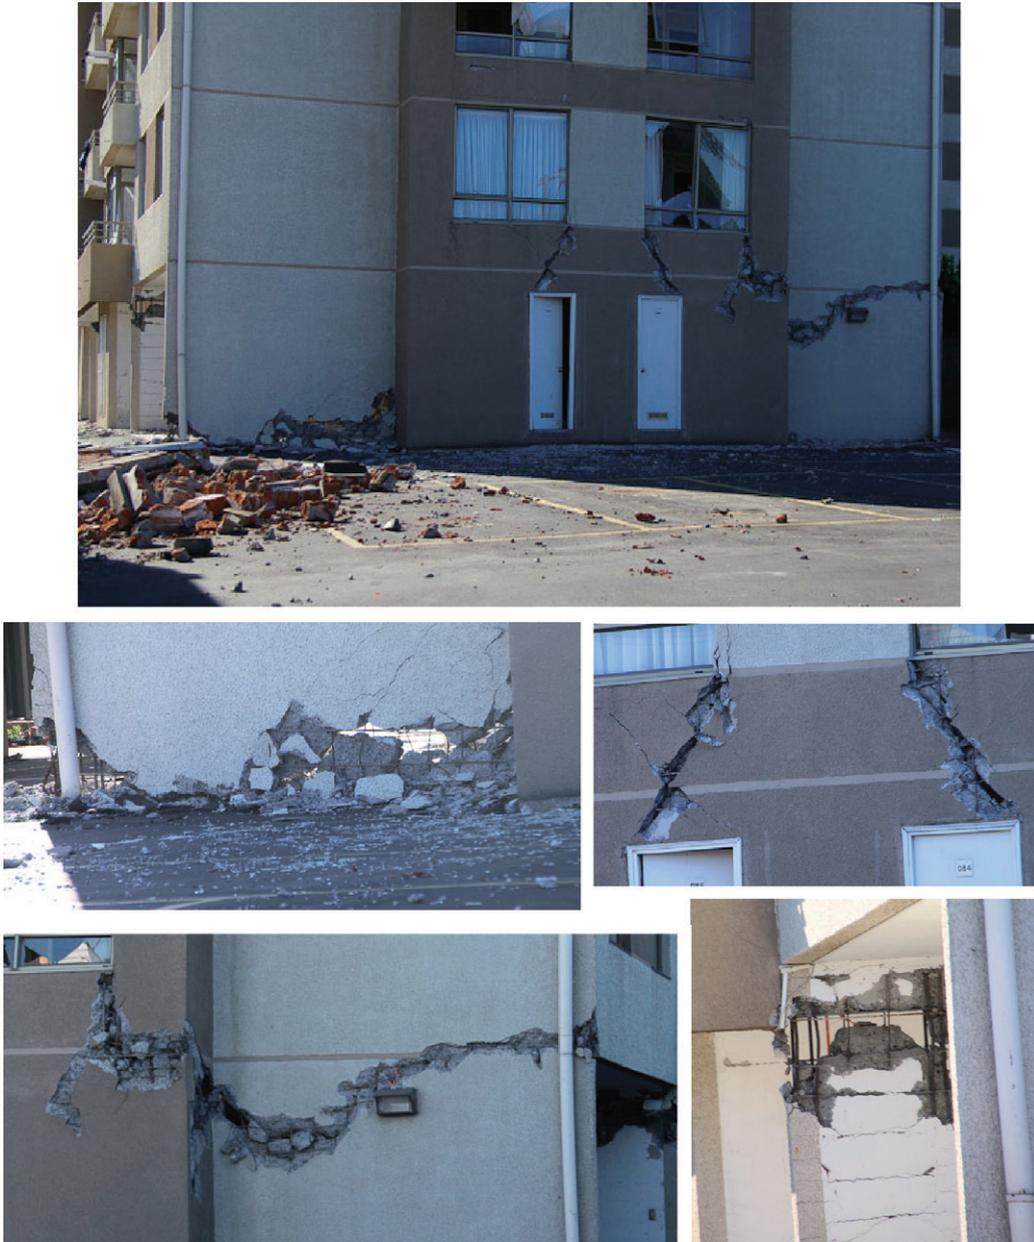
Figure 13. Wall failures at the first floor in Building A.

In addition to the tension and compression failures, other damage probably occurred due to discontinuities in walls, producing short beam shear failures as shown in Figure 13.

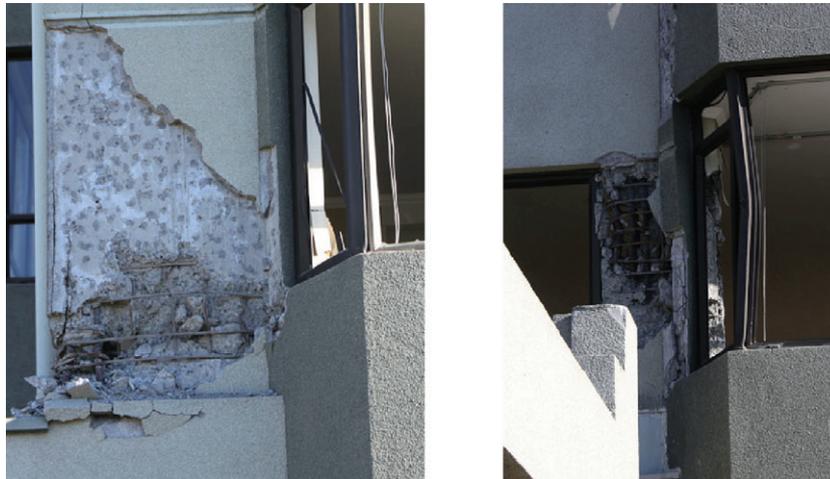
Figure 15. Failure of piers in Plaza Mayor I at the second floor.

Plaza Mayor I was the tower that suffered the most damage. Figure 15 shows two examples of the typical damage (tension-compression failure). Some damage to boundary elements was also observed, as shown in Figure 16.

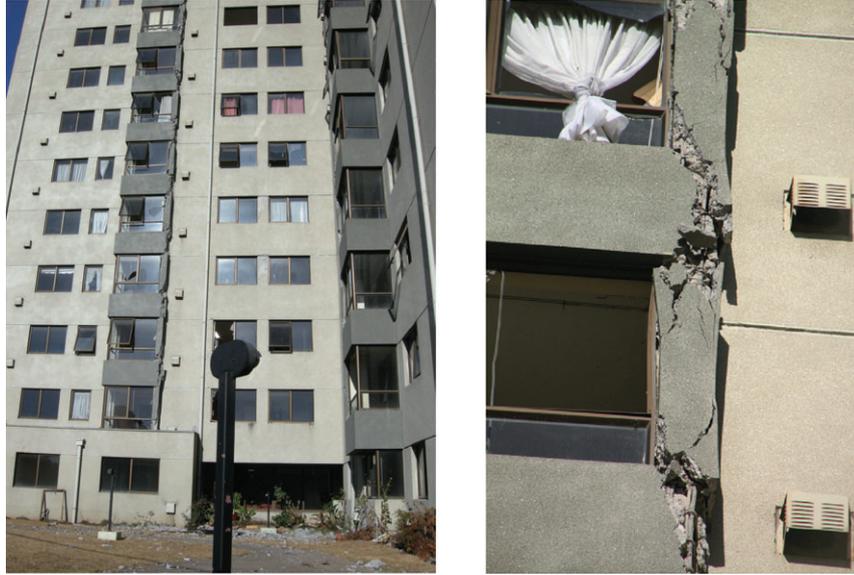
Figure 16. Failure of the connection of beams with boundary elements in Plaza Mayor I.

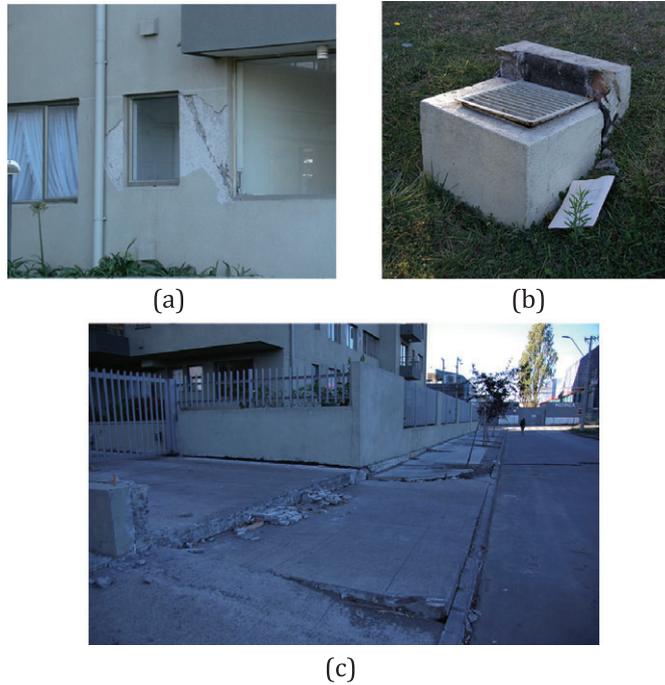
The Plaza Mayor II (two buildings) and III (one building) did not suffer severe damage, only some soil settlement of backfill probably due to poor compaction and some cracks in walls (Figure 17).

Figure 17. (a) Short column shear failure (b and c) soil settlement at Plaza Mayor II.

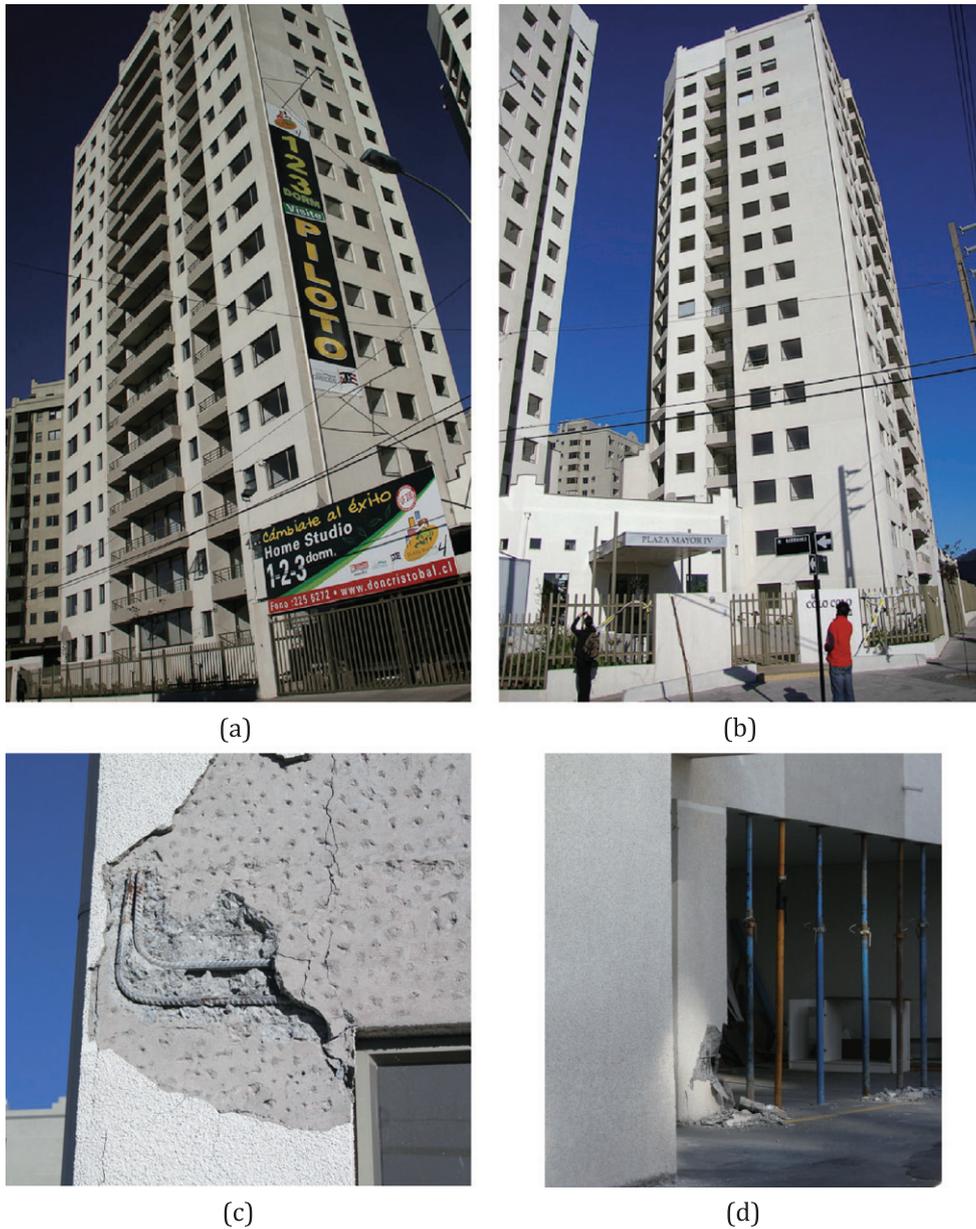
Plaza Mayor IV (two structures) was the last building built in the complex. It also suffered structural damage. Damage due to poor construction execution (Figure 18c) was observed and some wall failures were also observed.

Figure 18. (a,b) Elevation view of the two towers of Plaza Mayor IV (c) problem in construction execution (d) failure of concrete and buckling of reinforcing steel.

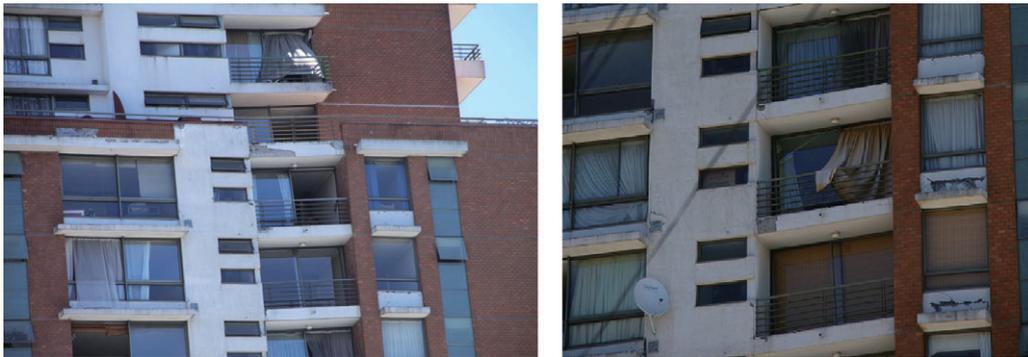
The east side of the building (Figure 20) experienced damage up the structure due to the compression failure of the wall at the lower portion of the building (Figure 21); the reduction of the height of the wall in the first floor produced the damage in the beams (Figure 20).

Figure 20. Failure of beam in the centre of the right (east) elevation, due to the failure of the central pier at the first floor.

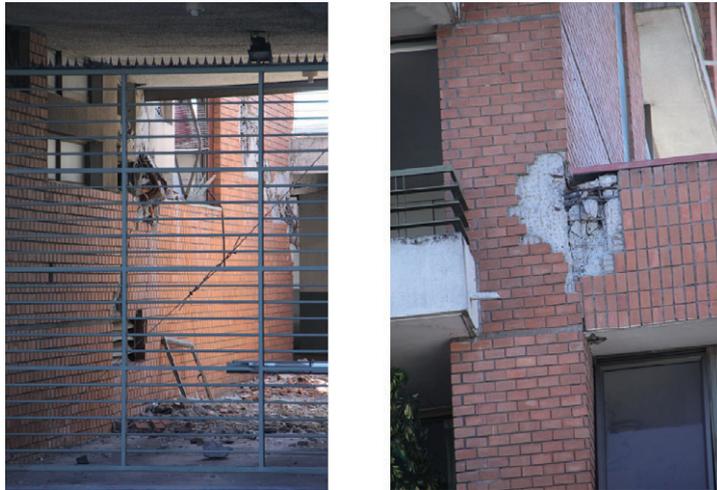
The Alto Arauco II is an 18-storey reinforced concrete building without a basement. The structural system is a wall system. This structure suffered severe structural damage in the first floor of the building and at the fifth floor where some irregularities in plan configuration occur as shown in Figure 19.

Figure 21. Failure of the centre pier of the east elevation at first floor (right), failure in singularity point at top of fifth floor in the front elevation (left).

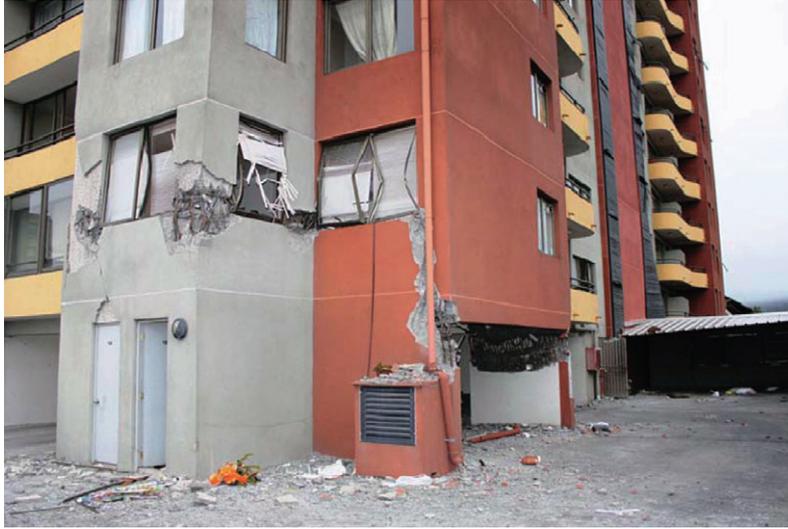
The observed damage is principally compression and tension failure in the walls (Figure 23) and crushing of the boundary of the walls elements with buckling and fracture of the reinforcing steel bars; a lack of confinement of the ends of the walls was observed. Also, it was observed that there were some shear failures in the walls (Figure 24).

Figure 23. Failure in compression and tension in the back of the building D (Moehle *et al.*, 2010).

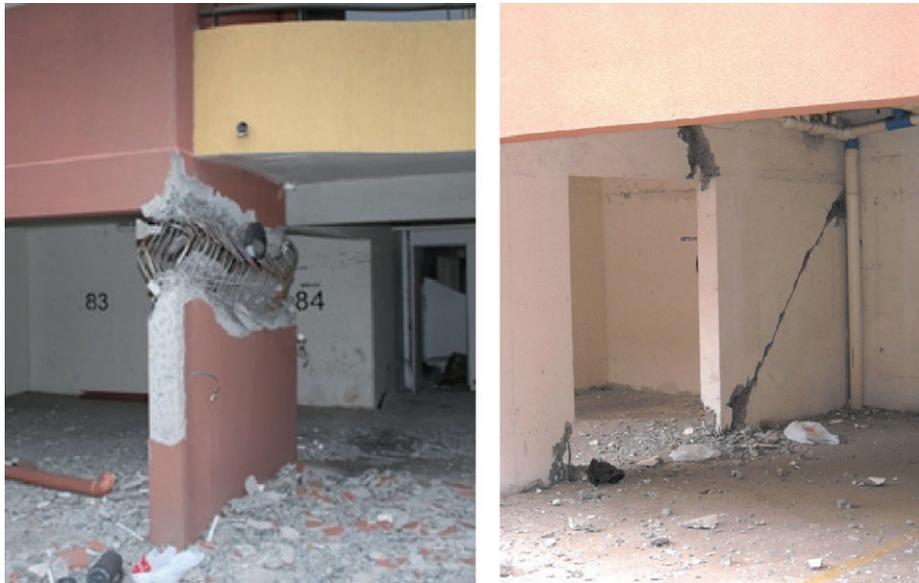
Figure 24. Concrete crushing and buckling of reinforcing bars (right) (Moehle *et al.*, 2010) and shear failure in wall (left) (Betanzo, 2010).

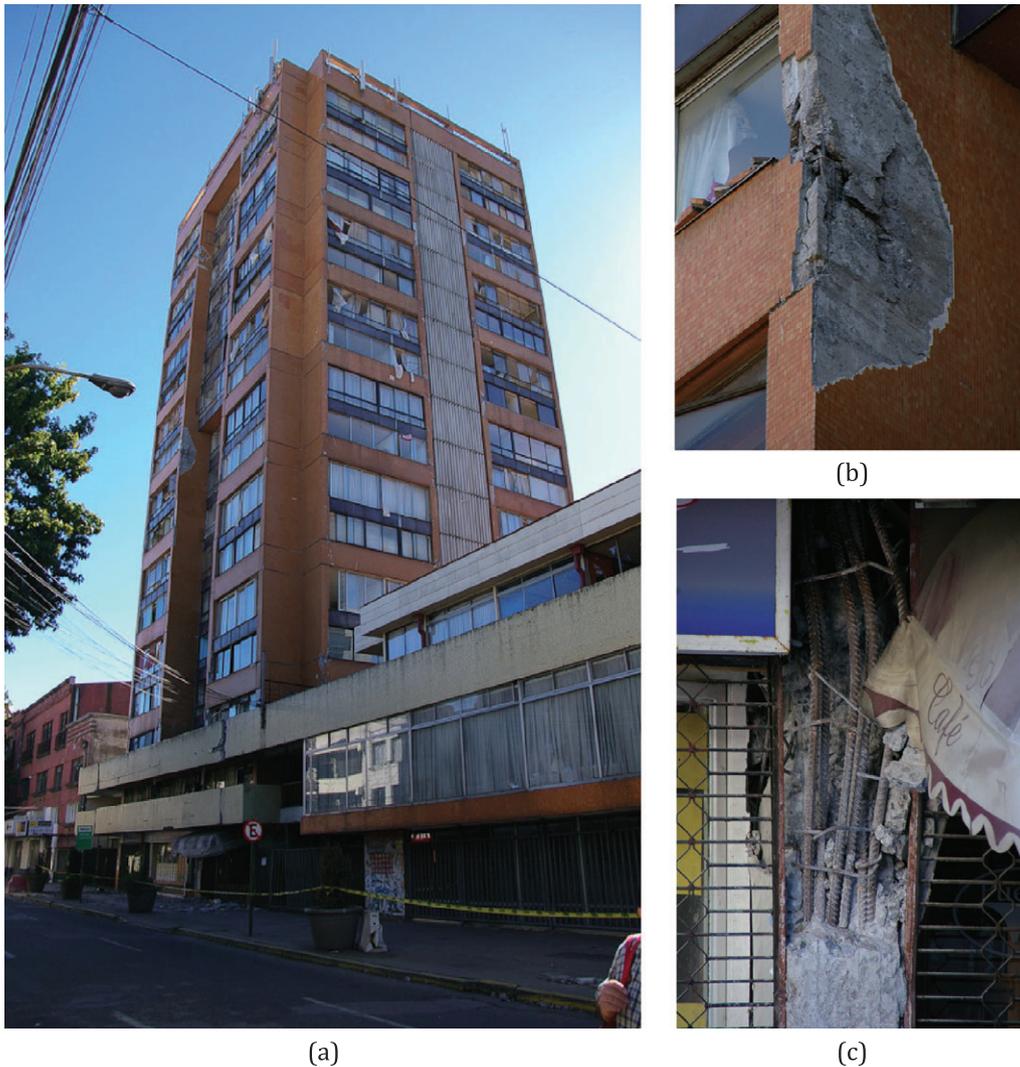
Figure 25. (a) Elevation view (b) failure at the connection of beam with wall, (c) compression failure of the wall at ground level.

The Torre Libertad is an 18-storey building without underground levels; the system of the building consists of concrete walls. The first two storeys consist of a podium used for retail stores. The principal damages in this structure are crushing of walls and buckling of steel reinforcing bars at the ground level.

In addition, failures were observed at the connections of beams with walls; the beams were connected to the weak side of the walls, see Figure 25b.

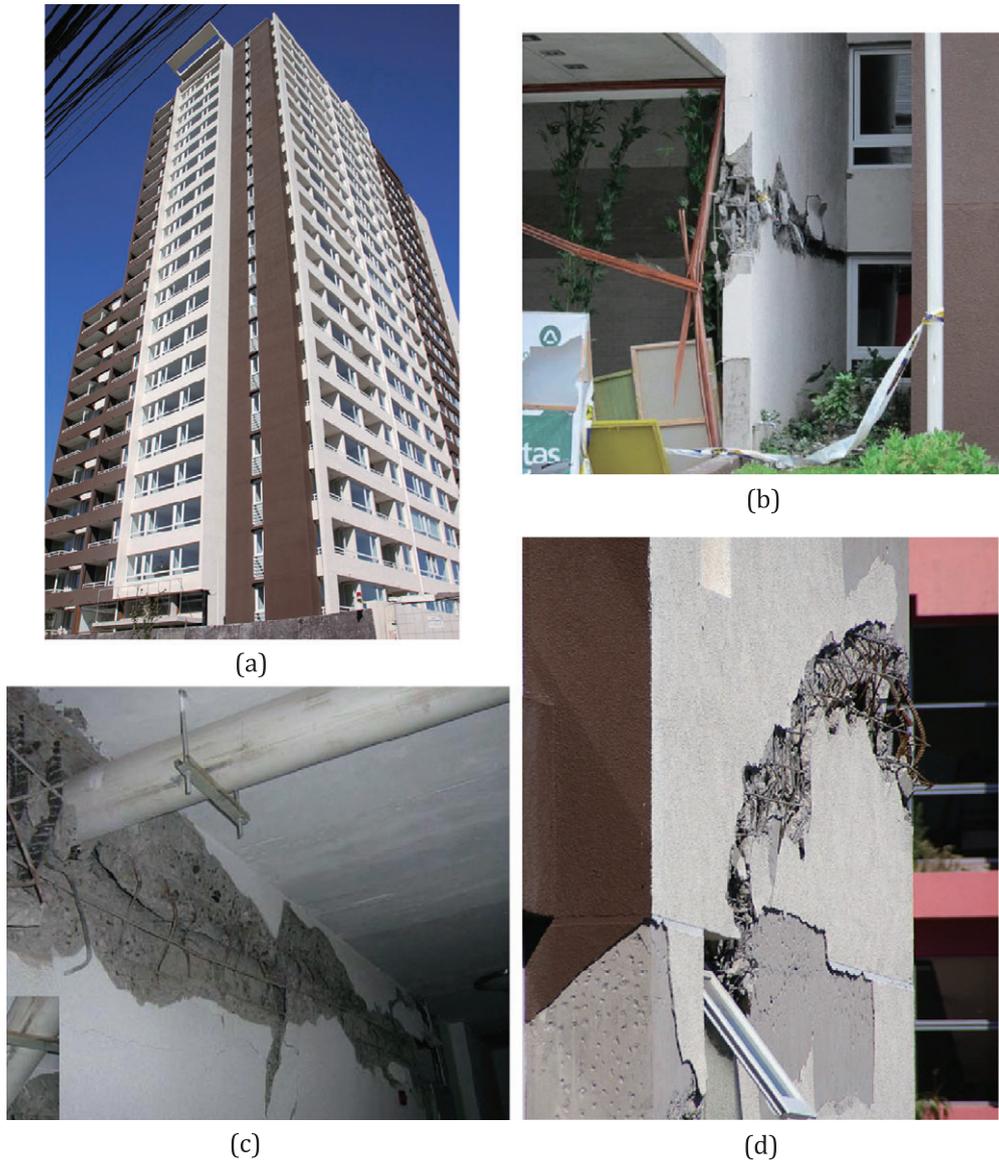
The Obispo Salas is a 24-storey building with two underground levels. The building was in the last stage of the construction when the earthquake occurred. It is a reinforced concrete building with a structural wall system. It suffered damage in the first underground level (Figure 26c) and at the ground level. Crushing of the concrete and the buckling of the steel bars due to tension and compression at

Figure 26. (a) Elevation view (b) failure in the wall at the entrance (c) failure in the top of the wall at the basement (Moehle *et al.*, 2010) (d) failure in the wall at the back of the building.

the end of the walls occurred; confinement of the boundary elements of the walls was not observed (Figures 26b and 26d).

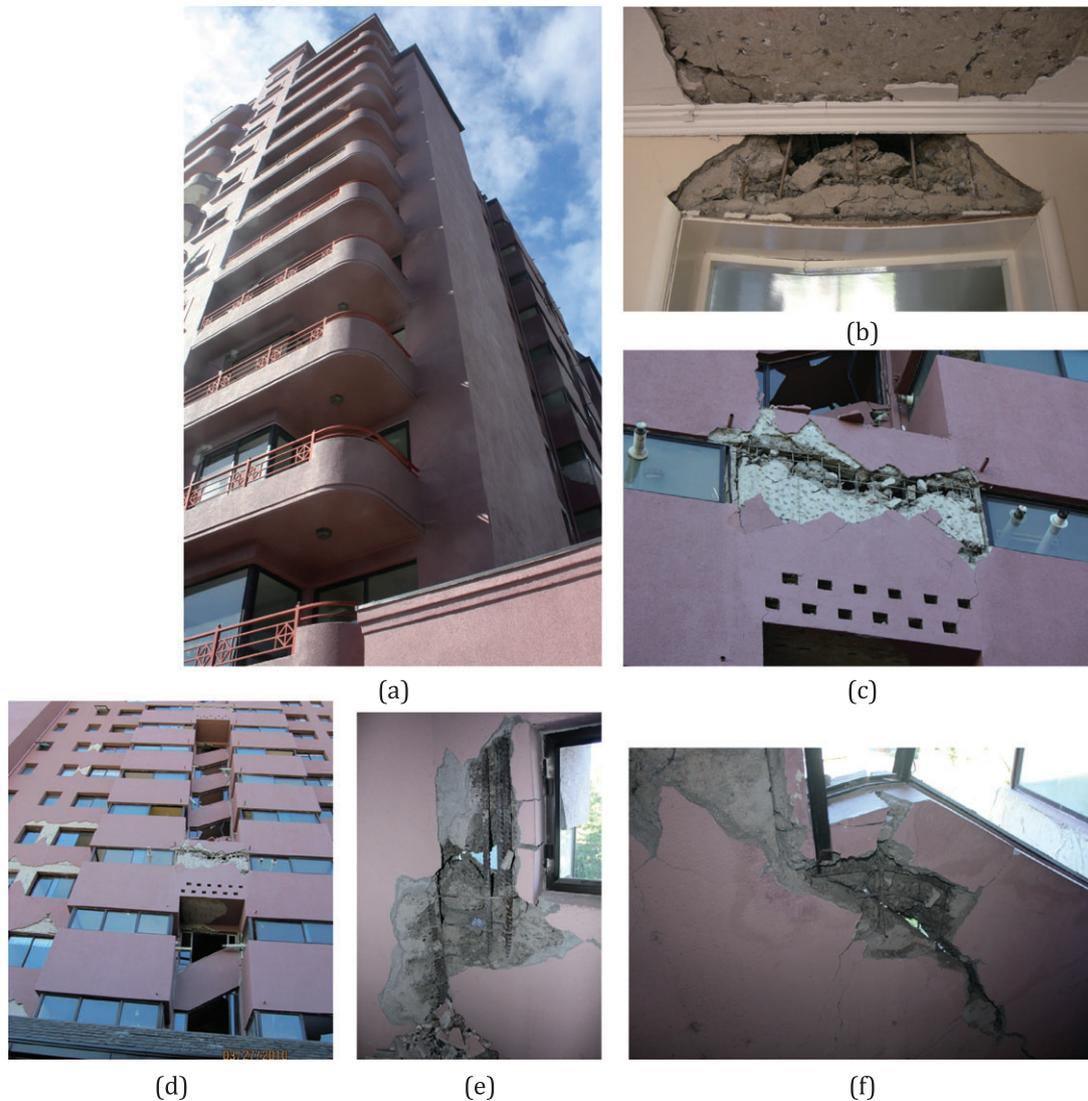
The Pedro de Valdivia is a 13-storey reinforced concrete building without underground levels, and has a structural wall system with coupling beams. The damage observed in the structure is concentrated in the connections of the beams and piers in the stairs (Figures 27e and 27f) which were not able to resist the seismic demands, and in the coupling beams inside of the building such as those above door openings (Figure 27b). Also, the building had a service area to accommodate water and power systems protruding outside of the stairs at one level; these elements worked as a short column and failed in shear, see Figure 27c.

Figure 27. (a) Elevation view (b) failure in the coupling beam inside of the apartment (c) failure of coupling element in the stair area (d) elevation view of the stair area (e) column failure in the stair (f) failure of non-ductile coupling beam.

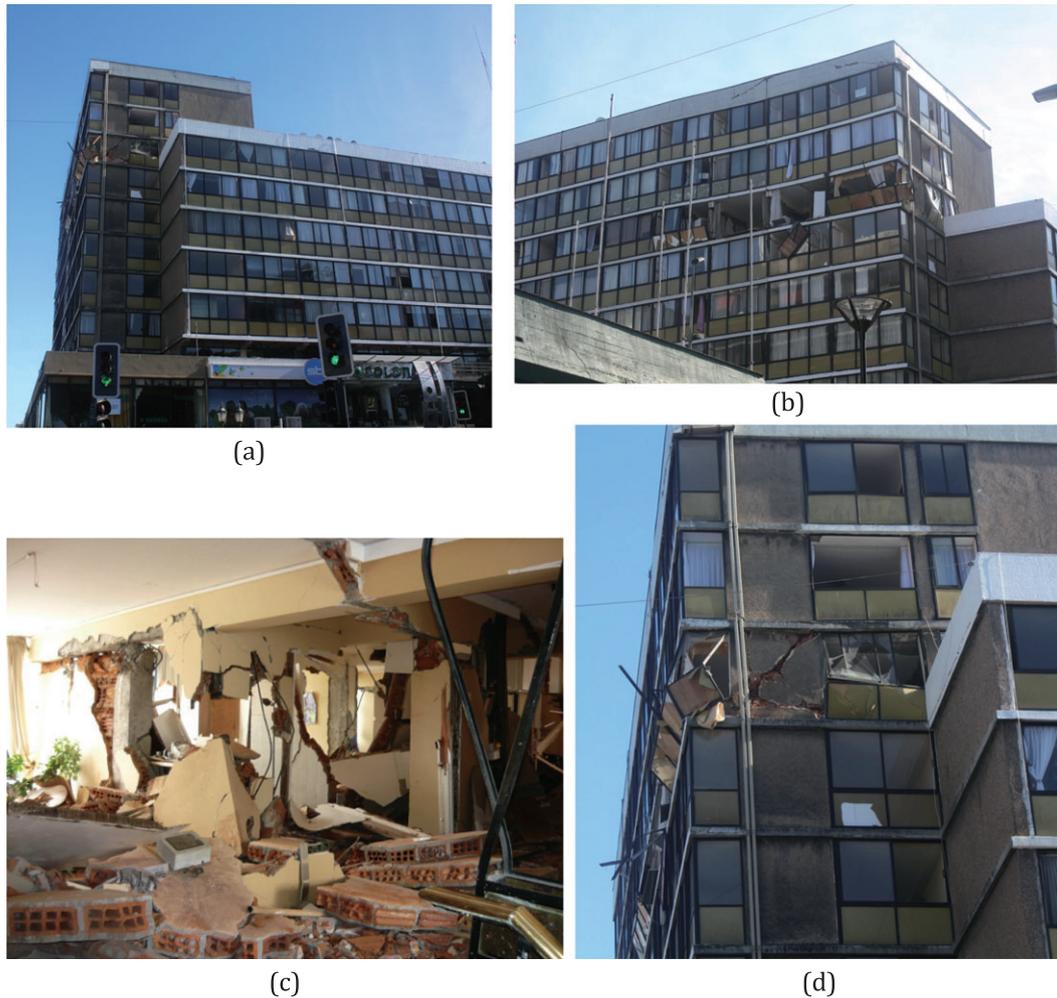
This is an 11-storey building, where the upper three storeys were added to the original eight-storey structure. The building is constructed of reinforced masonry. The upper three storeys have a smaller floor area with respect to the lower storeys (see Figures 28a and 28b), which cause a change in the stiffness of the structure. There was concentrated damage at the ninth floor, with failures of masonry walls in shear (Figure 28d) and failure of some of the reinforced columns that were used to confine the masonry (Figure 28c).

Figure 28. (a,b) Elevation Views (c) damage inside of an apartment at the ninth floor (Betanzo, 2010) (d) shear failure of a masonry wall.

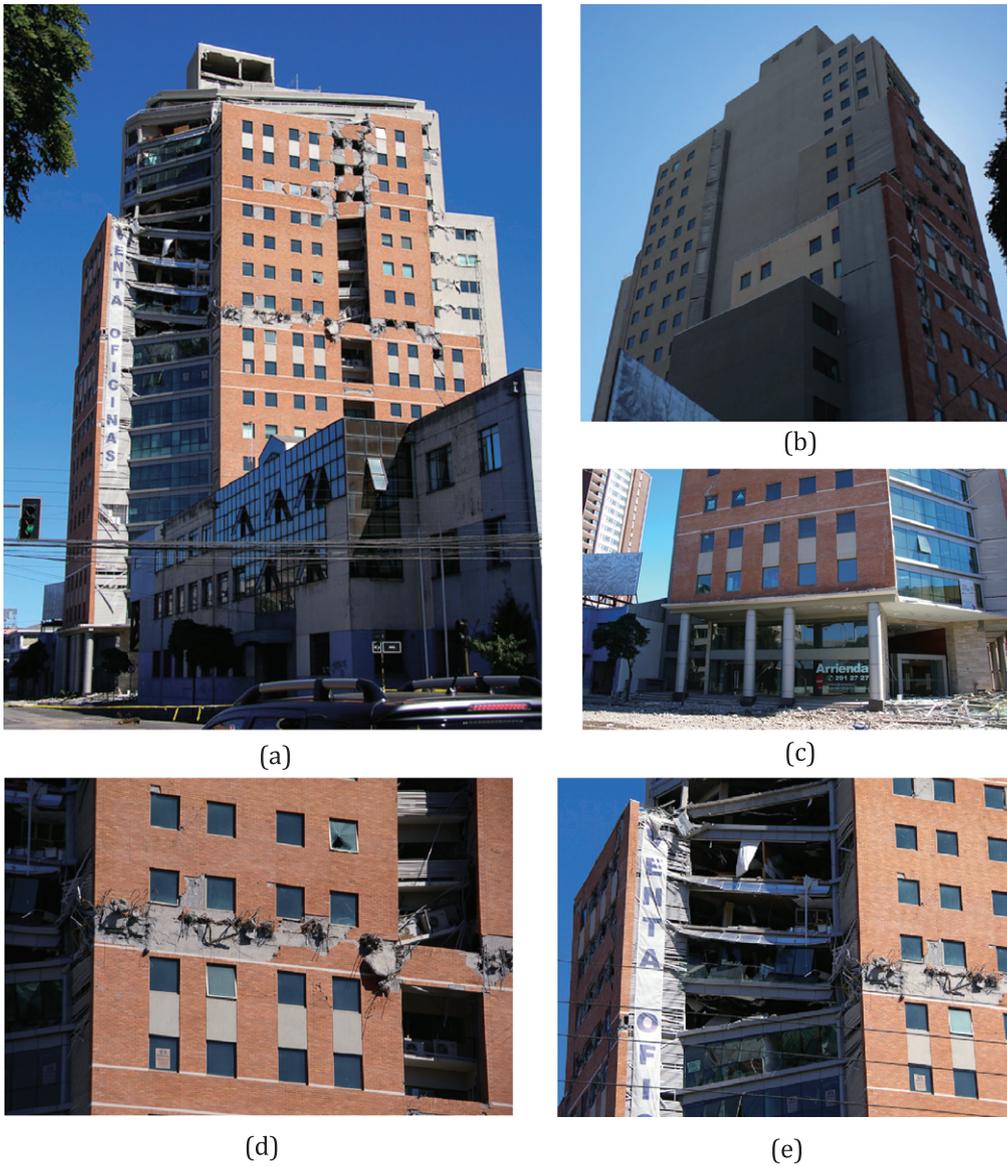
In contrast with other buildings in Concepción, this structure did not have damage at the ground level (Figure 29c). The damage is concentrated in the front of the building over the 12th floor (Figure 30), where there is a change of the floor area, causing a variation in the stiffness of the structure. In addition, according to a report on the website of Radio Bio-Bio, dated May 2010, the Director of the Public Works of Concepción stated that some structural modifications were made on the building by tenants above the 10th floor.

Figure 29. (a) Elevation (east) view (b) View of the back (west side) of the Building (c) front entrance (d, e) view of the collapsed piers at the 12th floor.

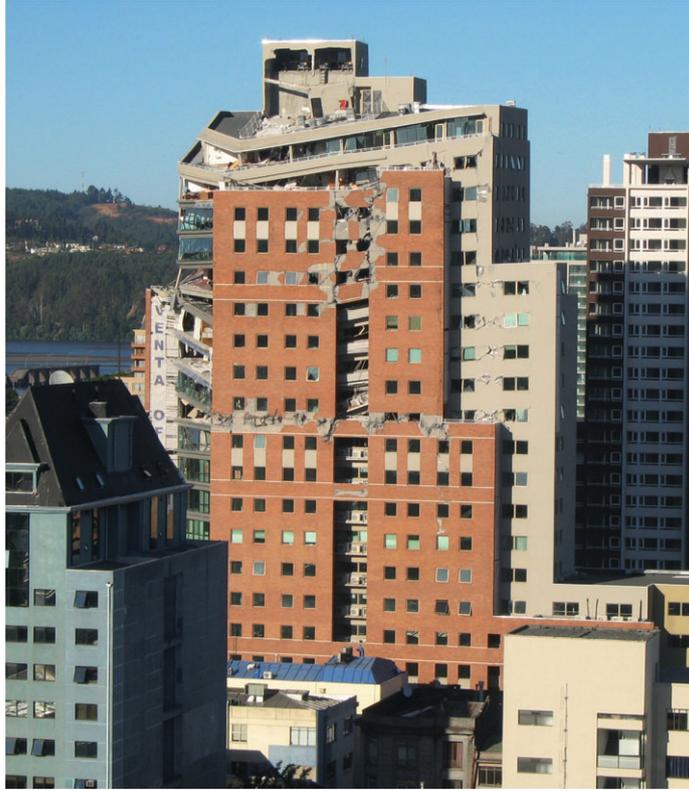
The partial collapse of the 12th floor caused the upper floors to slope and induce damage to coupling beams, as shown in Figures 30 and 31.

Figure 30. Panoramic view of the elevation with collapsed floor (courtesy of P. Correa).

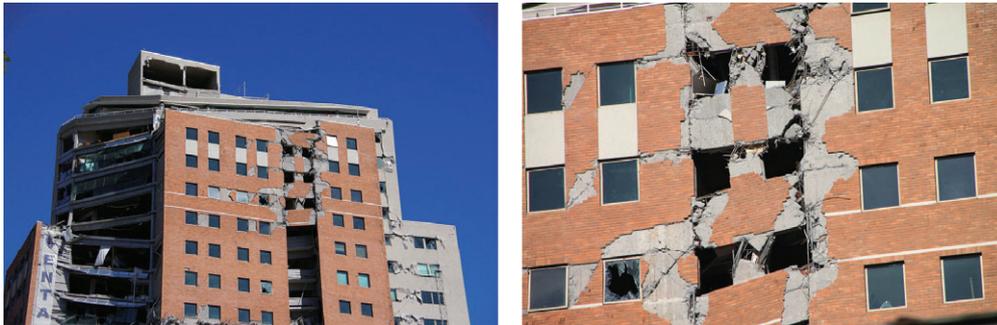
Figure 31. Failure of the coupling beams at top floors.

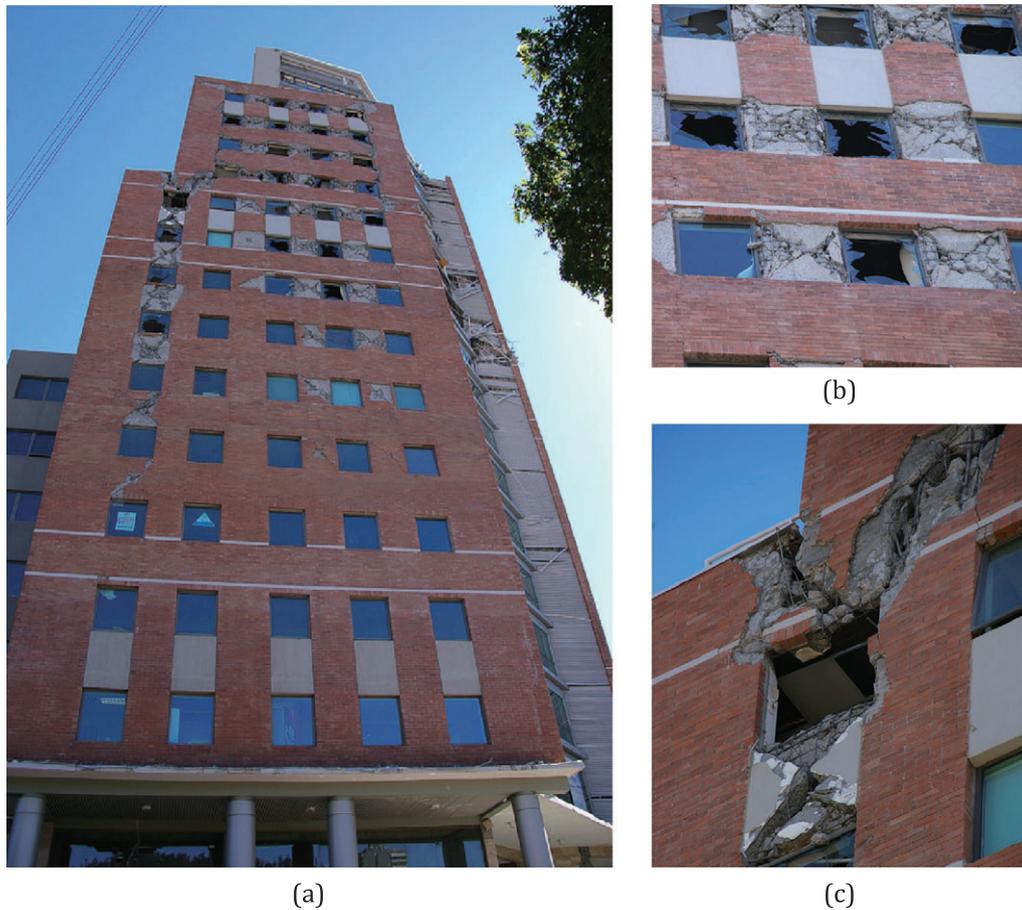
On the south side of the building, some shear damage failure was present in the short columns (Figure 32b) and coupling beams, and also at the point of discontinuities (Figure 32c).

Figure 32. (a) Elevation of south side (b) shear failure of the short column (c) failure at singularity and shear failure of beams.

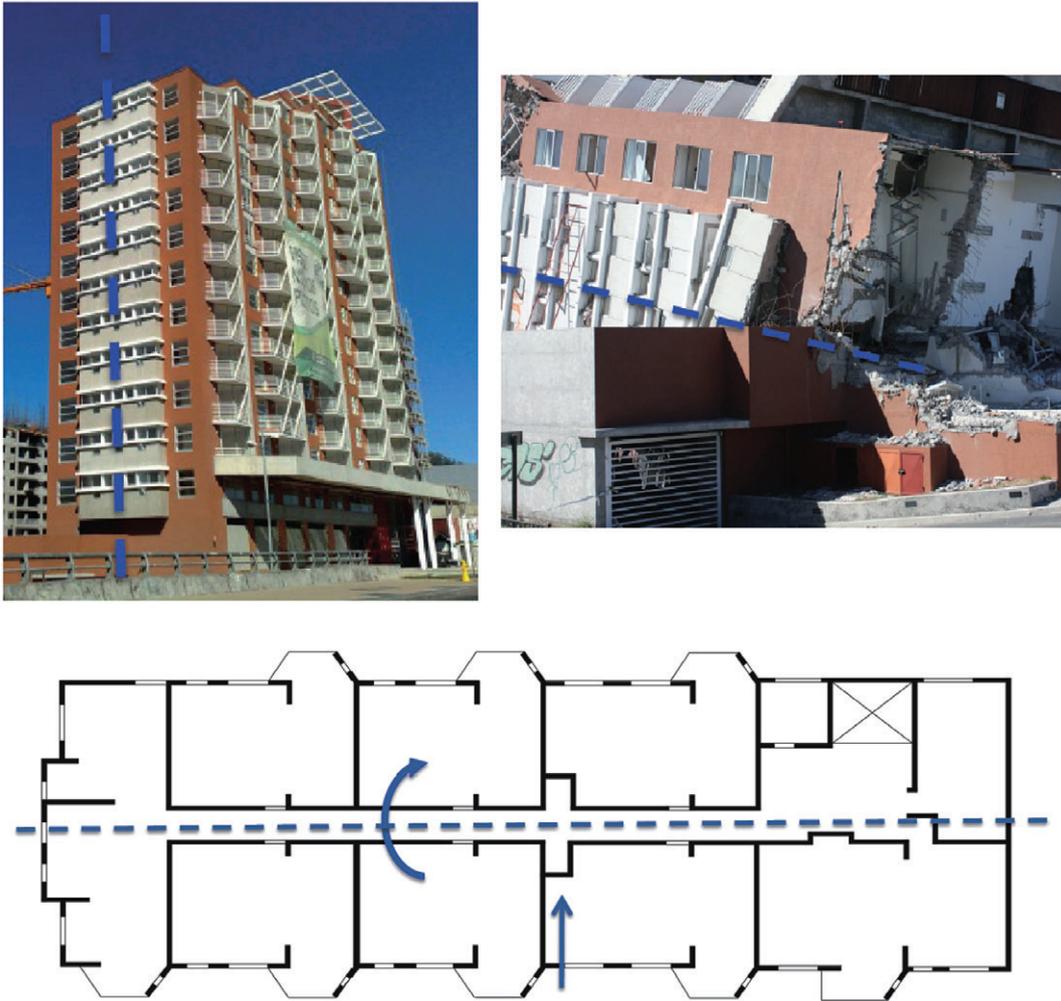
Figure 34. Elevation view with the centreline of the building (Concepcion under Construction, 2010), position of the centreline after the collapse, sketch of the typical floor plan.

Figure 34 shows a sketch of the typical floor plan for the building. One hypothesis of the collapse is that the boundary elements of the walls failed from the strong and long duration ground motions. From observations in other buildings, compression in the walls could cause crushing of the concrete and buckling of the steel reinforcement and tension could cause breaking of the bars and possibly pull out of the vertical reinforcement if the development lengths were insufficient. The eastern walls may have failed in compression causing the building to tilt and fall in the eastern direction (Figure 35). Another hypothesis of the collapse is that a large co-seismic displacement generally to the west of about 3 m over a time span of about 25 s caused an overturning collapse of the building; this hypothesis has been examined by Alimoradi and Naeim (2010) in a companion paper.

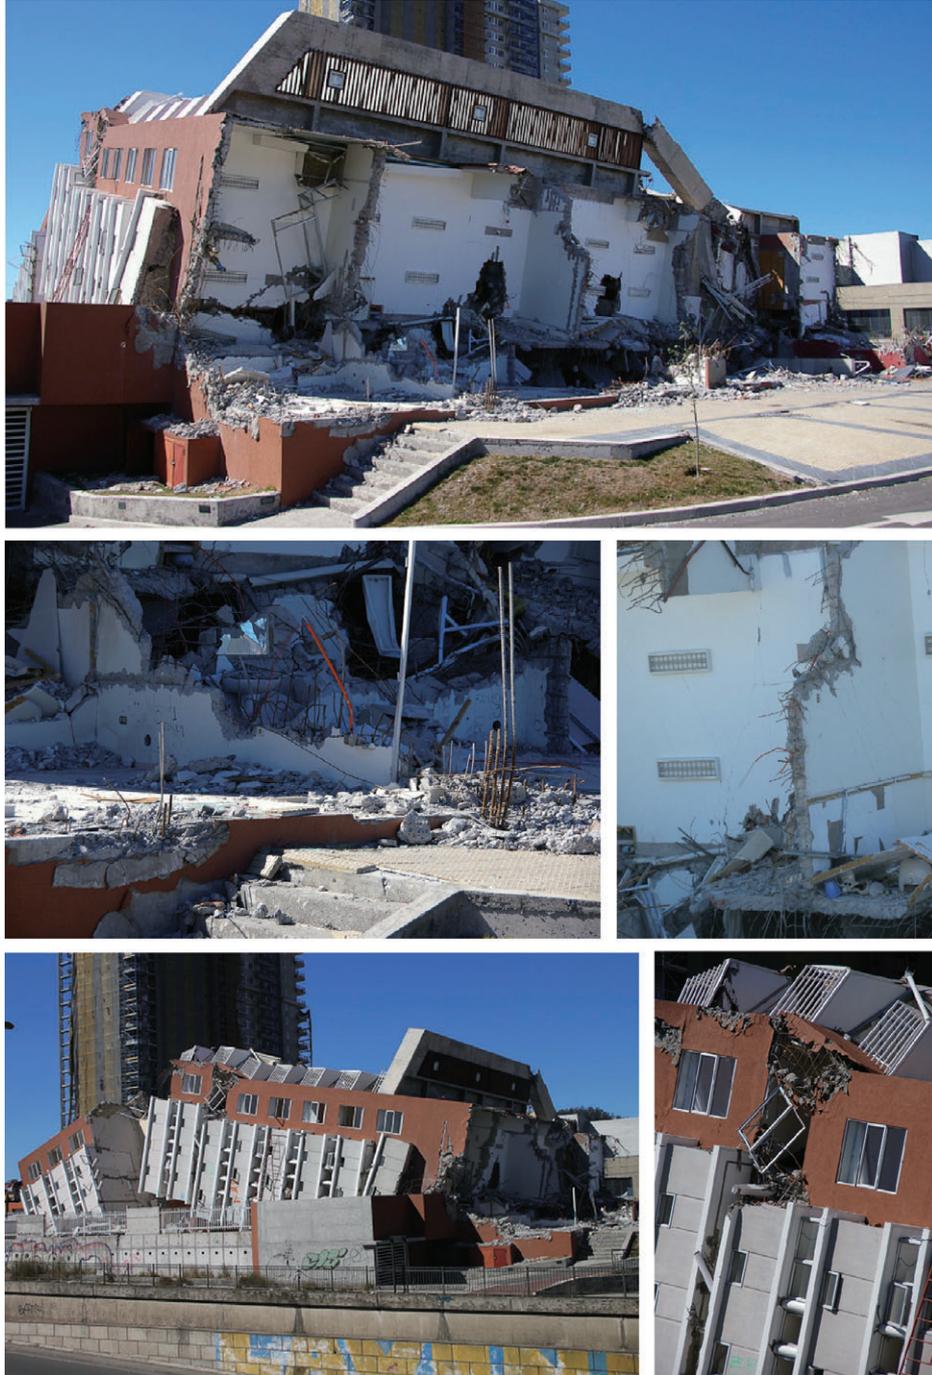
Figure 35. Different views of the damage of the collapsed Alto Rio building.
