Article

Inspection Data Collection Tool for Field Testing of Photovoltaic Modules in the Atacama Desert

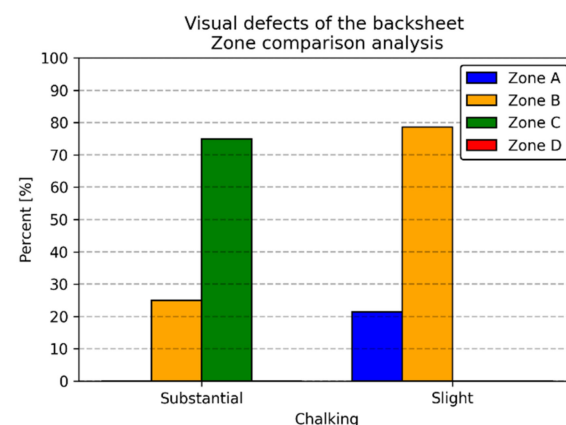
In relation to chalking, it was found in three zones: A, B and C. As shown in Figure 4, PV modules with substantial chalking were found in zone B and C. It must be noted that those PV modules had the longest operating period (since 2005) of all 95 inspected modules. Modules with slight chalking at the backsheet were found at zones A and B, where zone B contains a greater number of modules with slight chalking than zone A, being 22 and 6, respectively. Chalking of the backsheet seems to be related with locations in the city and young PV modules (3 years of operation). Chalking, which corresponds to a chemical degradation, may be triggered by chemical components of the air in combination with coastal winds. In this case, the city is very close to the coastal area, hence, it is difficult to separate the origin of the failure. In the city, there is high amount of contamination due to public and private transportation that it is combined with salty winds from the coast. For these cases is highly recommended to design PV modules for special conditions (such as corrosive).

Figure 4. Zone comparison of backsheet failures/defects.

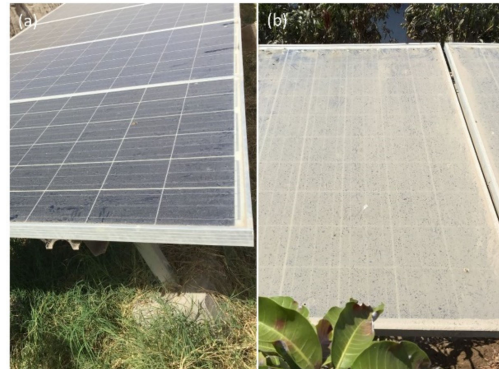
Regarding to the level of soiling, a light soiling has impact on the current but not the voltage. Conversely, heavy soiling influences both, current and voltage, reducing their values [30]. Referring to the inspected modules, light soiling on glass was found in all zones except in zone A, which only contains modules with heavy soiling (see pictures in Figure 5). As shown in Figure 6, zone C is the region with more modules with light soiling (44.23%), and zone D is the region with less affected modules (23.08%). Heavy soiling was

found in all zones except in zone D, which only contain modules with light soiling. Zone B is the region with more modules with heavy soiling (38.46%), while zone A and C contain the same number of modules (30.77% each).

Figure 5. PV module (a) in location 9 (zone B) and (b) location 11 (zone C).

Results depending on manufacturer, shown in Figure 7, indicate that the 52 modules with light soiling (Figure 5a) are RISEN (46.15%), SOLAR WORLD (19.23%), SUNEL (17.31%), HANWHA SOLAR (7.69%), SIEMENS (7.69%) and BP SOLAR (1.92%). Regarding to modules with heavy soiling (Figure 5b), they are mainly from SOLAR WORLD (46.15%) and ET TOWARDS EXCELLENCE (30.77%). The rest of the modules with heavy soiling are LUXOR (15.38%) and JA SOLAR (7.69%).

Soiling was found in all visited locations being strongly present in PV modules from the city and the valley. Although studies must be carried out to specify the composition of the soiling, it is highly probable that the soiling of the PV modules installed in the city has different composition than from the soiling of PV modules operating in the valley. Soiling in the valley was light while in the city was sometimes heavy and sometimes light. Since the frequency (and presence) of cleaning is unknown, it cannot be concluded that modules in the city suffer from a stickier soiling than in the valley. The classic solution for soiling will be cleaning but depending on the composition of the soiling it is possible to select a proper coating for the glass in the design of the PV module [31].

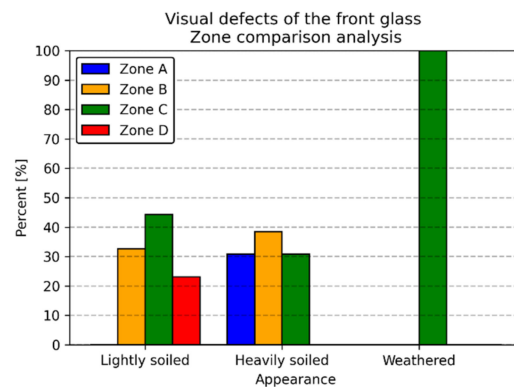
Figure 6. Zone comparison of front glass failures/defects.

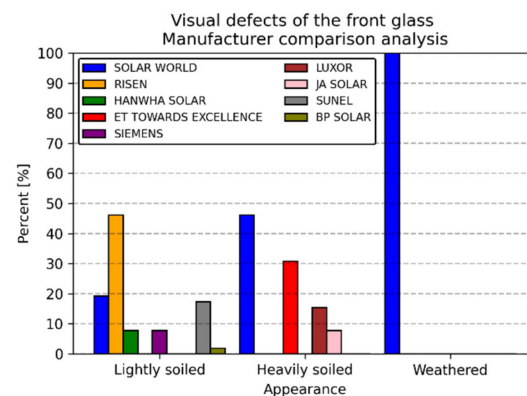
Figure 7. Manufacturer comparison of front glass failures/defects.

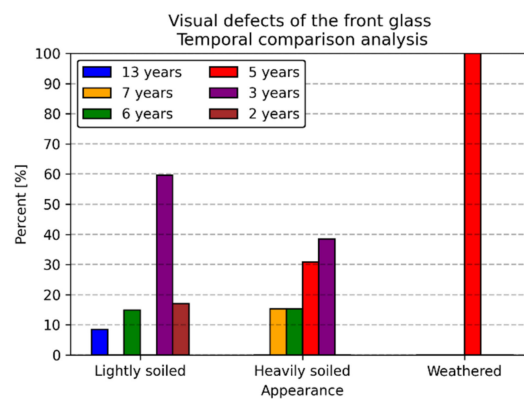
Figure 8 shows that soiling is present in PV modules that have been operating since different installation dates: light soiling is mostly seen in modules installed in 2015 (59.57%), while it is less seen in modules installed in 2005 (8.51%). Heavy soiling is seen mostly in

modules installed in 2015 (38.46%) and 2013 (30.77%), and less in modules installed in 2011 and 2012 (15.38% each). The 2 modules with weathered glass have been operating for 5 years (2013), and the modules with milky discoloration have been operating for 5 years (extensive discoloration) and 6 years (localized discoloration). The term weathering refers to a component of a PV module, which experiments changes to the color or form of that component over a period because of the effects of solar radiation, ultraviolet (UV) light, wind, sand, dust, humidity, temperature, or another weather condition. Note that modules in zone A are in direct contact to humidity. Therefore, it is possible to find heavily soiled modules just after 3 years in zone A and lightly soiled modules after 6 or 13 years in zones B, C, D.

Figure 8. Temporal comparison of front glass failures/defects.

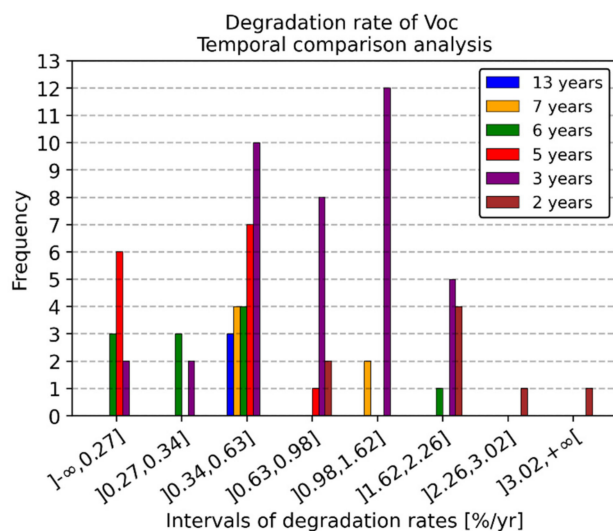
According to Table 1, population under study concentrates its voltage drop in the range 0.95–5.43%. Regarding to the voltage degradation rate, the maximum value is 3.03%/year, but most of the rates are in the range 0.21–1.55%/year. According to Figure 9, which shows a temporal analysis of V_{oc} , the lowest degradation rates are for modules operating during 5 and 6 years, where the voltage degradation rate is lower than 0.63%/year. PV modules operating the longest (13 and 7 years).

Figure 9. Temporal analysis of the degradation rate of the open-circuit voltage. Modules operating for long periods present lower degradation rates (below 0.63%/year). Conversely, modules operating the shortest (3 and 2 years) exhibit higher voltage degradation rates (up to 1.62%/year).

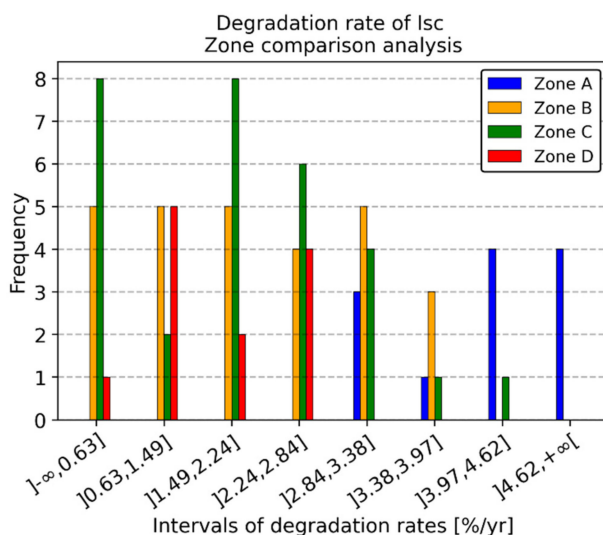
In general, as shown in Table 1, current degradation rates (2.30%/year) are higher than voltage degradation rates (0.88%/year). Current absolute degradation is mainly in the range 3.09–14.51% while current degradation rates are in the range 0.84–3.76%/year. At first sight, where Figure 10 shows the distribution of the degradation rates of the current for each zone, it is possible to establish that zone A is the region with higher degradation rates of current, being 6.76%/year the largest rate. In contrast, zone D is the one with lower degradation rates with an average of 0.63–2.84%/year. In zone B and C degradation rates are below 3.38%/year. Most current degradation rates in zone C are below 0.63%/year and in the range 1.49–3.38%/year, while zone B has nearly half of the modules below 2.24%/year and the other half in the range 2.24–3.97%/year.

Figure 10. Zone analysis of the degradation rate of the short-circuit current.

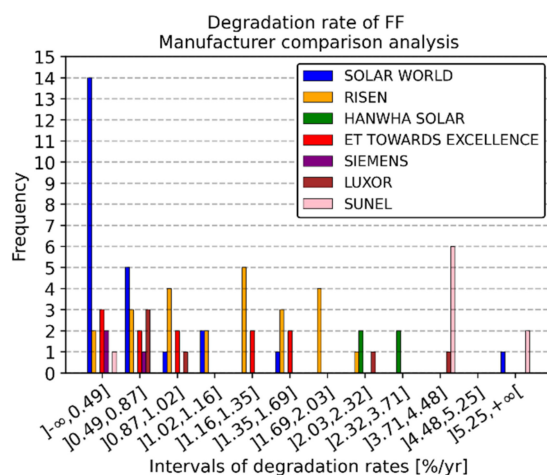
The maximum drop for the *FF* is 34.35% and, as it can be seen in Table 1, most of the values are in the range -0.86% – 10.02% . Regarding the degradation rates, the maximum value is 6.87%/year and most of the values are in the range -0.15% – 2.83% /year. Figure 11 indicates that PV modules with lower degradation rates correspond to SOLAR WORLD and SIEMENS (0.87%/year) while RISEN and ET TOWARDS EXCELLENCE have modules with a wide range of degradation rates (1.16–2.03%/year). Following are HANWHA SOLAR modules that have degradation rates in the range 2.03–3.71%/year while SUNEL modules have degradation rates above 3.71%/year, where the highest is 6.87%/year. Finally, modules from 4 out of 6 LUXOR modules have low degradation rates below 1.02%/year, and the rest is above 2.03%/year.

Figure 11. Manufacturer analysis of the degradation rate of the fill factor.

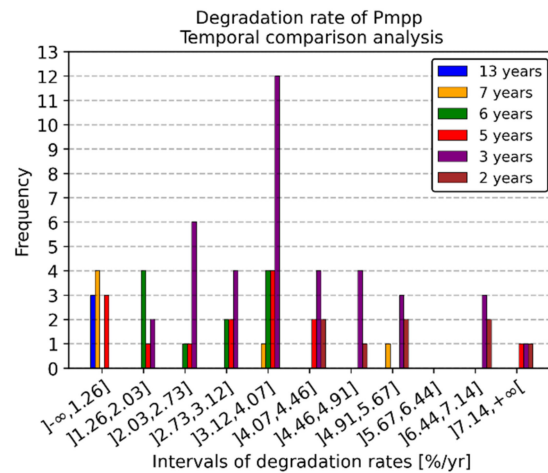
The critical maximum power drop among all modules is 39.08% with an average in the range 6.97–19.41%. According to [32], most common guarantees from manufacturers of PV modules indicate that after 25 years the PV module will generate 80% of the power rated in the nameplate. This can be translated into a maximum power degradation loss of 0.8%/year. From the 81 modules inspected, only one is within a typical guarantee (0.67%/year). According to Figure 12, the modules operating the longest period (13 and 7 years) are the ones with power degradation rates below 1.26%/year. Following those operating for 6 years (1.26–4.07%/year). For those operating 5 years, most degradation rates are below 4.07%/year. Regarding to modules operating for 3 years, most modules power degradation rates in the range 1.26–4.07%/year while the rest concentrate in the range 4.07–5.67%/year. Finally, modules operating for 2 years have power degradation rates above 4.07%/year.

It can be stated that the power degradation rate values are inversely proportional to the exposure time, i.e., at shorter periods of exposure, the degradation rate is higher. Modules show a fast initial degradation, and during their operating lives they do not degrade so fast. Hence, with more years of exposure, the power degradation rate tends to decrease.

Figure 12. Temporal analysis of the degradation rate of the maximum power point.

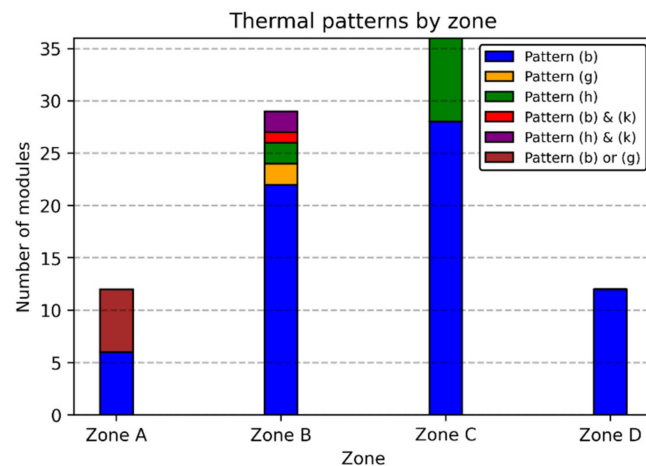
According to the definition of considered thermal abnormalities in Table 2, 6 modules present pattern 2 or 7 but it cannot be determined. Among the abnormalities, only the patterns 2, 7, 8 and 11 were found. It must be highlighted that modules were under short-circuit conditions when the thermal image was taken. In this context, modules with the pattern 2 are not defected. Also, to be able to determine a thermal pattern information regarding the thermal image in combination with the electrical parameters and the visual inspection of the modules were combined to make a conclusion.

Figure 13 shows the number of modules having specific thermal patterns, which are sorted by zone; whereas Figure 14 depicts the corresponding thermal patterns [33–36] described in Table 2. In zone A, half of the modules (60) presents a short-circuit pattern and the other half (6) exhibits an uncertain pattern. It cannot be determined whether those 6 modules have a short-circuit pattern or PID, even observing the electrical and visual data. Regarding zone B, 75.9% of the modules present a short-circuit pattern, 2 modules present PID, 2 modules present a hot cell, 1 module shows a short-circuit pattern and indicating heating due to bird drop. In zone C, 77.8% of the modules present the short-circuit pattern while the remaining 22.2% present hot cells. Finally, in zone D all the modules present the patchwork pattern due to short-circuit condition.

Figure 13. Thermal patterns found within 89 PV modules. Modules are sorted by zone.
