The Role of Site Conditions on the Structural Damage in the City of Valdivia during the 22 May 1960 M_w 9.5 Megathrust Chile Earthquake

Abstract

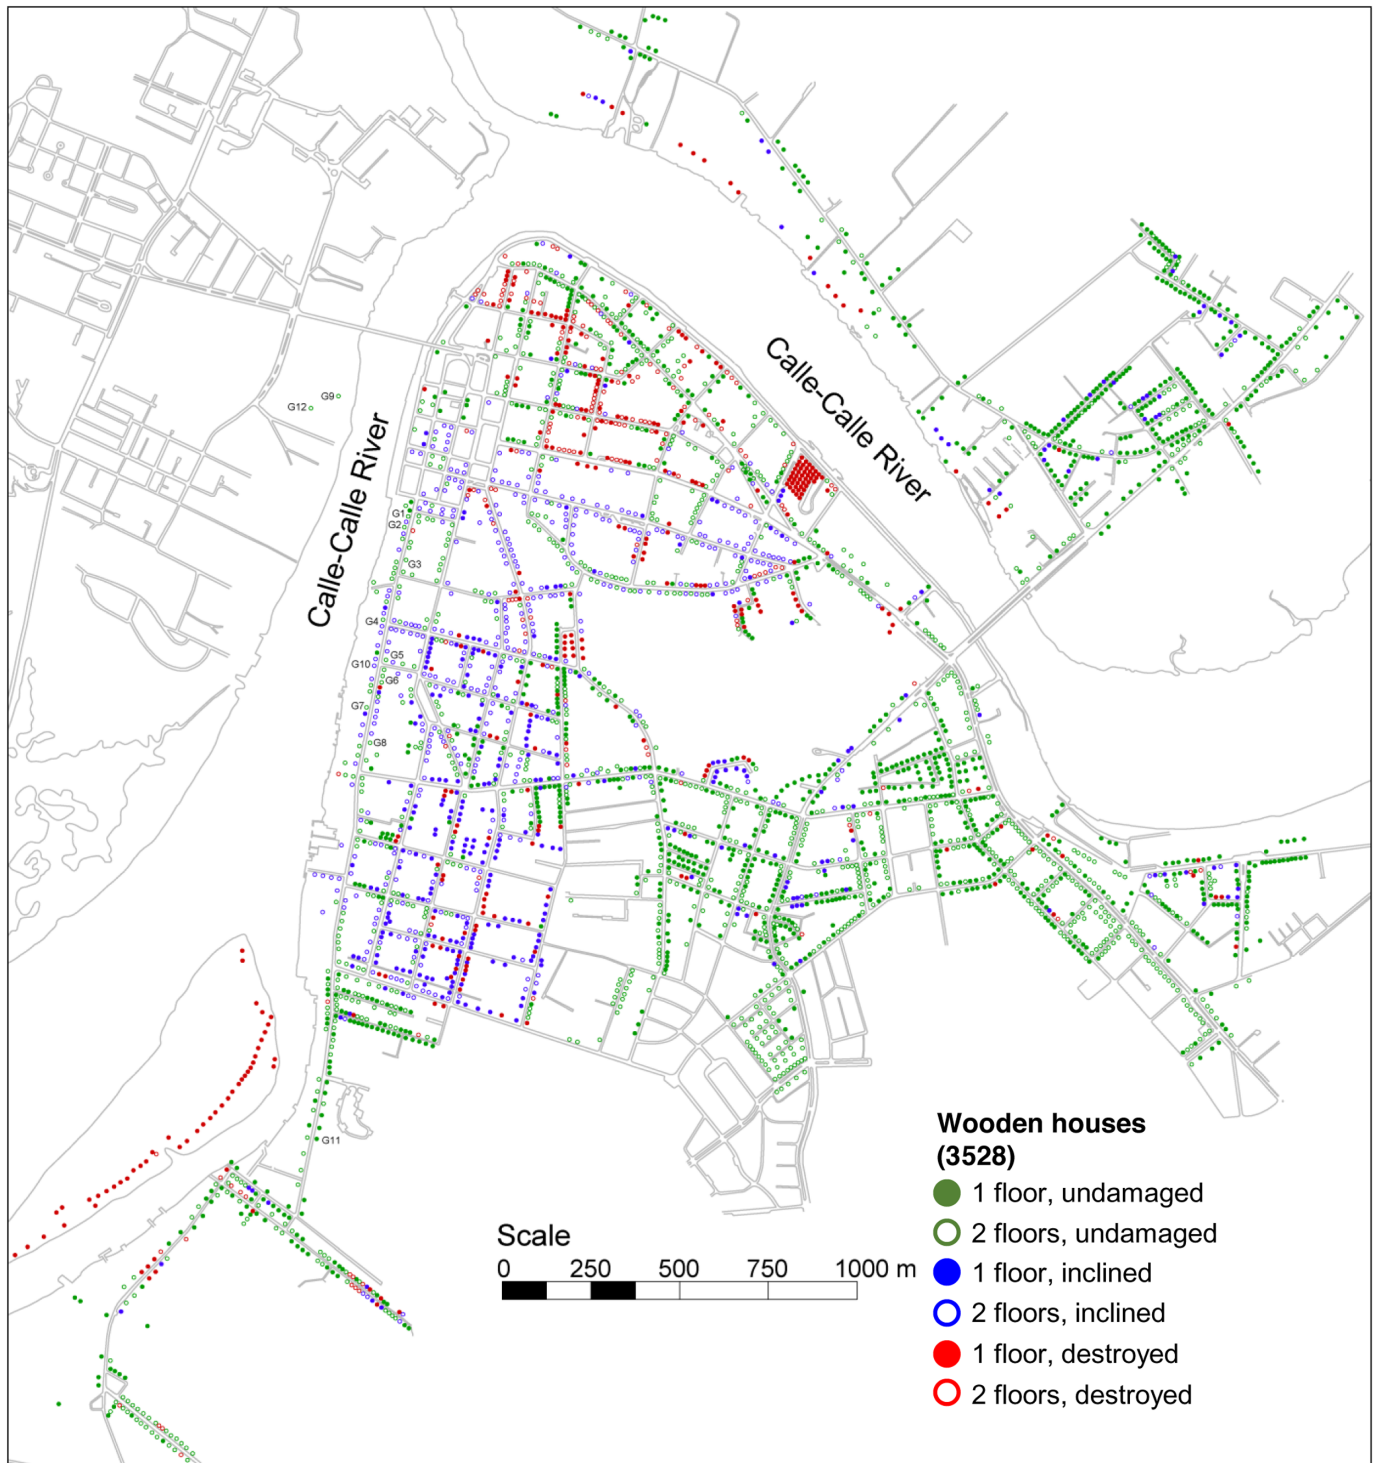
In general, wooden houses performed well during the earthquake. The failure of wood-frame structures was caused

Figure 5. Wooden houses undamaged, inclined, and damaged during the 22 May 1960 Chile earthquake (data from Weischet, 1963; Barozzi and Lemke, 1966; Lástrico, 1967). The location of the 12 undamaged German-style wooden houses are indicated as G1–G12. The color version of this figure is available only in the electronic edition.

by construction quality problems, such as insufficient nails and poor maintenance of the foundation system in the highly humid Valdivia climate. Wood-frame structures with lightly reinforced-concrete or unreinforced-masonry partitions or exterior walls behaved poorly. For instance, the unbraced reinforced-concrete firewalls on property lines between wooden buildings often fell, destroying or severely damaging the adjoining wood-frame houses (Steinbrugge and Flores, 1963).

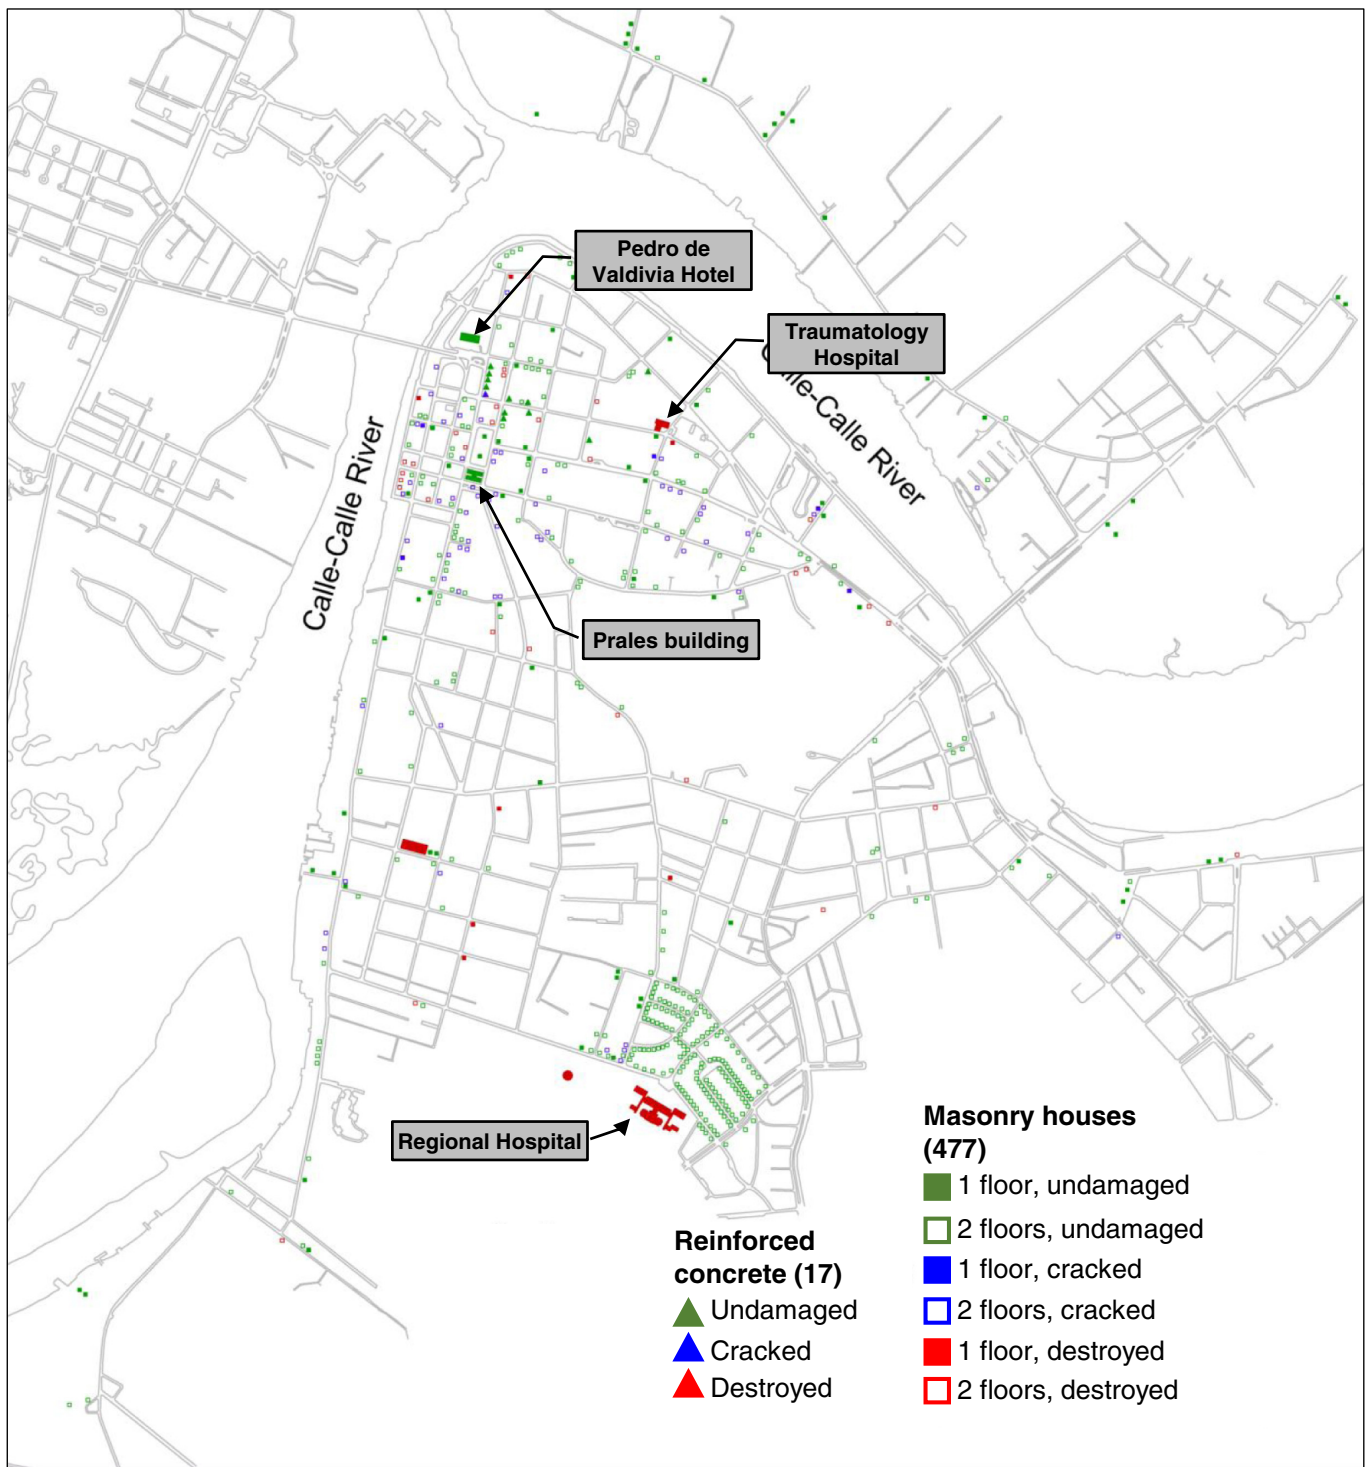
Figure 6. Masonry houses and reinforced-concrete structures undamaged, cracked, and damaged during the 22 May 1960 Chile earthquake (data from Weischet, 1963; Barozzi and Lemke, 1966; Lástrico, 1967). The color version of this figure is available only in the electronic edition.

Figures 5 and 6 show the distribution of wooden and masonry houses in the city, respectively. Each figure indicates houses of one story and two stories that were undamaged,

inclined, cracked, and destroyed. Figure 6 also shows the reinforced-concrete buildings in the city. This study considers 4022 structures, from which 65% were undamaged, 21% resulted inclined or cracked, and 14% were destroyed.

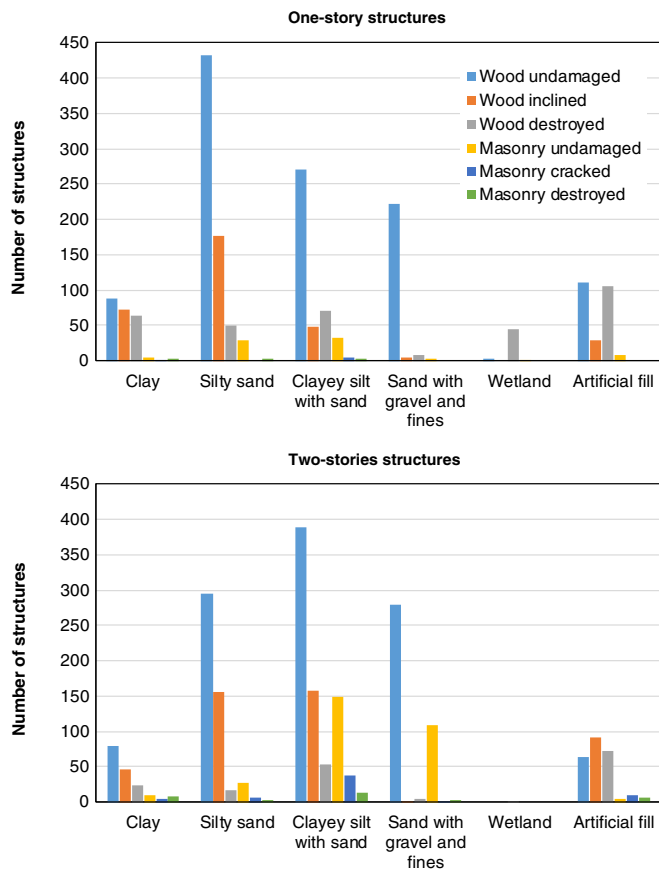
Figure 7. Number of one- and two-story structures undamaged, inclined, cracked, and destroyed during the earthquake, founded over soil types defined in the surface geology in Figure 2. The color version of this figure is available only in the electronic edition.

Figure 7 summarizes the number of undamaged, inclined, cracked, and destroyed structures founded over the different geologic units (data provided in Table 1). Most of the damage focused on structures over the artificial fill unit: 43% of the one-story wooden houses over the artificial fill were destroyed, along with 32% of the two-story houses made of wood and masonry. The geologic unit that follows in terms of damage was the clay unit. In contrast, the unit over which the structures experienced less pronounced damage was the well-graded sand with gravel and fines. We summarize the spatial correlation between the local site conditions and the damage pattern in Figure 8, considering destroyed, inclined, cracked, and undamaged structures.

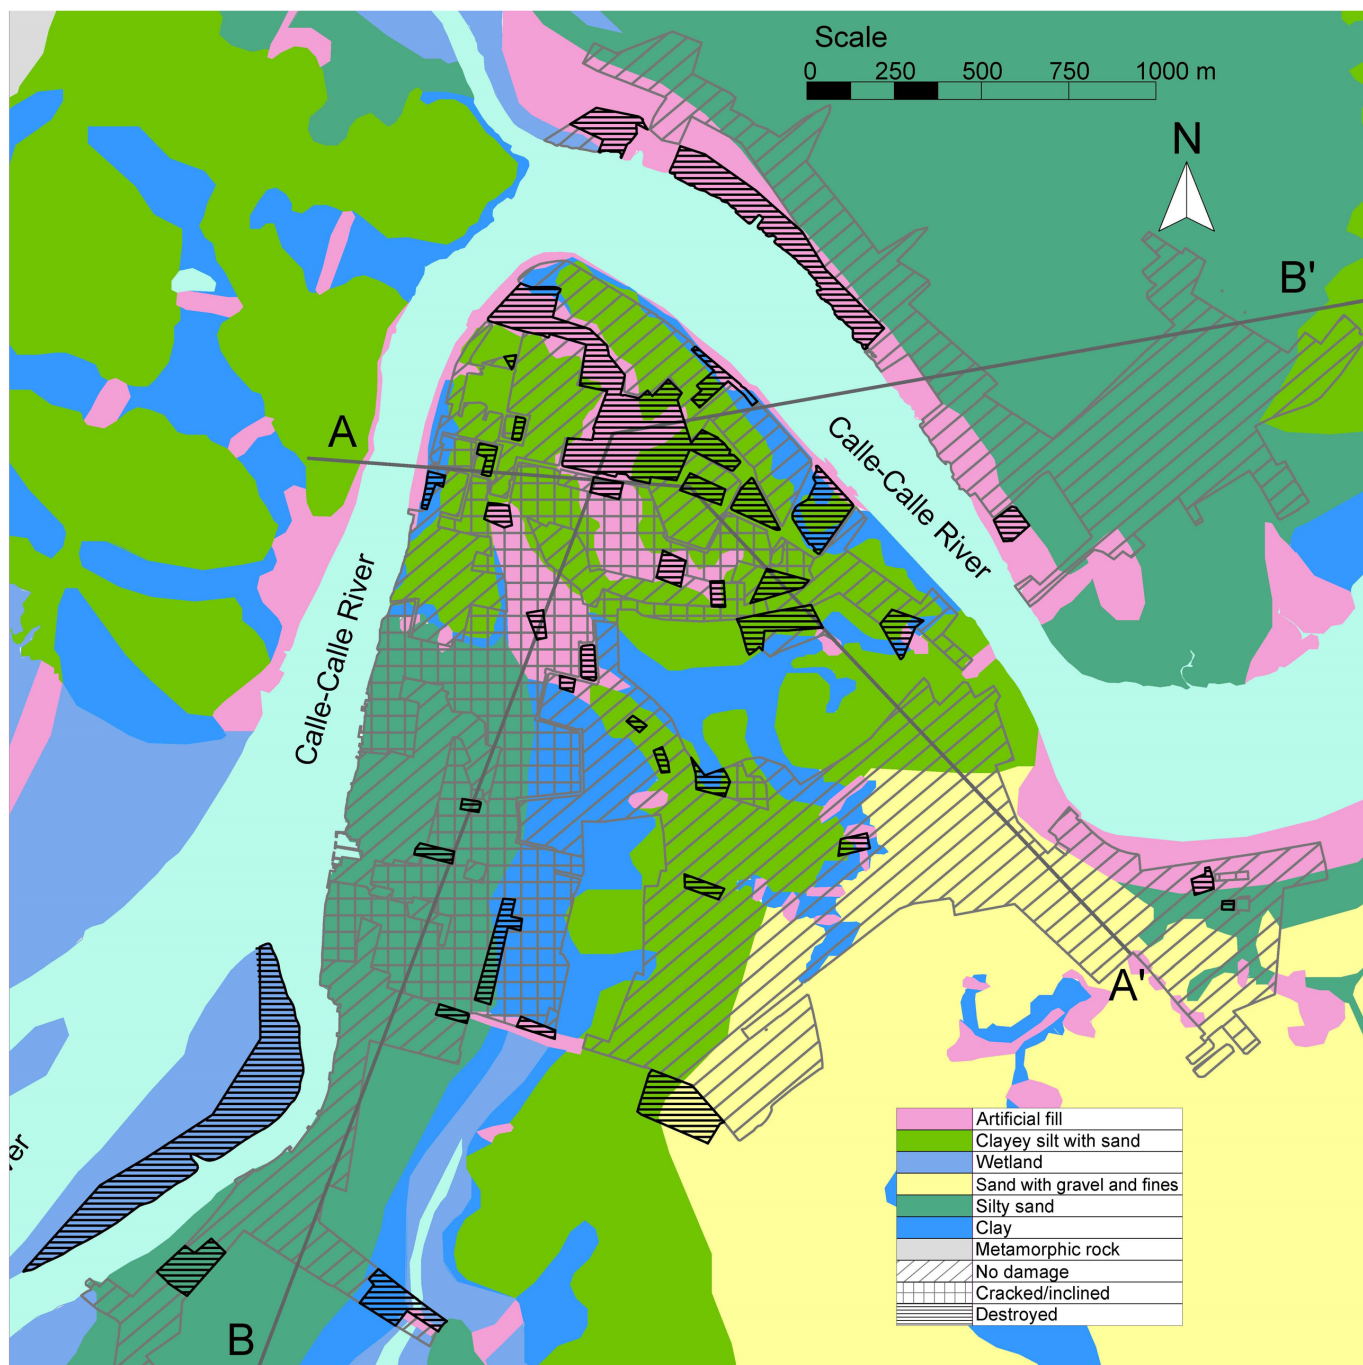
Figure 8. Correlation between surface geology and structural damage. The color version of this figure is available only in the electronic edition.
