Soil Dynamics and Earthquake Engineering

Performance of bridges with seismic isolation bearings during the Maule earthquake, Chile

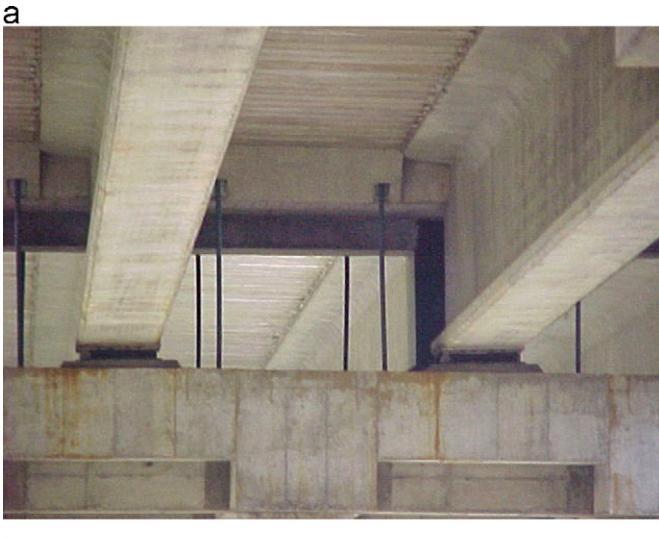
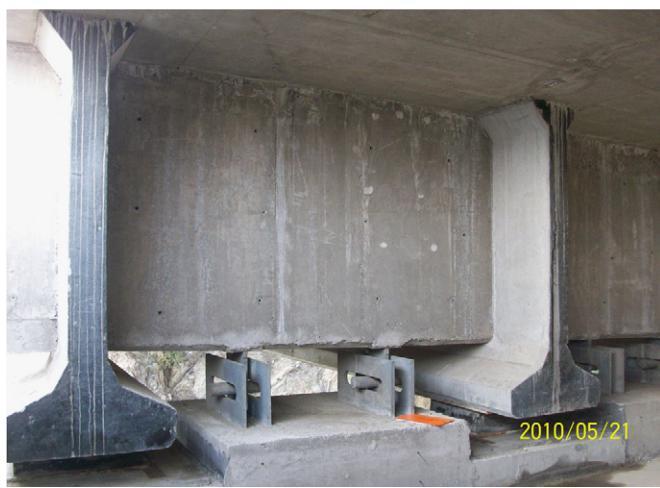
Fig. 1. "Seismic bars" and transverse diaphragms in typical simply supported bridge.

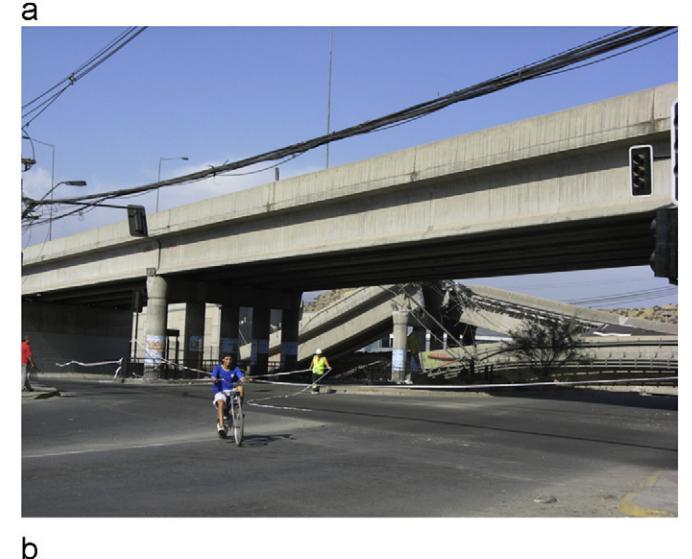
Fig. 2. (a) Vespucio Norte Overpass. Insufficient steel stoppers.(b) Overpass near Rancagua.

Vespucio Norte where the steel side stoppers were insufficient to hold the beam flanges. Other factors that contributed to the damage were the lack of vertical restraint bars at the supports and the small size of the supporting area. Fig. 2b shows a damaged overpass with a significant lateral displacement of the superstructure that broke the reinforced concrete stoppers. In addition, local amplification of seismic waves and poor soil quality was reported in all these sites.
