Soil Dynamics and Earthquake Engineering

Liquefaction-induced ground damages during the 2010 Chile earthquake

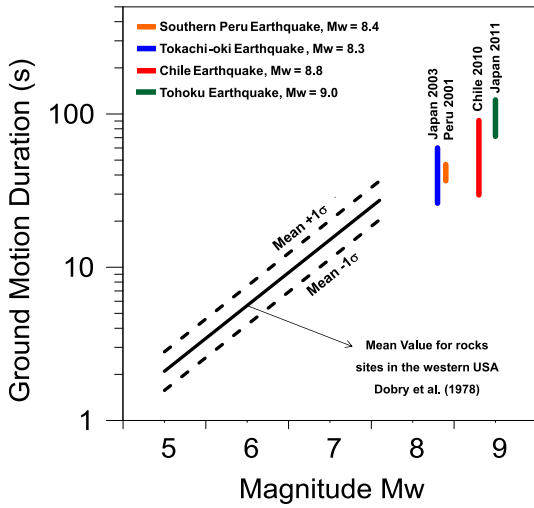
Fig. 8. Relationship between ground motion duration and earthquake magnitude (modified from [11] and [12]).

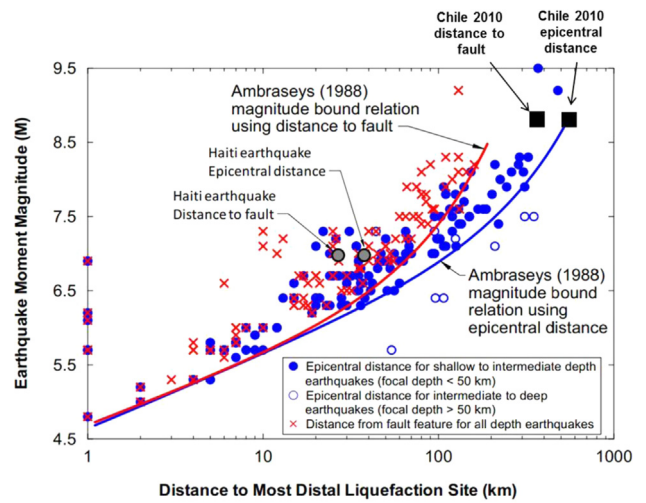
Fig. 11. Earthquake Magnitude and distances to most distal liquefaction sites (modified from [14] and [15]).

The farthest site that experienced liquefaction is located to the south-east of Valdivia city, in a border of Llanquihue Lake, approximately at 550 km from the epicenter and 350 km from the fault. The distances to the most distal liquefaction site has been reported as a function of the earthquake magnitude [14,15]. This empirical relationship is shown in Fig. 11, where the farthest liquefaction site observed during the 2010 Chile Earthquake is included. As it can be observed, there is a good agreement with the epicentral distance, while the prediction for the distance to fault is underestimated.

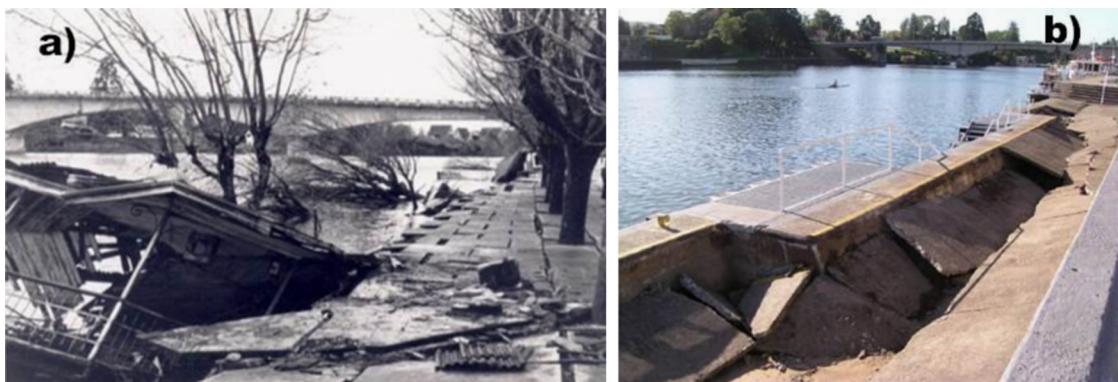
Fig. 12. Liquefaction in Muelle Schuster at Valdivia City: (a) 1960 Valdivia Earthquake (El Mercurio) and (b) 2010 Chile Earthquake (Sernageomin).

Nonetheless, considering the fairly moderate level of accelerations recorded in Valdivia (PGA=0.14 g), the liquefaction observed in this city and surroundings is rather difficult to explain. A singular condition of this area is associated with the fact that it has been previously subjected to a mega earthquake of magnitude 9.5 (1960 Valdivia Earthquake), which also induced liquefaction in several sites. It is possible to venture that previously-liquefied soil deposits may remain in a susceptible condition to liquefy again. One example is presented in Fig. 12. The same site (Muelle Schuster) located in Valdivia City was affected by important

One clear example is the site, Muelle Schuster, located in Valdivia and shown previously in Fig. 12. Another case occurred in the mouth of the Maipo River, approximately 90 km south-west of Santiago. During the 1985 Earthquake, the first three spans adjacent to the right abutment (North) of Lo Gallardo Bridge collapsed due to the occurrence of liquefaction (Fig. 23). The bridge constructed in 1958 consists of 28 simple-supported spans, each 30 m long [26]. The damaged piers consisted of five square columns of 1 m thickness supported by 17 precast concrete piles, each 14 m long (Fig. 24a). The bridge was repaired after the 1985 Earthquake by means of additional piles to a depth of 25 m. As can be observed in Fig. 24b, these additional piles were installed laterally, connecting them to the original foundation system by enlarging the pile caps. Due to the 2010 Chile Earthquake it underwent some lateral deformations, as can be observed in Fig. 25, which is a symptom of the re-occurrence of liquefaction.

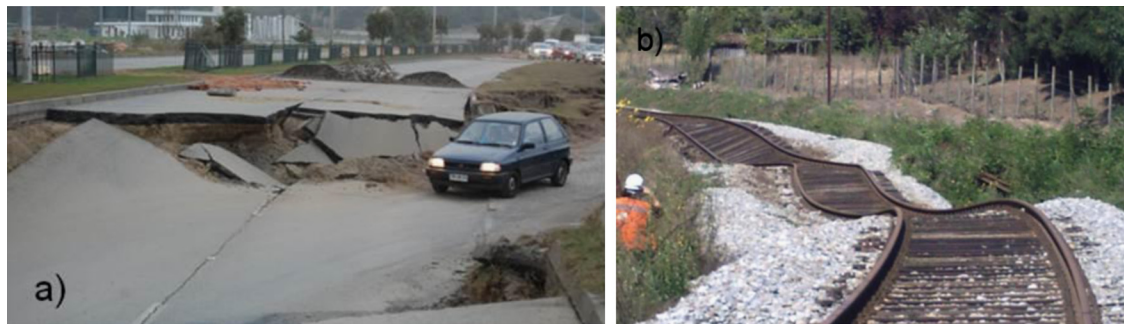
Fig. 14. Post-liquefaction settlements. (a) Costanera route in Concepción and (b) near Concepción City (EFE).

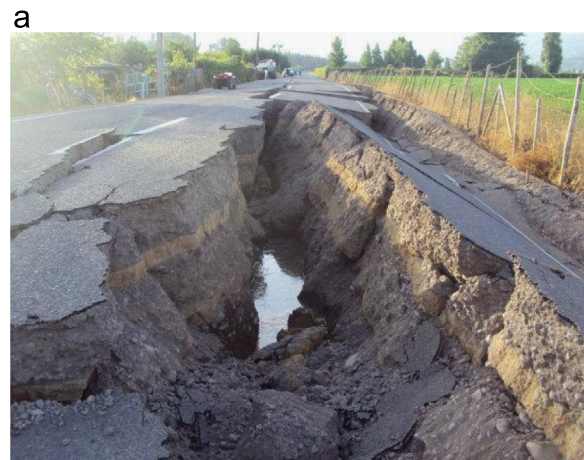
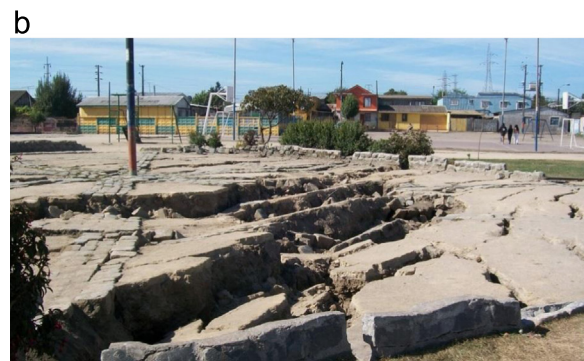
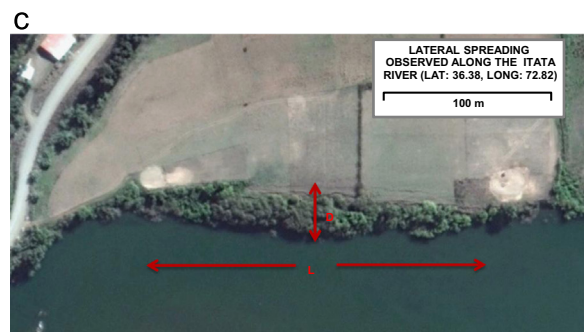
Fig. 17. Lateral spreading observed in (a) Apalta route (<http://sites.google.com/site/valledepalta>), (b) Lo Custodio Lagoon, near Concepción (<http://losandes-concepcion.blogspot.com>) and (c) Itata river.

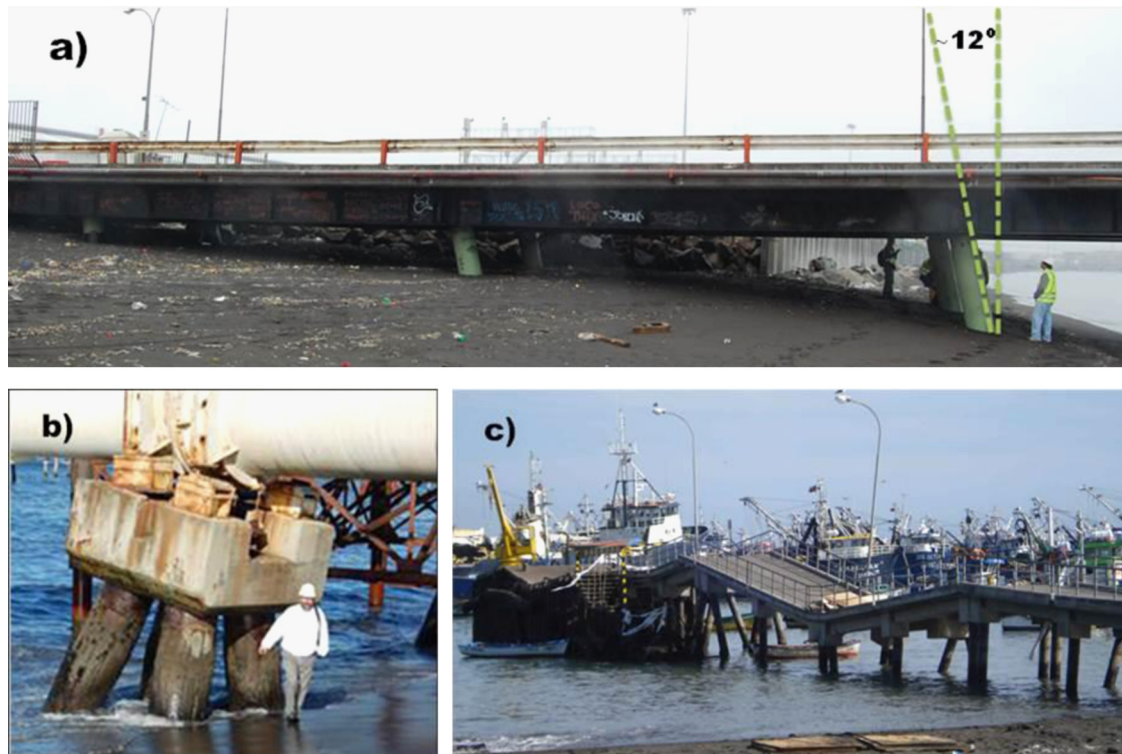
Fig. 18. Lateral spreading, (a) Coronel Port, (b) Bocamina Port and (c) Fishermen's Port.

Pile foundations of several port facilities were damaged by the action of liquefaction-induced lateral spreading as shown in Fig. 18. This phenomenon has been observed and widely studied [21–23]. This type of damage is usually associated with a high economic cost, which is primarily caused by the halted operations of the port structures supported by piles. It is important to bear in mind that the costs of operation disruption of ports or electrical power plants are an order of magnitude greater than the cost of reparations.

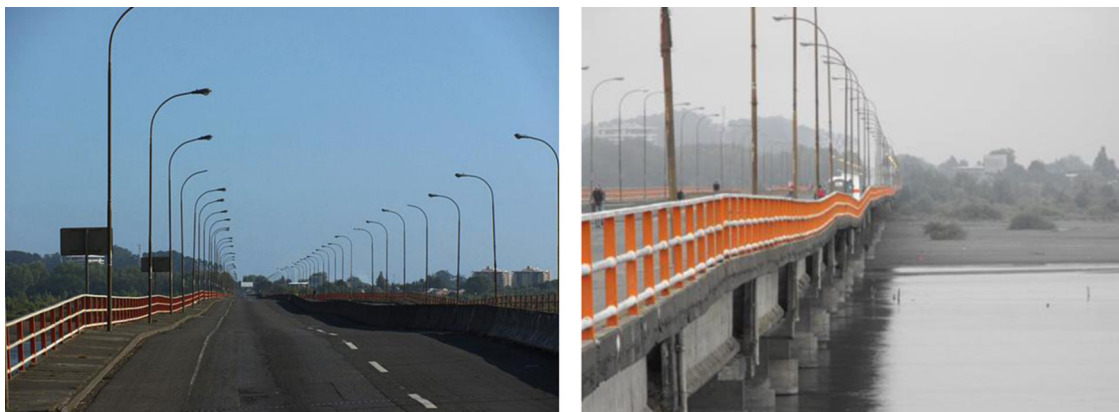
Fig. 20. Settlements along Juan Pablo II Bridge with no evidence of horizontal displacements.

It is interesting to realize that although important settlements occurred on several piers, no permanent transverse horizontal displacements were observed along the bridge. This fact necessarily implies that non-liquefiable layers were able to provide sufficient lateral stiffness and strength to ensure the transverse lateral stability of the bridge. From a point of view of the structural design, this is a crucial issue because it reduces considerably the required sub-structure to guarantee the lateral stability.

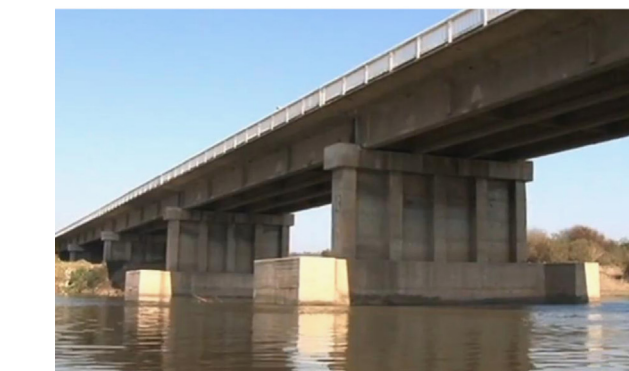
Fig. 24. (a) Plan and elevation of original piers (modified from [26]) and (b) Repaired piers after 1985 Earthquake (Videos MOP).

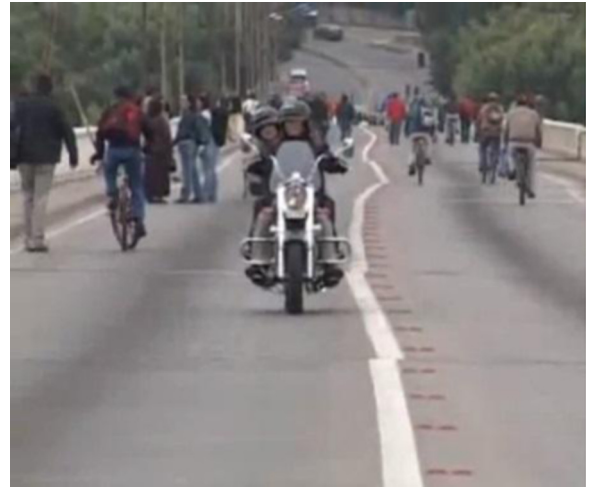
Fig. 25. Misalignment of Lo Gallardo Bridge (TV San Antonio).

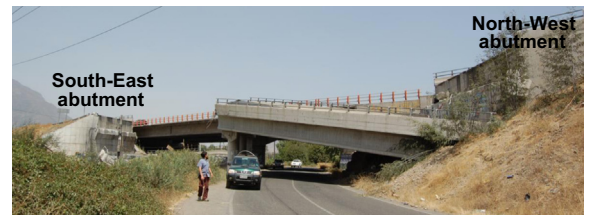
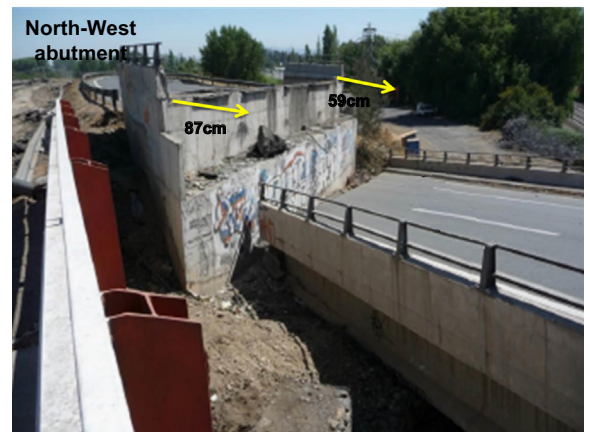
Fig. 26. Collapse of Hospital overpass.

from liquefaction caused the collapse of this overpass (lane with north direction). A maximum permanent horizontal displacement of 87 cm was measured at the north abutment, which triggered the fall of the bridge deck (Fig. 26). The stratigraphy of the ground, shown in Fig. 27, indicates the existence of saturated loose layers of sandy soils characterized by SPT blowcount of less than 20. These sandy layers are enclosed by fines soils, which generate an optimum condition for an undrained behavior. To reproduce the observed permanent horizontal displacement, the sandy layers have to be considered completely liquefied with their residual undrained strength [27]. In this case, the previous earthquake of 1985 only induced a limited liquefaction and its recurrence was activated by the 2010 Earthquake of Magnitude 8.8.
