# The Basement of the San Francisco Church: An Earthquake-resistant Foundation on a Prehispanic Layer?

Article in ARQ · August 2016

**Starting from this question, this research examines the church's subsoil to suggest that its foundations, built in 1586, perhaps would be one of the first earthquake-resistant structures in Chile.**

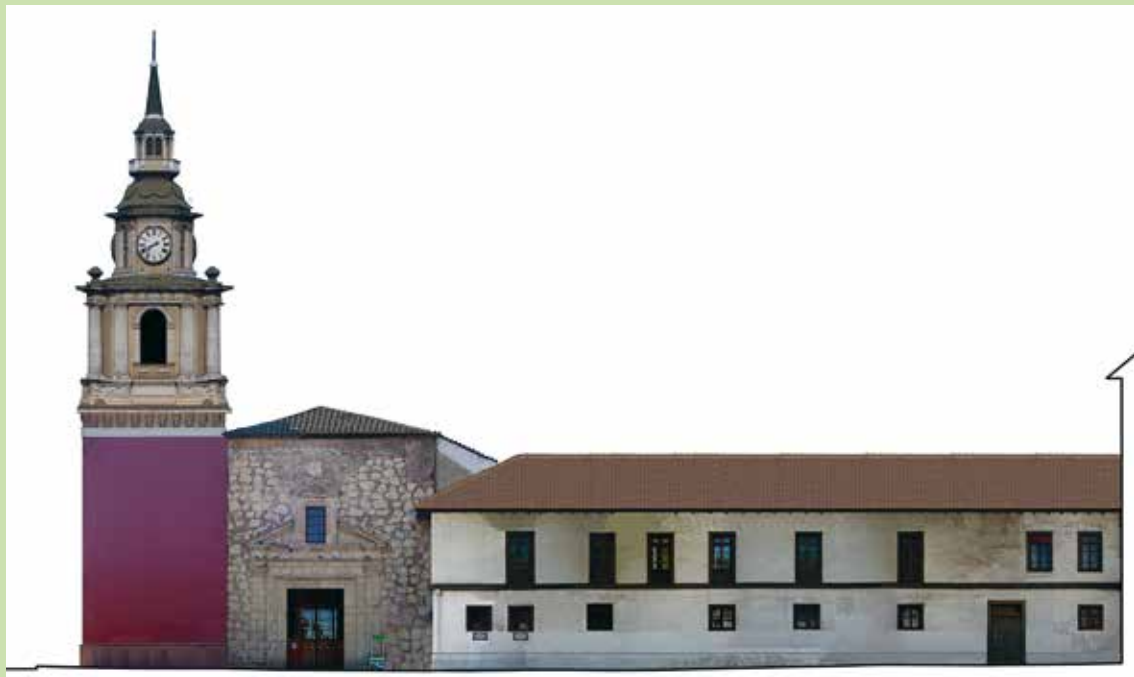
**FIG 1** Fotogrametría elevación poniente Iglesia y Convento San Francisco /  
*Photogrammetry west elevation San Francisco Church and Convent.*  
Escala / Scale 1: 500. Fuente / Source: FONDECYT N° 11130628

The San Francisco Church and Convent in Santiago comprise both the capital's and the country's oldest built complex (FIG. 1),<sup>1</sup> being "the only authentic sixteenth-century architectural testimony preserved in Chile" (Benavides, 1988:128). The building, which has undergone numerous alterations, still preserves its original Latin-cross shaped stone structure (FIG. 2), an element that today constitutes the church's central nave and transept (FIG. 3).

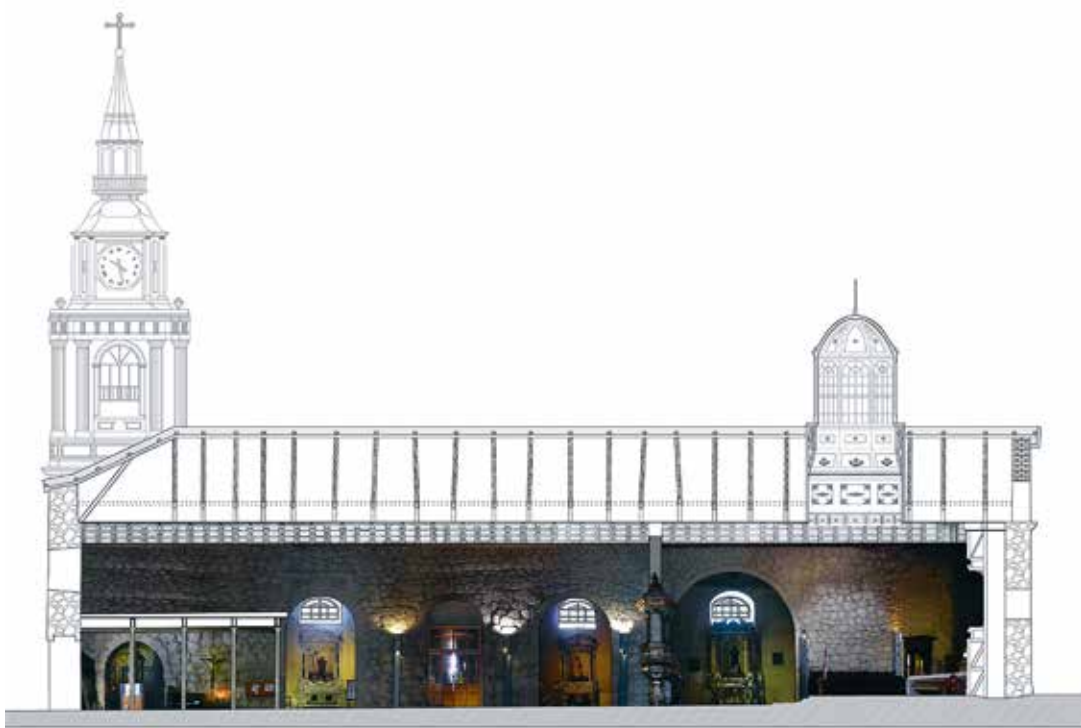
**FIG 3** Corte fotogramétrico longitudinal iglesia San Francisco. Nave central original. /  
*Photogrammetric longitudinal section San Francisco Church. Original central nave.*  
 Escala / Scale 1:500. Fuente / Source: FONDECYT N° 11130628

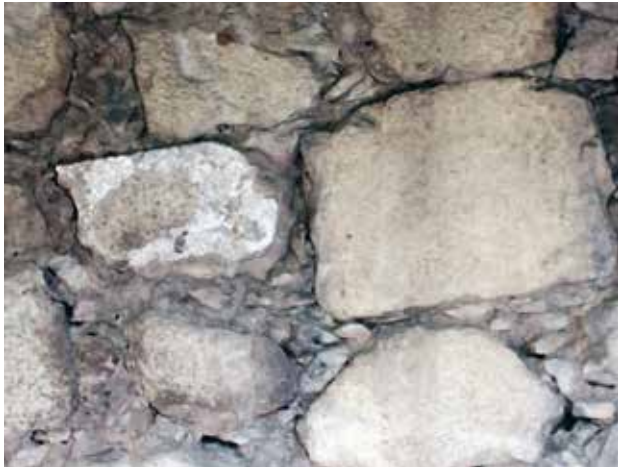
**FIG 4a** Detalle mampostería de piedra original / *Original stone masonry detail.*  
Fuente / Source: FONDECYT N° 11130628

Thus, although the church has been modified and shows partial damage of seismic origin, these have been minor. This, despite the apparent fragility of the constructive systems employed, consisting of stone masonry in the original nave and brick masonry in the aisles (FIG. 4); basically, systems with low capacity to resist horizontal forces.

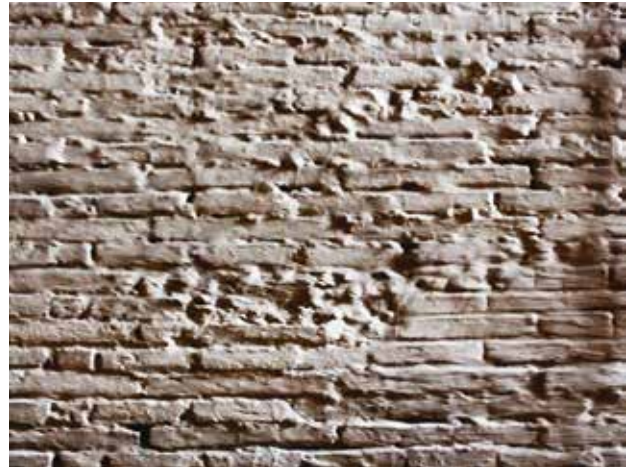
**FIG 4b** Detalle albañilería de ladrillo de las naves laterales, de construcción posterior / *Masonry brick detail in side aisles, of later construction.* Fuente / Source: FONDECYT N° 11130628

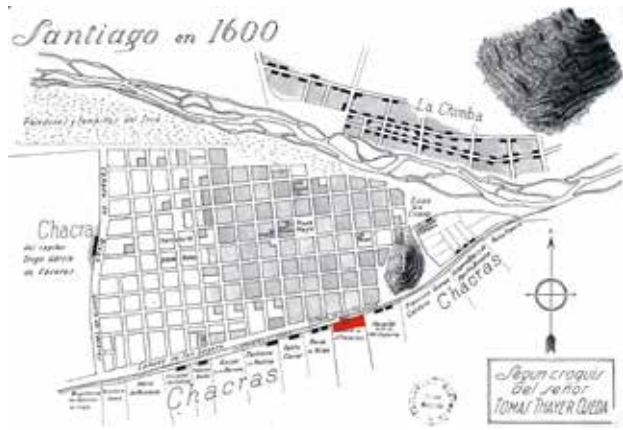
**FIG 5** Plano de Santiago, 1600. En rojo se destaca la iglesia y convento de San Francisco / *Plan of Santiago, 1600. Highlighted in red San Francisco Church and Convent.* Fuente: Imagen reelaborada a partir del croquis original de Tomas Thayer Ojeda, 1600. / *Source: Image developed from Tomas Thayer Ojeda original sketch, 1600.* Colección Biblioteca Nacional.

Despite its early construction in the Conquest period (1541-1598), the San Francisco Church and Convent are located outside the foundational triangle’s grid plan, at the time limited by the two branches of the Mapocho river (FIG. 5), The soil of this site belongs to the Unit II type defined by Leyton et al (2011), composed of sandy gravels from the Mapocho. In addition, it is part of the seismic zone A, “where less damage from earthquakes is expected” (Leyton et al. 2011).

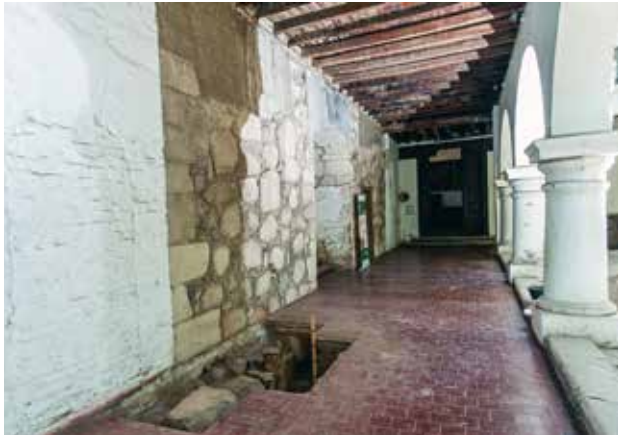
**FIG 7** Ubicación de la excavación en el actual corredor del Museo / Location of the excavation in today's Museum's corridor. Fotografía / Photograph: Claudio Zamorano. Fuente / Source: FONDECYT N° 11130628

excavation area (FIG. 6), a place where the church's southwest corner used to be and where the San Francisco Colonial Art Museum's corridor is today (FIG. 7). This specific location was chosen considering that the transept corresponds to the church's original stage and that it has never collapsed with earthquakes or been modified; therefore, the foundations to be found here could be representative of the church's entire first phase. The excavation polygon was entitled Unit 1; subsequently, due to the findings –the atypical characteristics of the foundation and also human remains– it was decided to extend it to more than twice its size, about 4 linear meters by 1 meter wide and 1.5 meters in the burial area. The excavation's enlargement area was called Unit 2, while the burial area was called Burial 1 (FIG. 8).

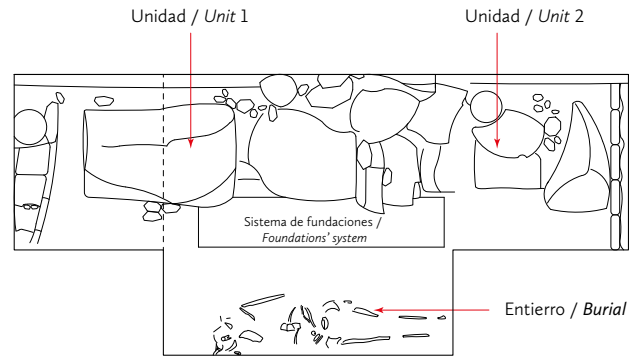
**FIG 8** Planta detalle excavación / Excavation detail plan. Escala / Scale 1: 50. Fuente / Source: FONDECYT N° 11130628

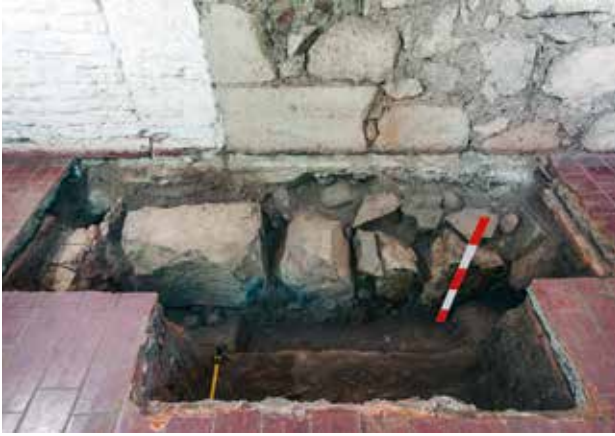
**FIG 9** Vista frontal del sistema de cimientos / *Front view of the foundation system.* Fuente / *Source:* FONDECYT N° 11130628

The foundations of the original San Francisco church constitute an atypical case and, therefore, are dissimilar from most colonial buildings in Santiago. Their structure starts 10 cm below floor level –where the 1.7 m thick stone wall ends– and is made of cobblestone ('boulders' in colloquial language), contained laterally by two megalithic stone axes. Cobblestones –likely extracted from the Mapocho river– vary in size, ranging between 10 and 30 cm, and are submerged in loose soil and sand; that is, they are not bounded by mortar and, therefore, they have no rigidity. This means that the thick wall is simply rests on a sort of mobile support. The lateral axes –of which only one was observed during the excavation– are composed of large semi-shaped stone blocks about 60 × 60 × 60 cm, parallel to the foundations and detached 20 cm from the wall, with a larger stone (90 × 60 × 60 cm) located at the corner of the transept. At the junction between the large blocks are small cobblestones and wedge-shaped stones, presumably to keep together the ensemble, transforming the axis into an immovable lateral retaining wall (FIGS. 9-10).

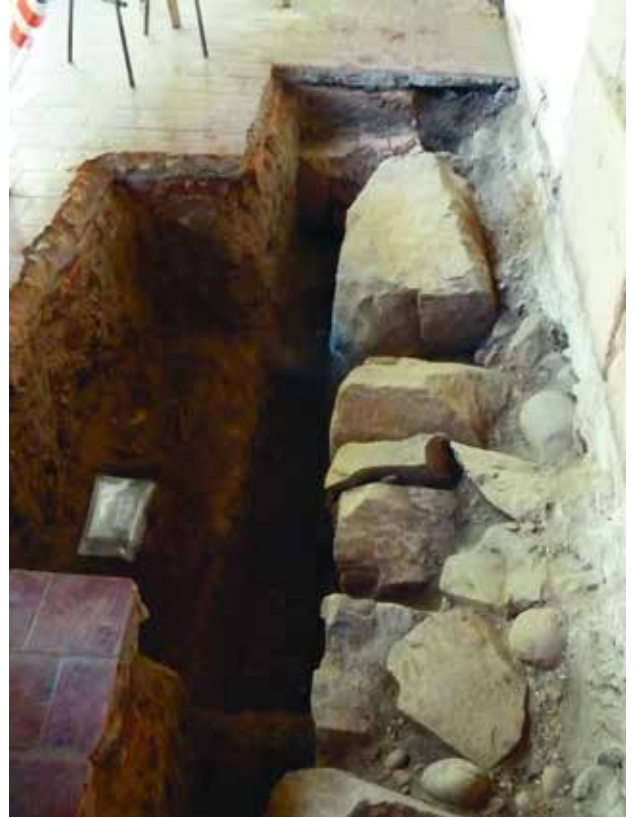
**FIG 10** Vista superior del muro de contención lateral del sistema de cimientos / *Top view of the foundation's retaining lateral wall.* Fuente / *Source:* FONDECYT N° 11130628

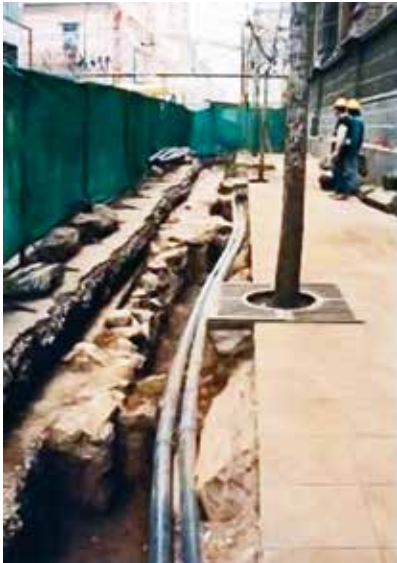
**FIG 12a** Cimientos de piedra con argamasa de cal de la Catedral de Santiago / Stone and lime-mortar foundation of Santiago's Cathedral. Fotografía / Photograph: Claudia Prado. Fuente / Source: FONDECYT N° 1090325

It is noteworthy that although the use of cobblestones in foundations was relatively common during the colonial period, these were used in the deepest part as filling material –immediately above the soil– and if they were more superficial or near the wall, they would be bound by mud or lime and sand mortar. In addition, in monumental buildings in Santiago like the Cathedral, the Real Audiencia and the Real Aduana (current Museum of Pre-Columbian Art) it is usual to find great depth and thicker-than-walls foundations, built of stone or brick and mortar (FIG. 12). In other words, conventional foundations belonging to Spanish tradition.

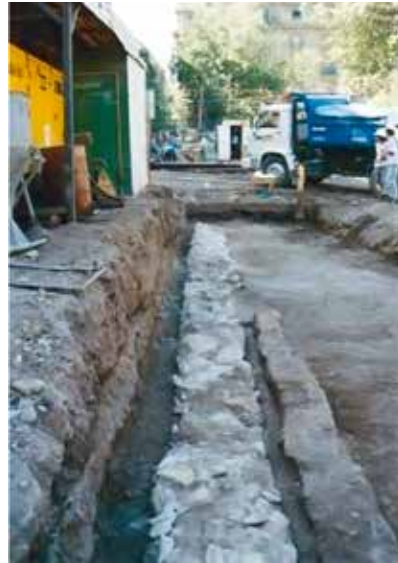
**FIG 12b** Cimientos de piedra con argamasa de cal del antiguo mercado de la Plaza de Armas de Santiago / Stone and lime-mortar foundation of Santiago's ancient market at Plaza de Armas. Fotografía / Photograph: Claudia Prado. Fuente / Source: FONDECYT N° 1090325

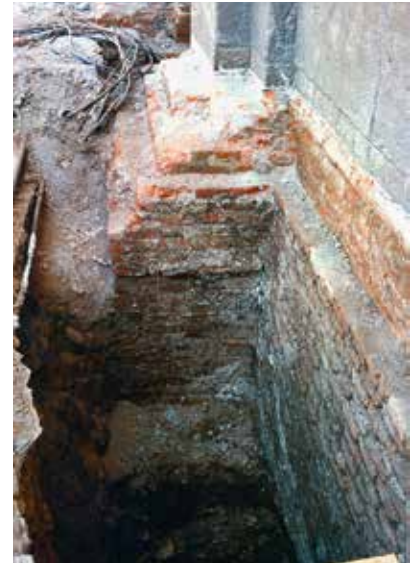
**FIG 12c** Cimientos de piedra con argamasa de la ex Real Audiencia de Santiago. Excavaciones realizadas en el marco de la construcción de la Estación Metro Plaza de Armas / Stone and mortar foundation of the former Real Audiencia in Santiago. Excavations performed during the construction of Plaza de Armas Subway Station. Fotografía / Photograph: Claudia Prado, 1997.

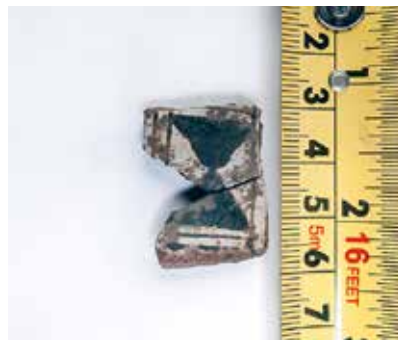
**FIG 14a** Fragmento cerámico de escudilla con motivo propio de la época Inka, de origen foráneo / Ceramic bowl fragment with Inka motif, of foreign origin. Fotografía / Photograph: Claudio Zamorano. Fuente / Source: FONDECYT N° 11130628

Among the material remains documented are fragmentary ecofacts (faunal, malacological and floral) along with ceramic, glass, metal and stone artifacts. Noteworthy are the 119 pottery fragments recovered, among which it was possible to distinguish ten decorated pre-Hispanic pieces, one of them –fragmented in two and with a clepsydra motif– clearly belongs to the Inka period (FIG. 14) as well as the presence of a high percentage of open red-slipped vessels used in rituals and funeral contexts (FIG. 15). Three majolica pottery fragments belonging to the late colonial period (18<sup>th</sup>) and five fragments of high temperature pottery (crockery) of the *Whiteware* type, attributable to the second half of the 19<sup>th</sup> century, were also found.

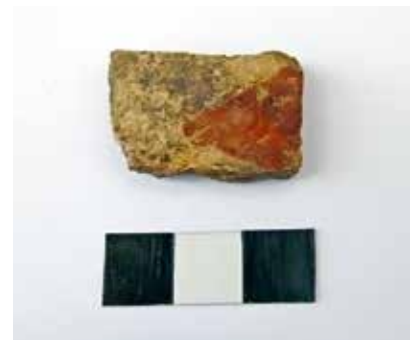
**FIG 14b** Fragmento cerámico con decoración roja sobre blanco, propio de épocas tardías de presencia Inka en la zona / Ceramic fragment with red on white decoration, belonging to late Inka presence in the area. Fotografía / Photograph: Claudio Zamorano. Fuente / Source: FONDECYT N° 11130628

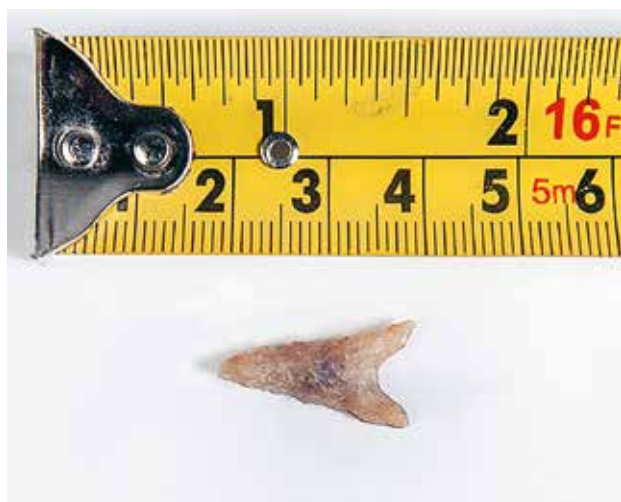
**FIG 16** Punta de proyectil de base escotada, utilizada como pieza del conjunto arco y flecha, propia del período Intermedio Tardío y Tardío en la zona central de Chile / *Irregular based projectile point, used as part of bow and arrow set, typical of Late Intermediate and Late Period in central Chile.* Fotografía / *Photograph:* Claudio Zamorano. Fuente / *Source:* FONDECYT N° 11130628

Regarding the lithic assemblage, some slices of different raw materials (silica and obsidian) were noted, underlining the presence of an irregular based projectile point (FIG. 16). These remains, together with the decorated ceramic fragments belonging to the late period and the Inka vessel, are unambiguous indicators of the existence of a late pre-Hispanic occupation of local groups in contact with the Inka or directly subjected to the Inka Empire (Sanchez, 2004; Uribe, 2000), on top of which San Francisco was possibly built.
