## Debris flows in the Andean ranges of central Chile and Argentina triggered by 2013 summer storms: characteristics and consequences

**Abstract** In January and February 2013, heavy rainfall during local summer storms triggered a large number of landslides in the Andes Main and Frontal ranges of central Chile and Argentina (32°–34° S). Most of the mass movements classify as debris flows, while rockfalls and debris avalanches also occurred. The major debris flows occurred in the Maipo and Aconcagua valleys (Chile) and along the Mendoza River valley (Argentina). The debris flows caused serious disruption to the international highway connecting both countries and local roads and produced a large impact on the population of major cities downstream, mainly due to potable water supply cutoffs. Debris flow deposits have silt and clay particles usually ranging between 10 and 20% by weight, which favors the movement of viscous flows in short, steep lateral gullies. Most of the flows tended to channelize, and the materials were deposited in alluvial fans and cones in areas with previous records of such events. This indicates that they constitute a significant hazard that may not have been

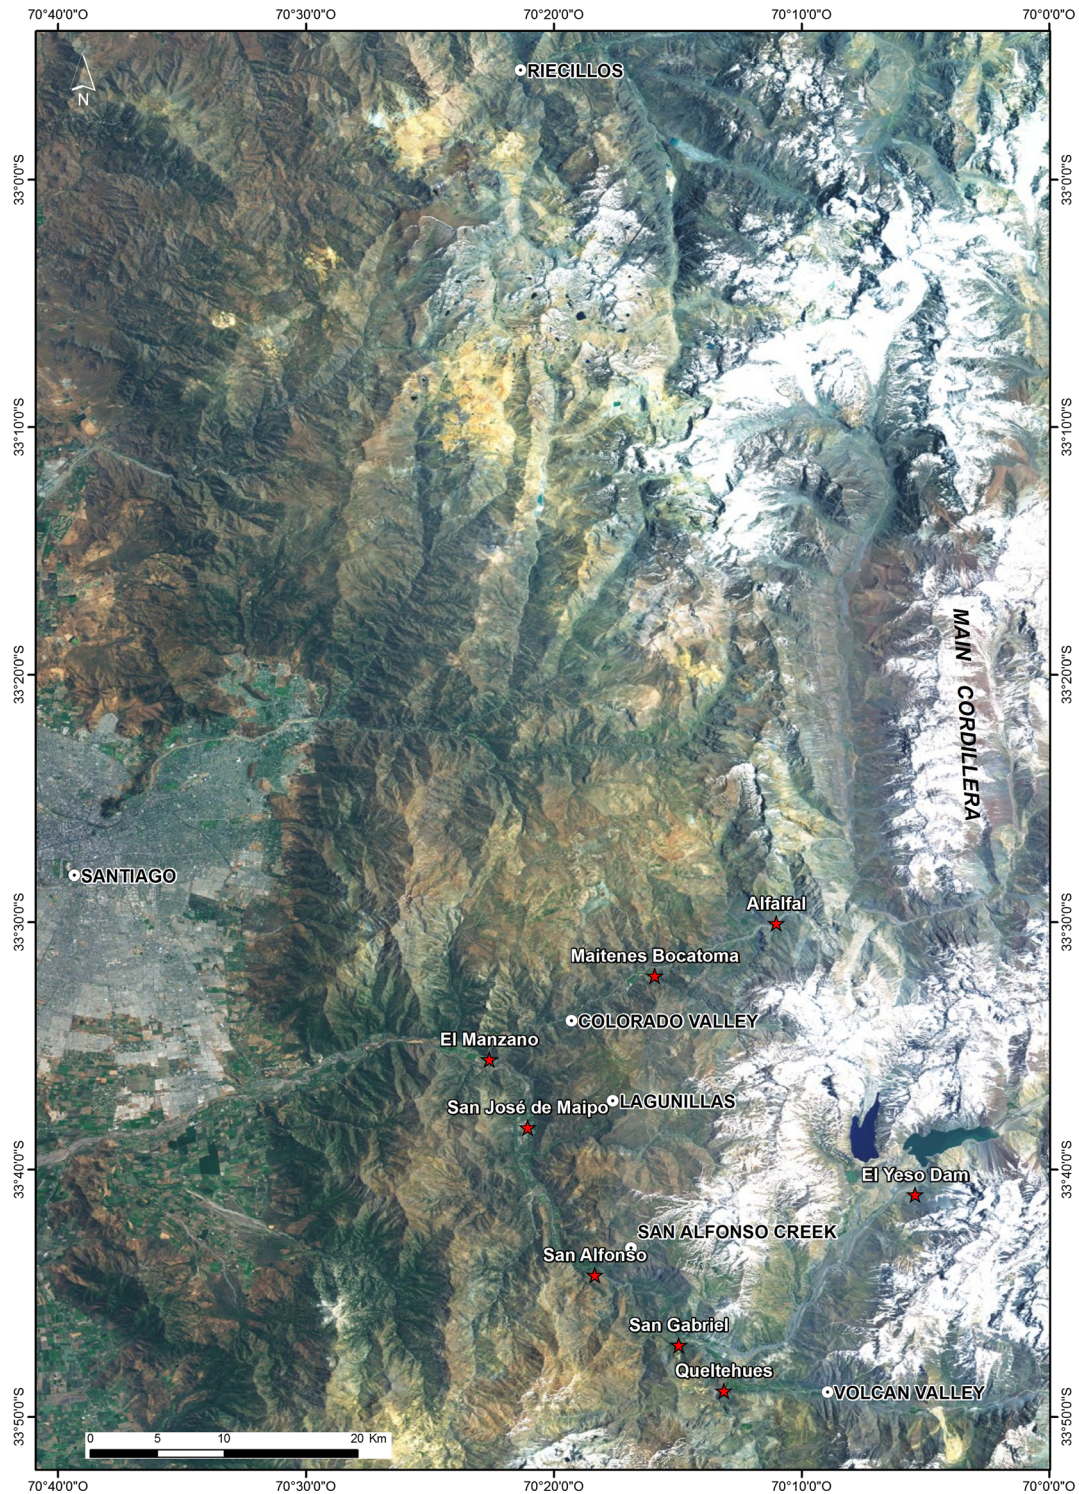
**Fig. 2** Google image showing location of main debris flow events that occurred during summer of 2013 in the Maipo and Aconcagua valleys in Chile (*dots*), and location of meteorological stations indicated in Table 1 (*stars*)

San Alfonso Creek and other minor lateral tributaries of the Volcán River in the Maipo basin (Fig. 2 and Table 2).

In Chile, in the evening of 8 February 2013, intense localized rainfall produced at least nine debris flows in small tributaries of the Colorado River (33.5° S, Fig. 2 and Table 2), a main branch of the Maipo basin along the route to the Maitenes and Alfalfal power stations. Other minor mudflows were located at the Lagunillas ski

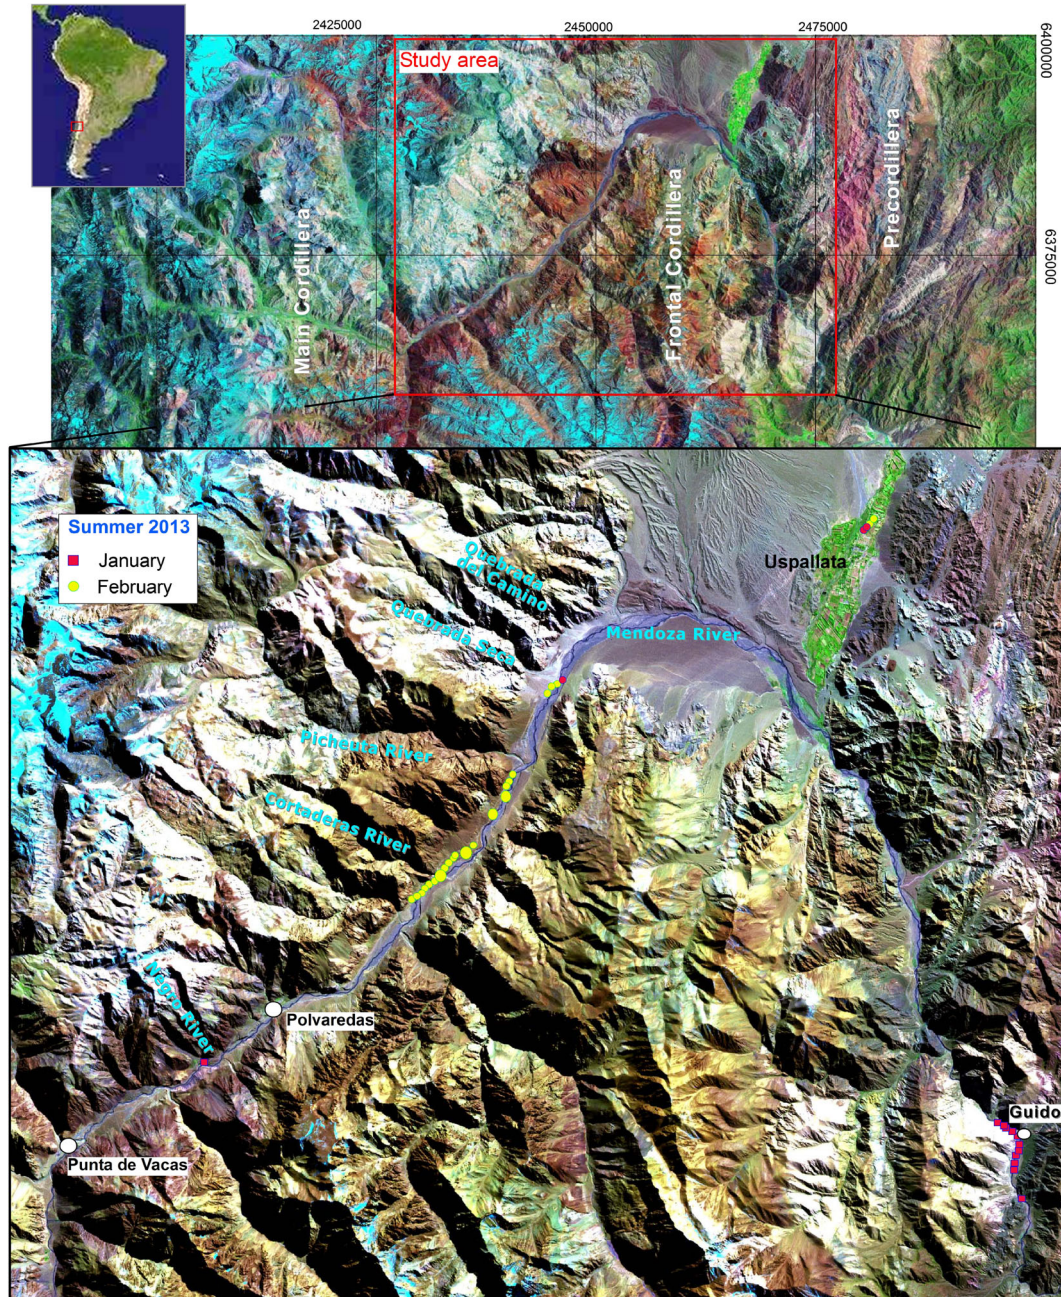
Fig. 3 Google image showing location of events that occurred during summer of 2013 along the international road to Chile in the Mendoza River valley

The first event occurred on January 12 in Uspallata Village (Fig. 3), located in the valley separating the Frontal Cordillera and Precordillera ranges. The hyperconcentrated flow sourced by intense rainfall affected the Provincial Route 149, which was impacted by a new flow on the following day and again 2 weeks later on January 30. Also, an isolated debris flow was recorded in the Arroyo Negro Creek located 20 km to the west on January 13 damaging the international road to Chile (Fig. 3). Huge blocks came down into the road.

and a violent flow channelized into the Quebrada Seca gully (Fig. 3) interrupting the international traffic of Road 7 to Chile later on January 23. According to a report by the National Directorate of Roads (DNV 2013), a huge amount of debris must have been remobilized from the road due to this event.

On 7 February, at least 38 landslide events occurred along a 20-km section of the Mendoza River valley between Polvaredas and Uspallata (Fig. 3). They mainly correspond to debris flows and rockfalls according to Hungr et al. (2014; Table 2). As a consequence, the international traffic was interrupted for 5 days. As a result, 180 trucks were stranded, 660 people were isolated, and 74 tourists had to be evacuated by helicopters.

A large hyper-concentrated flow coming from the Quebrada Seca gully also interrupted the road on February 7 (QS1, Fig. 3 and Table 2). This flow reached the road depositing material of 3 m high and affecting 500 m of the road and entered the Mendoza River burying two bulldozers and other road machinery (Fig. 12). Thirty vehicles were stranded in the mountains as a result of this event. Debris material transported boulders up to 3 or 4 m<sup>3</sup>, and

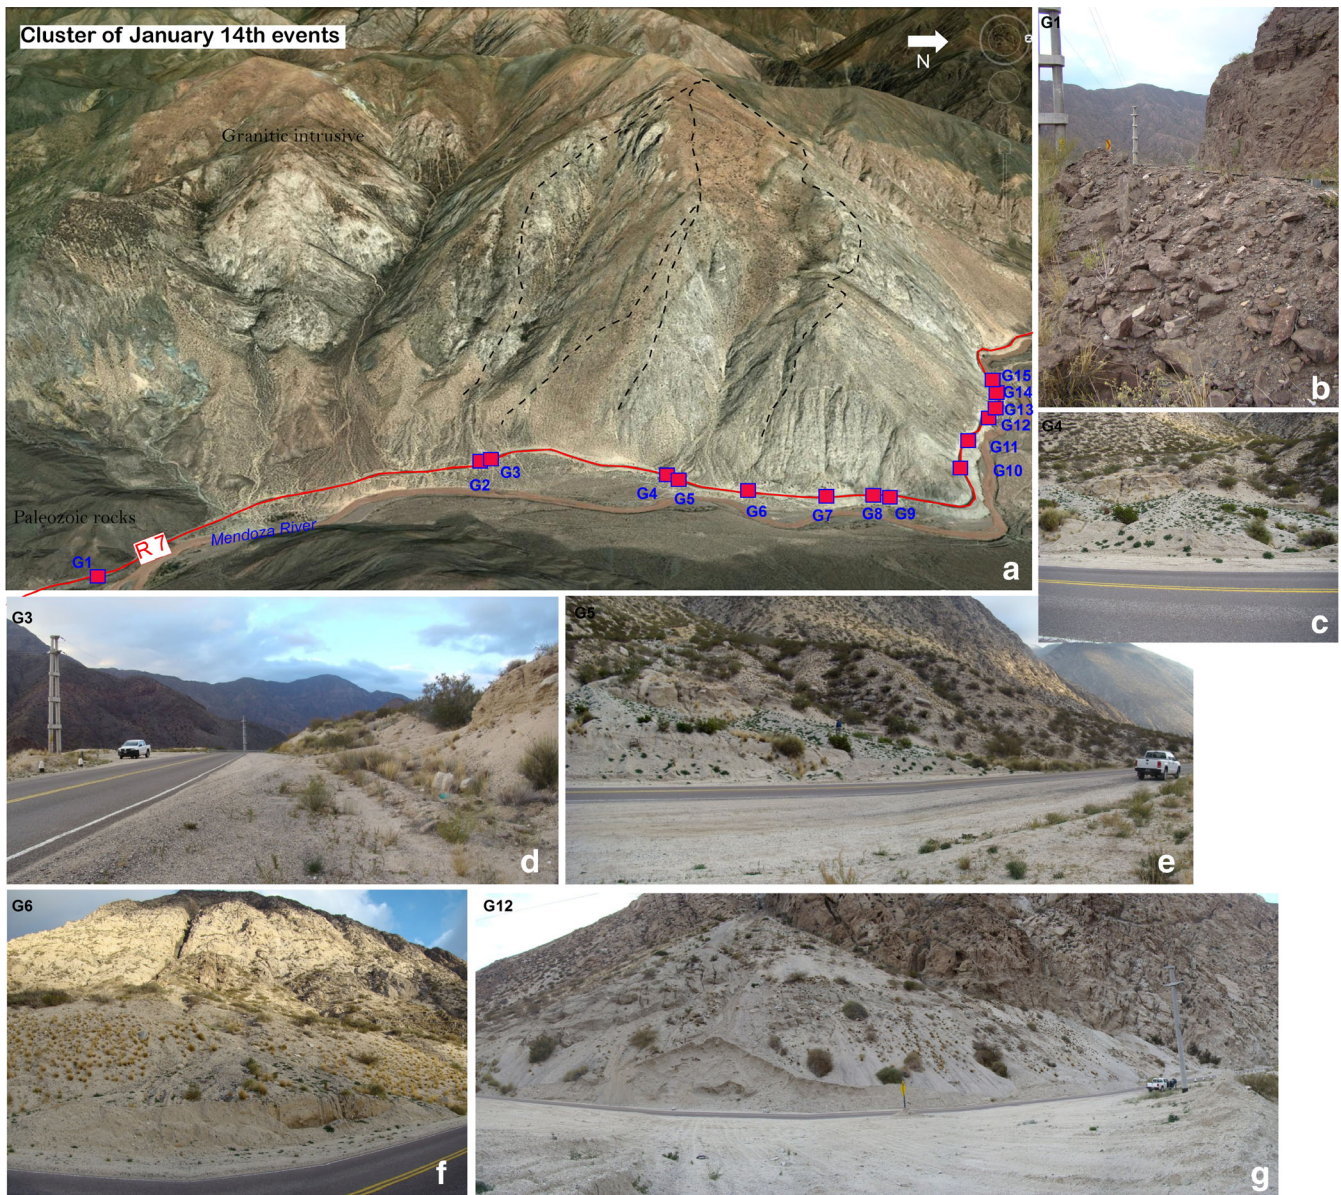
**Fig. 4** a Location of debris flows reported at Guido locality (FC) on January 14 along the international road generated from the Permo-Triassic Guido Granite, and a minor rockfall originating from fractured Paleozoic outcrops (G1); b the G1 rockfall deposit; c the G4 debris flow associated with a minor alluvial cone; d the G3 debris flow was deposited on the road as a consequence of the lack of any channelization system (*culvert*); e active alluvial cone of the G3 (please note person for scale); f the G6 debris flow associated with talus cone; g the G12 debris flow generated by mobilization of fine granitic gravel accumulated on a talus cone on Guido Granite

On January 14, several small debris flows affected the sector known as Guido (FC) (Fig. 4), mobilizing at least a volume of 500 m<sup>3</sup> according to the dimensions of the deposits preserved in the area. The events were mainly triggered by water saturation of fine material provided from weathered Permo-Triassic granite belonging to the Choiyoi Group. The susceptibility of this material to generate debris flows had been previously discussed by Moreiras (2005). However, two types of debris flows could be distinguished: (a) debris flows associated with little basins—but steep slopes—draining onto active alluvial fans where flows are channelized, and (b) flows sourced from saturated fine material accumulated on talus cones that mobilized without confinement in pre-existent, well-established channels and may thus be

Debris avalanches G2 and G3 (Fig. 4) came from a basin with a small area ( $1.3 \text{ km}^2$ ) and a mean slope of  $36^\circ$ . These events affected the international road. Flows G4 and G5 corresponded to debris flows draining onto an alluvial cone. In contrast, G6, G7, and G8 were generated from a talus cone 2.5 km long fed by a steep granite outcrop of  $76^\circ$  slope and may also be classified as debris avalanches following Hungr et al. (2014). The greatest event at the

Guido locality corresponds to G12, a debris avalanche associated with a talus cone that mobilized an estimated volume of  $250 \text{ m}^3$  of gravel (Fig. 4b).

Further minor events were reported during the whole day of January 15 in the Guido locality, mainly in the sector of G9 (Fig. 4),

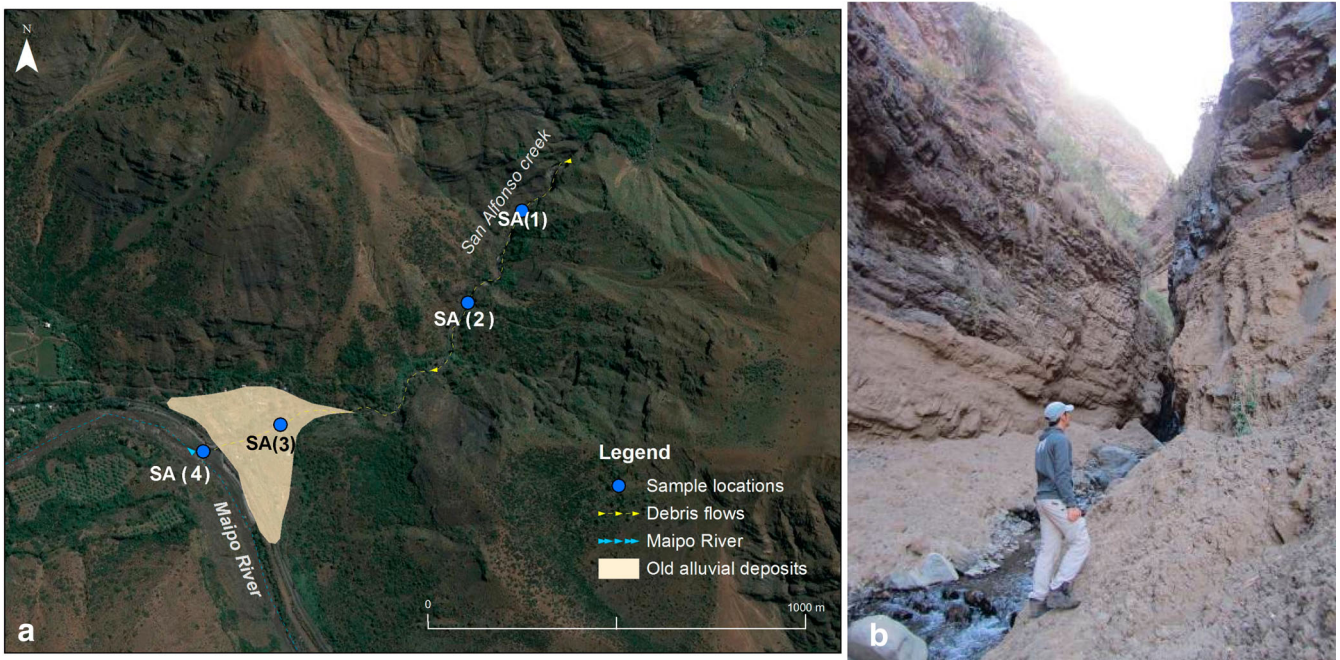
Fig. 5 a Middle and lower sections of San Alfonso Creek with indication of sampling points. b Splash marks and flow deposits at sampling point SA(1)

The debris flow event on this day in San Alfonso Creek, Maipo Valley (Figs. 1, 2, and 5), with an estimated deposit volume of over 5000 m<sup>3</sup>, followed a narrow, 9.3-km-long gully with a drop in height from about 3200 to 1090 m asl in its confluence with the Maipo River. The thalweg slope varies between 8° and 31°. Splash marks at bridges next to the confluence with the Maipo River show that the flow reached heights of up to about 3 m with marks up to 5 m upstream. The thickness of the deposits varies between less than 1 m in the distal zone up to 2 m in the middle section. The deposits are generally well graded and are composed of

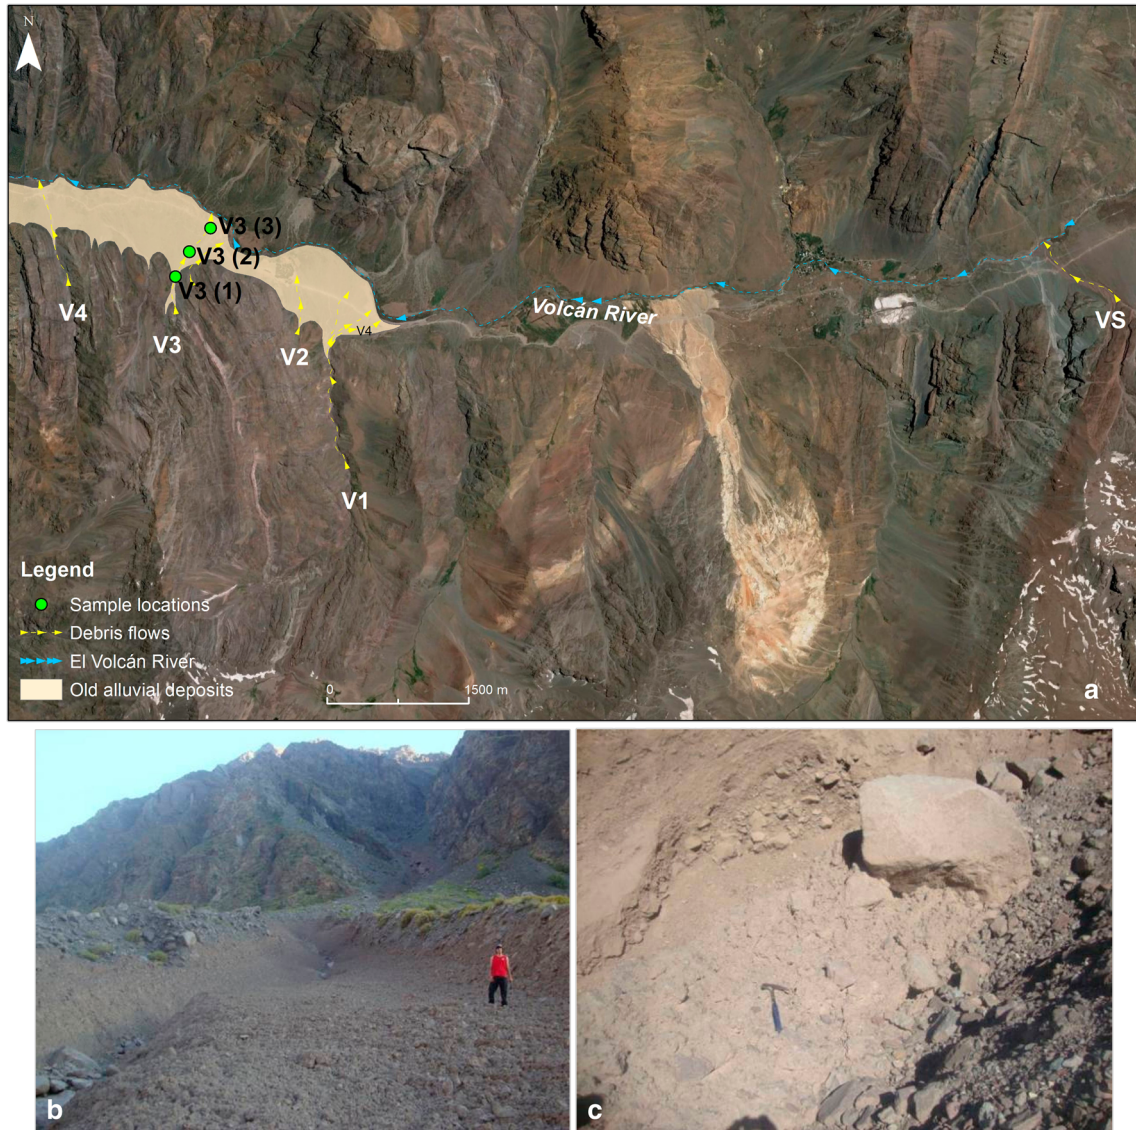
**Fig. 7** a Location of debris flows in lateral gullies of the Volcán River; b erosion channel formed by 21 January flow in a lateral creek of the Volcán River; c example of debris flow gravelly deposits

Meanwhile, the same climatic event caused smaller debris flows and mudflows in at least four lateral, steep creeks in a 4-km-long section plus a fifth a few kilometers further east in the Volcán River valley, a main tributary of the Maipo River (Figs. 2 and 7 and Table 2). The flows deposited on alluvial fans, where older deposits of similar characteristics can be recognized, and affected the G-25 road. The flows originated

at heights between 3200 and 3500 m asl, by remobilization of loose material in the gully channels and adjacent talus cones. The gullies vary between 3.5 and 5.5 km in length, with average thalweg slopes of 18°–27°. The alluvial fans have gradients between 6° and 15°. The flows tended to incise the former channels up to about 5 m, leaving levees on the edges and forming new erosion and deposition channels in the alluvial fans (Fig. 7). Deposit thicknesses, varied between 1 and 2 m, are poorly graded and are composed mainly of gravel and decimetric blocks of variable proportion in a sandy-silty matrix, sometimes with more abundant clay. In

this case, finer materials are found in the upper gully and the distal parts of the alluvial fan (Figs. 6 and 7).

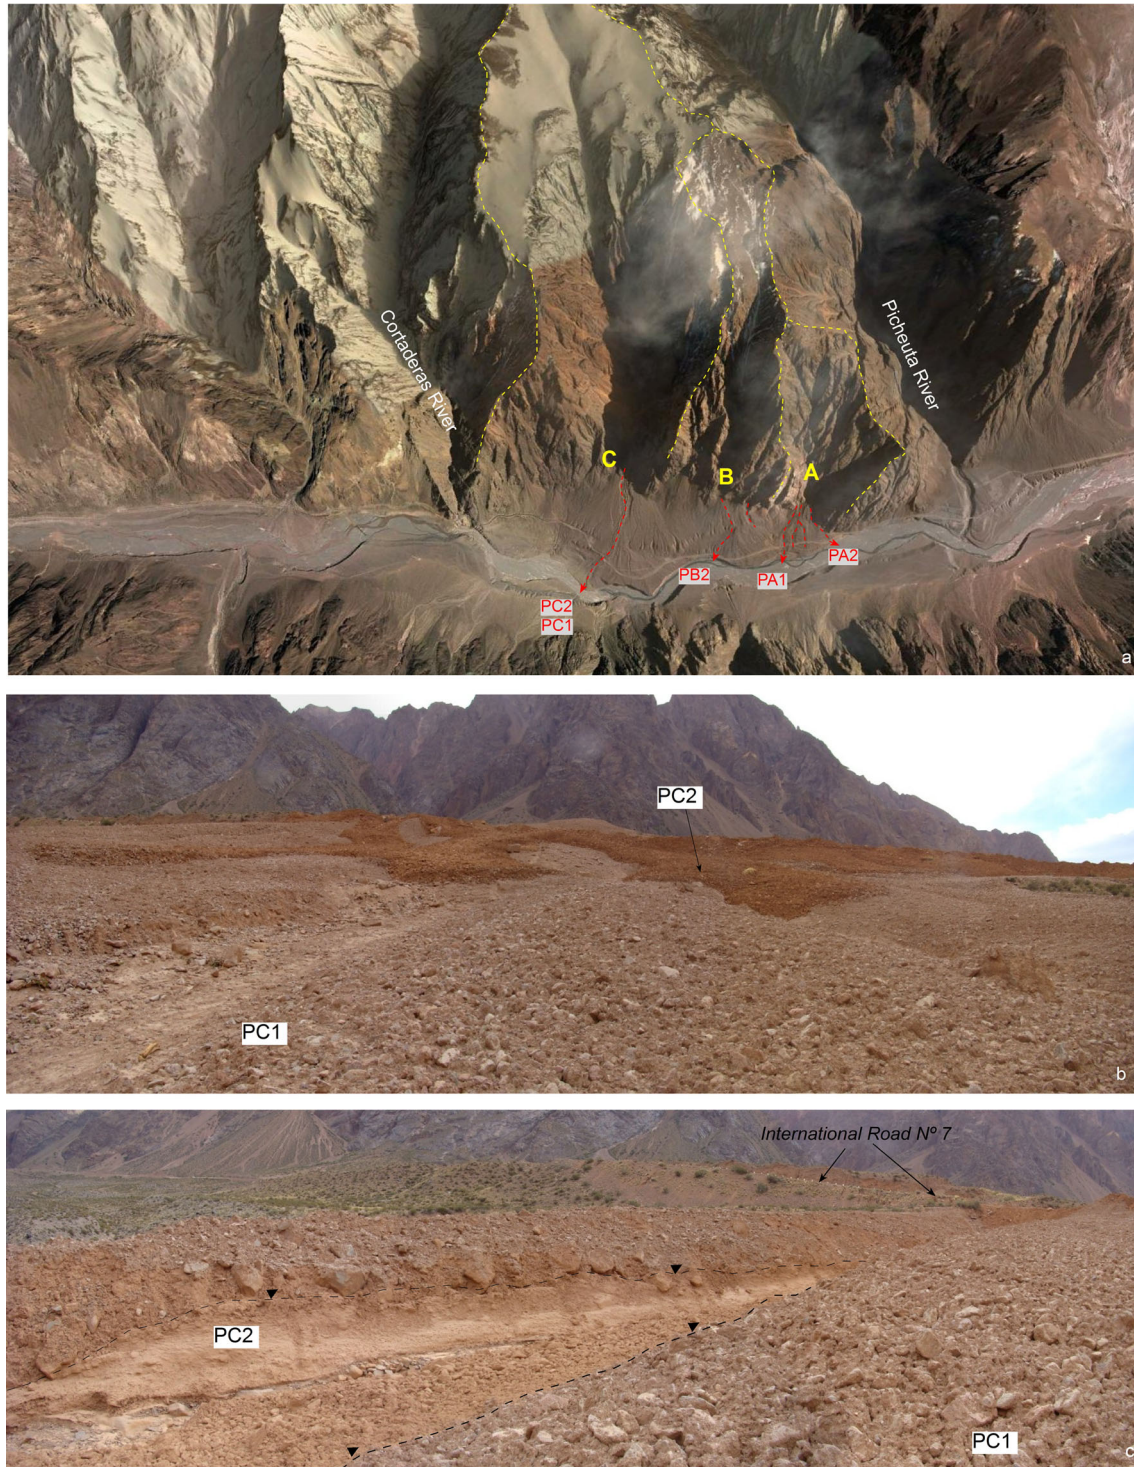
**Fig. 8** Debris flows in Picheuta area: **a** Google image on 15/02/2009 showing gullies of main debris flows in Picheuta area. **b** Deposit of PC2 debris flow over the previous PC1 that occurred 2 h earlier, both associated with the Picheuta C active alluvial cone system (Km 1,175.7). **c** Deposit of PC2 channelized into the previous one in the distal part of the alluvial fan. Predominance of red color is due to lithology

The first event recorded on February 7 was reported at 4 a.m. near Picheuta (PC<sub>1</sub>, Table 2) associated with an active alluvial cone system identified in this paper as Picheuta C. This channelized debris flow ran nearly 4 km from the source area descending 960 m over contrasting slope gradients that

range from 55° in the highest mountainous areas to less than 20° in the alluvial cone surface. This debris flow with an estimated volume of 115,000 m<sup>3</sup> was the largest recorded in these clustered events causing severe damages to the international road (Route N°7, hereafter R7). It generated a hole 8 m deep due to basal block erosion. The thickness of the deposit on the road was measured at 2 m over 300 m; preserved levees of 5.3 m were observed (Fig. 8). The mean boulder size was 0.30 to 0.60 m in diameter, while the largest blocks were 1.3 m in diameter. The matrix content was low in this deposit, around 20 %, where gravel and sand grain sizes predominated. Boulder composition was mainly monolithic, comprising red rhyolitic volcanites that belong to the Choiyoi Group. A new unsuspected, smaller debris flow happened 2 h later in the same alluvial track (PC<sub>2</sub>). Deposit thickness reached 3.8 m and maximum blocks of 0.7 m in diameter were observed,

During the same day, another large debris flow was reported 2 km down the valley (PA1, Fig. 8 and Table 2) on an active alluvial

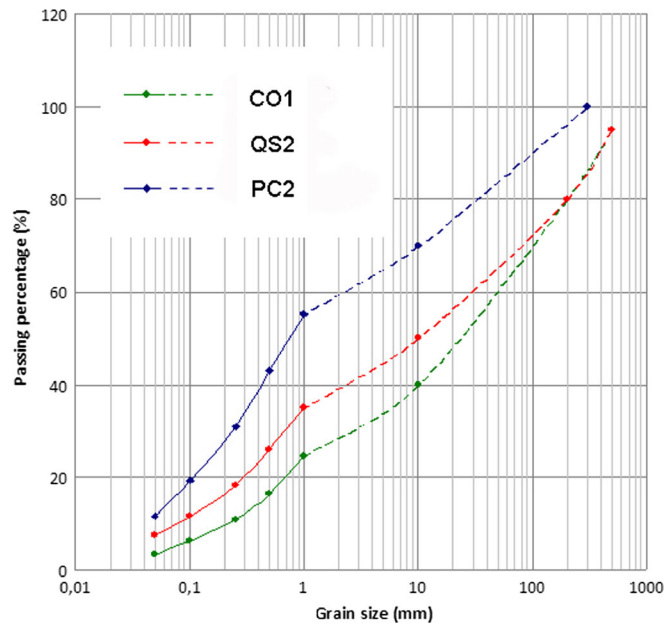
**Fig. 9** Grain size distribution of Picheuta (PC2), Cortaderas (CO1), and Quebrada Seca (QS2) debris flows. *Dashed lines* indicate field estimates, and *full lines* laboratory analyses of the finer matrix materials

with the mean clasts size varying from 0.2 to 0.8 m. In this case, the matrix was finer and more abundant, about 50 to 60 % (Fig. 9).

abundant matrix reaching 50 % was observed (Fig. 12d). The grain size distribution of this soil matrix reveals mainly gravel (Fig. 9). A volume of 15,000 m<sup>3</sup> was estimated for this event.

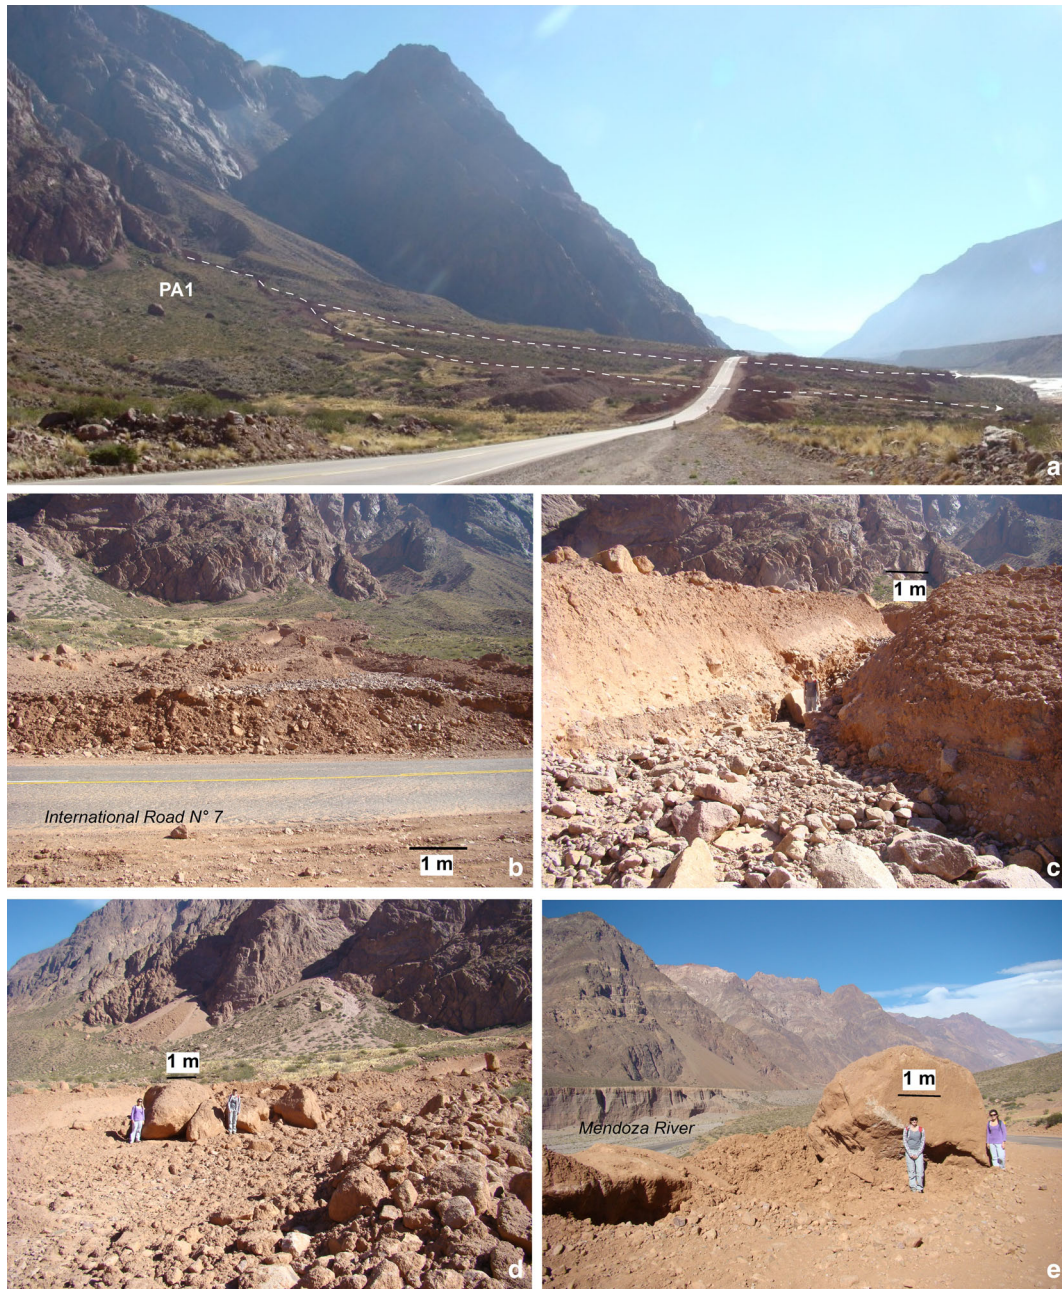
**Fig. 10** Debris flows that occurred on 7 February in Picheuta area generated on alluvial fan A (Km 1173.1): **a** location of two tracks of PA1. **b** Debris flow deposit removed from the international road N°7. **c** Characteristics of channelized debris deposit where matrix content and boulder sizes could be observed. **d**, **e** Greatest boulders observed in the PB1 debris flow

cone system identified in this paper as Picheuta A (Fig. 10). The channelized debris flow cut the alluvial cone in two tracks and blocked two sections of the road R7. The estimated volume for this event was 43,000 m<sup>3</sup>. Levees 5 m high are preserved in the main track (Fig. 10). Deposits along the two tracks show boulders

varying from 0.2 to 3 m in diameter (Fig. 10). Some blocks reached 10 and 16 m<sup>3</sup> in volume. The matrix content constitutes around 35 % in the middle track deposits, reaching 55 % at the toe. Boulder composition was mainly monolithic comprising rhyolitic volcanites of the Choiyoi Group. This debris flow ran 1.5 km from the source area descending 700 m over steep slopes ranging from 35° to 65°. Deposit thickness was measured at 2 m on the road.

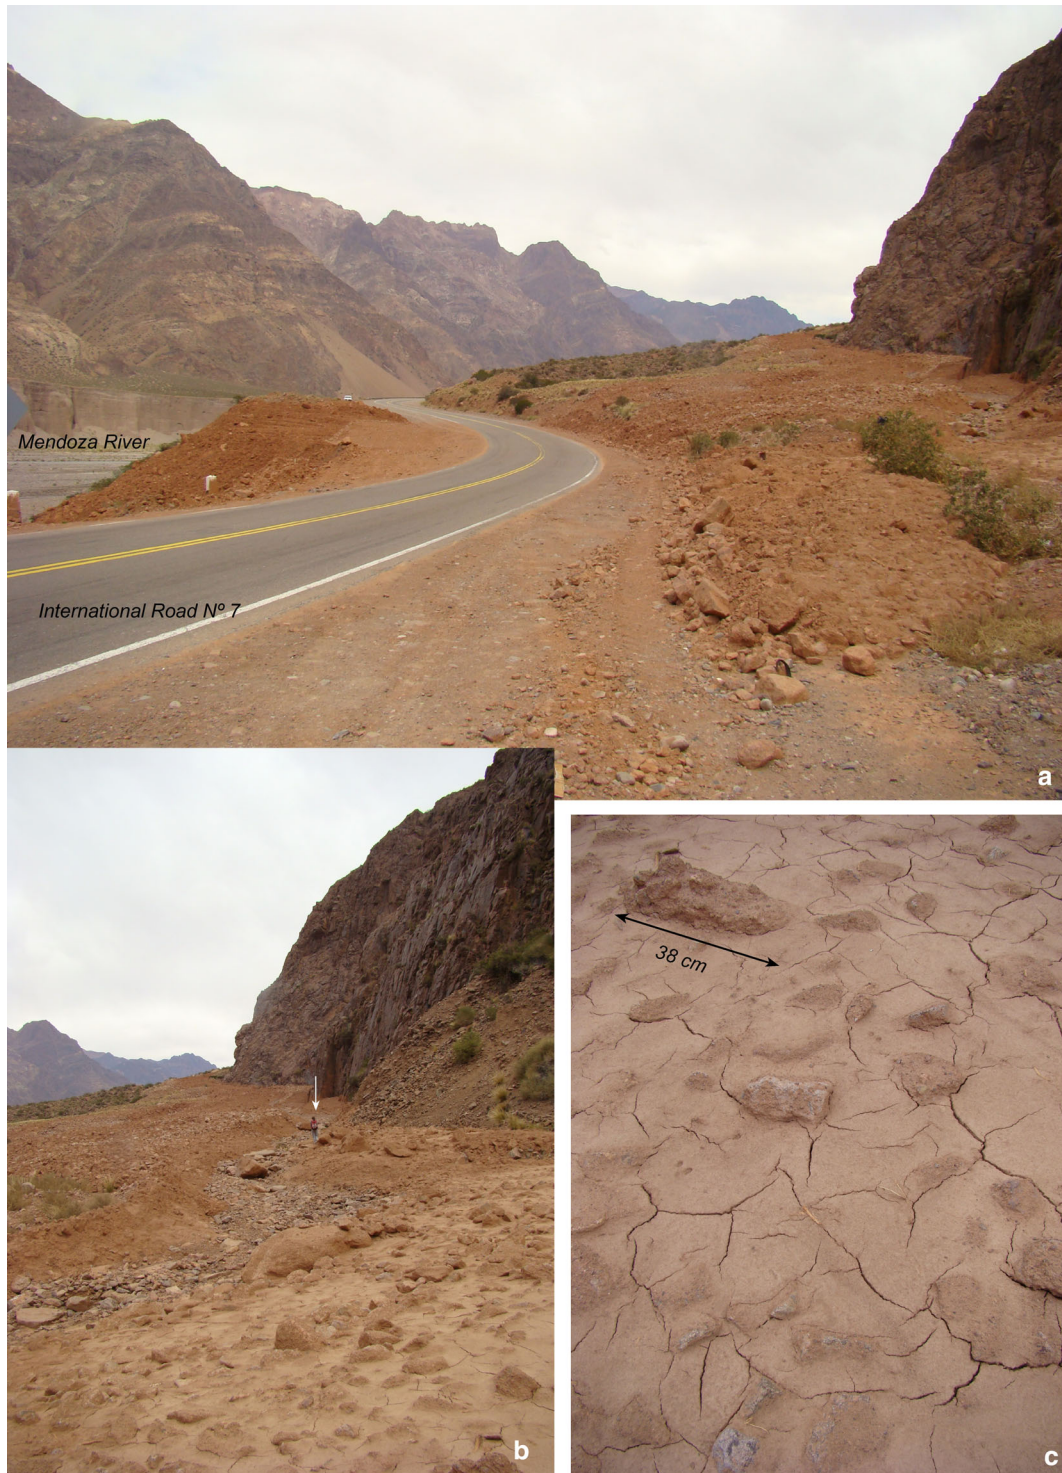
**Fig. 11** Pictures of PA2 in the Picheuta area (Km 1,171). **a** Debris flow deposit removed from international road. **b** Splash marks near Mendoza River valley showing the thickness of the deposit; the *arrow* indicates a person as scale. **c** Detail of debris flow matrix

Another debris flow was reported in this sector of Picheuta area (PA2) with an estimated volume of 14,300 m<sup>3</sup>. This channelized event ran nearly 1 km until reaching the Mendoza River and blocked the road for about 100 m with a 1-m-thick deposit (Fig. 11). Splash marks on a volcanite outcrop show that the flow reached a height of 0.7 m near Mendoza River valley (Fig. 11b). However, levees in the middle track are thicker, reaching up to 1.8 m. In this deposit, blocks of 0.3 to 0.7 m in diameter appear in an abundant fine red matrix (Fig. 11c). The area is well known for its past landslide activity, with previous debris flows in 1963, 1975, 1998, and 2006 (Moreiras 2005). However, estimated volumes of these ancient events, which rarely surpassed 6,000 m<sup>3</sup>, were a third part of the 2013 event (Moreiras 2006). Nevertheless, the availability of much material in this little basin could potentially generate a volume double that of the recent event.

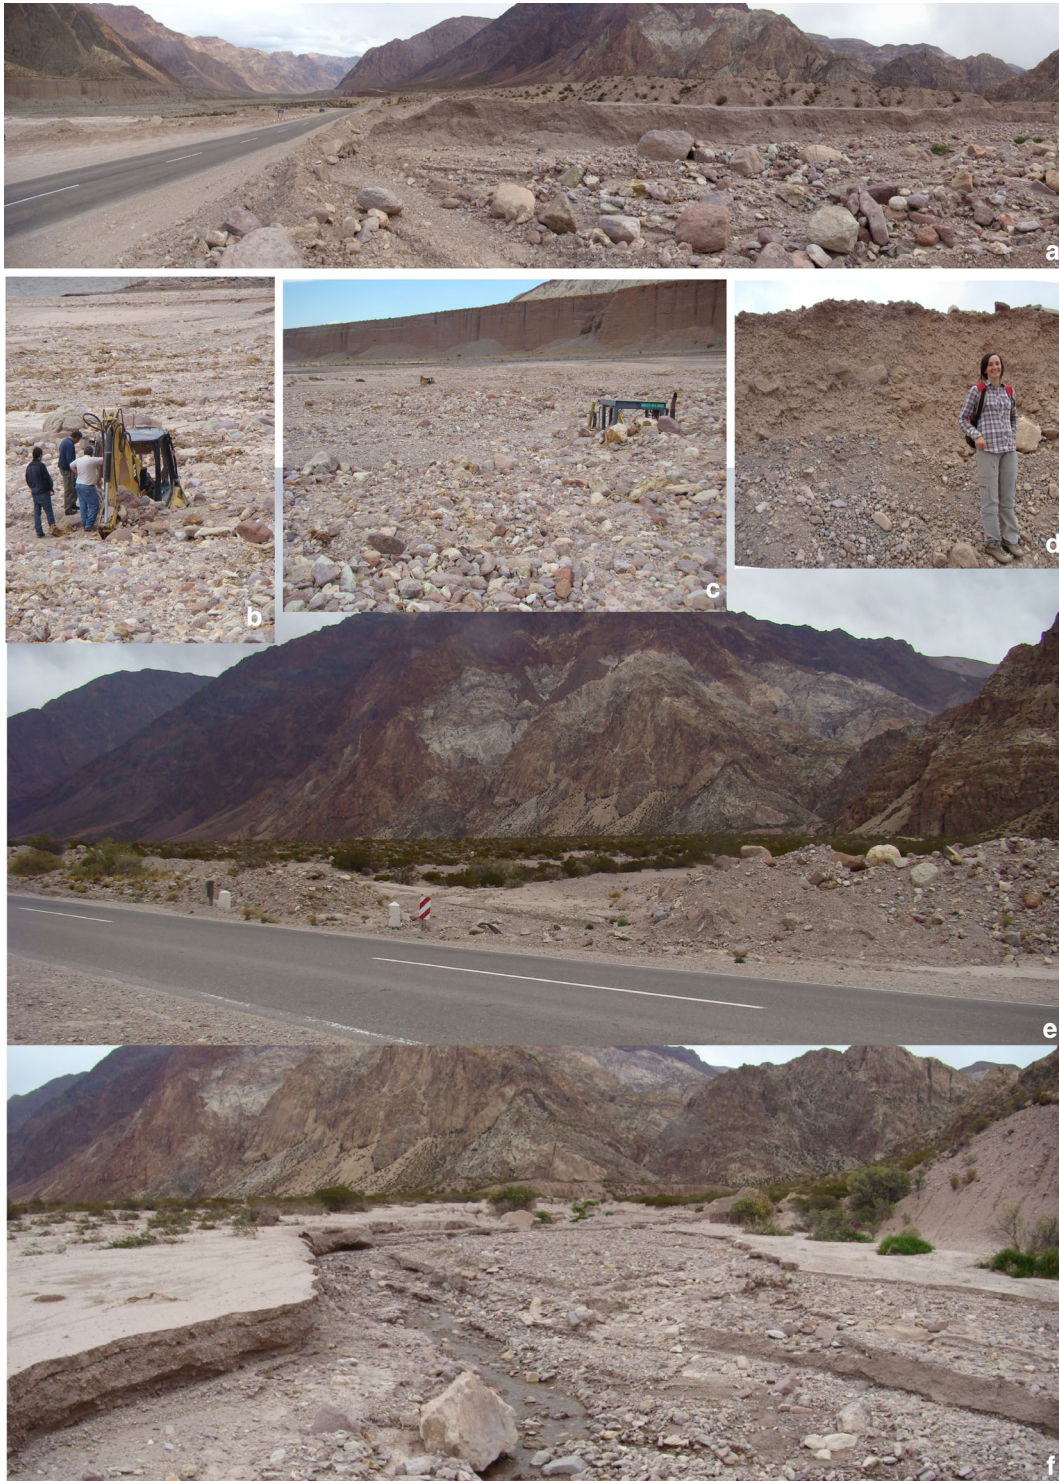
**Fig. 12** Pictures of the channelized debris flows in different parts of the Quebrada Seca alluvial cone system: **a** hyper-concentrated flow QS1 (Km 1,171) that severely impacted on international road. **b** Detail of bulldozer buried by the QS1 its path into the Mendoza River. **c** Both bulldozers buried by the flow. **d** Debris material with abundant matrix content (50 %). **e** Debris flow channelized into another channel invading the road due to culvert obstruction. **f** Minor debris flow coming from the northernmost channel

Toward the north, another channelized flow from Quebrada Seca affected the road in a section of 50 m after a culvert was clogged by the detrital material. At least 0.5 m of material was deposited on the road (Fig. 12e). A minor debris flow was reported in the northern channel of the Quebrada Seca fan, drained by a culvert that passes under R7 (Fig. 12f).

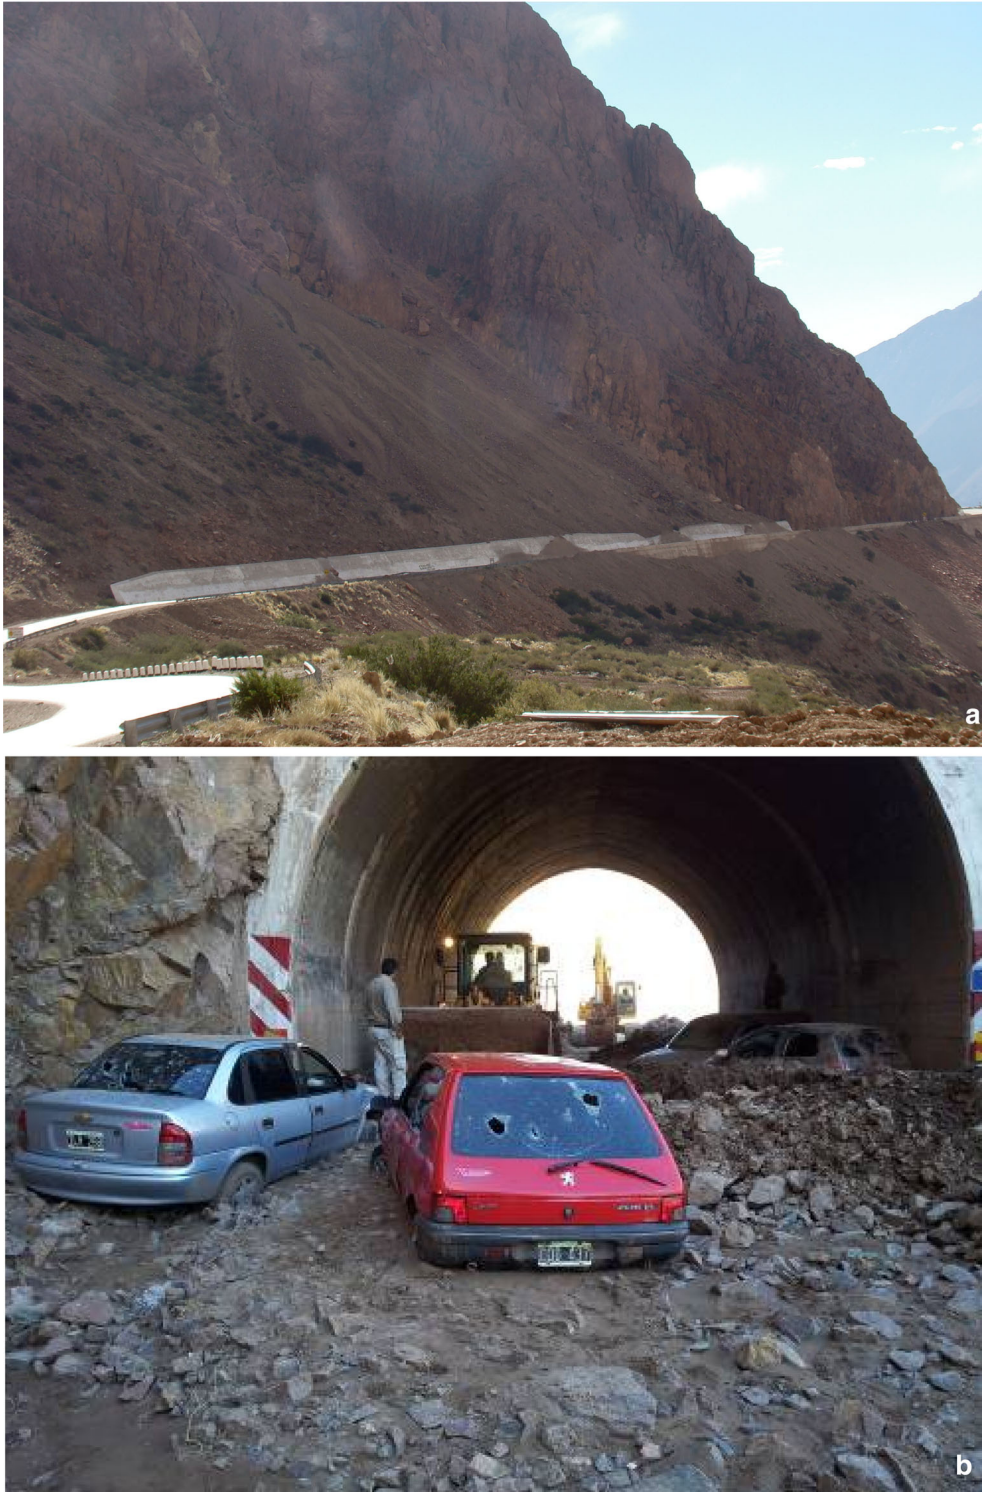
**Fig. 13** Pictures of rockfalls and debris flows reported in the Cortaderas area: **a** rockfall generated from talus cones passing over a contention wall along 1.5 km of international road, and **b** rockfall in tunnel 13 burying four cars (Km 1,178)

Furthermore, other 22 events were recorded on February 7 in Cortaderas area located 5 km upstream, along the international road. These events consisted mainly of rockfalls, but also debris flows, mobilizing a total volume estimated at 50,000 m<sup>3</sup>. Particularly, a rockfall in tunnel 13 buried four cars under mud and boulders (Fig. 13). This 1-m-high saturated deposit had a limited volume of up to 50 m<sup>3</sup>; however, it posed great danger. Fourteen persons including four children were isolated over the night before they were rescued by the police. The flows can be classified as debris flows (Table 2) as they are mainly composed of gravel and boulders with scarce (<30 %) sand and fines (Fig. 9). This event left a deposit of 1.5 m thick covering a 20-m-long section of the road.

Rockfalls in the Mendoza Valley are associated with intensely fractured outcroppings of volcanic rocks or weathered granites that become water-saturated after sudden and local rainstorms during summer time. A low threshold precipitation (6–12 mm

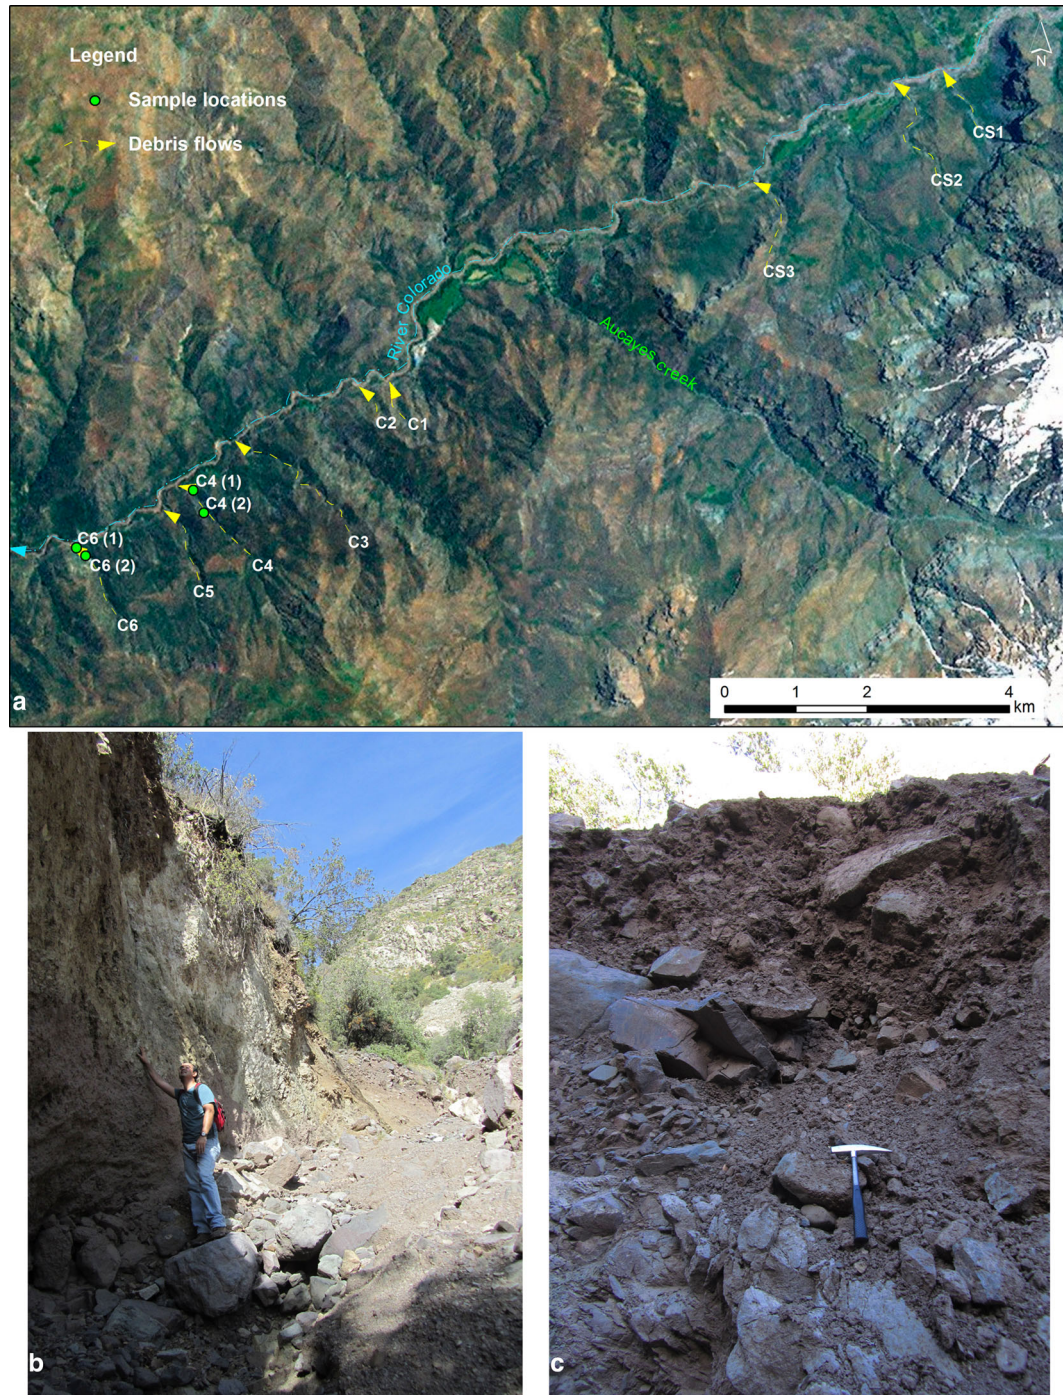
**Fig. 14** a Location of debris flows in lateral gullies of the Colorado valley; b example of splash marks; d example of 2013 fresh deposit above older, similar debris flow deposits

The rain in the Colorado Valley generated concentrated surface water flow in nine small and narrow gullies of ~1 km long in a section of about 10 km along the valley (Fig. 14), blocking the road

that runs a few hundred meters parallel to the river (Sernageomin 2013a). The gully catchments reach maximum elevations between 1500 and 2500 m asl, and thalweg slopes vary from between 20° and 25° in the gullies to 5°–10° in the depositional area. The thickness of the deposits varies between 1 and 2 m in the deposition area, diminishing to 20–30 cm up in the gullies. Splash marks

vary between 2 and 5 m high along the gullies and less than 2 m next to the road (Fig. 14). Profiles in the deposits show that this type of alluvial activity is recurrent, with fresh deposits on top of older but very similar deposits (Fig. 14). Field and laboratory granulometric analyses show that the deposits vary from poorly
