# Structural Characterization and Seismic Performance of San Francisco Church, the Most Ancient Monument in Santiago, Chile

Natalia Jorquera, Giulia Misseri, Nuria Palazzi, Luisa Rovero & Ugo Tonietti

<sup>a</sup>Department of Architecture, Universidad de Chile, Santiago, Chile; <sup>b</sup>Department of Architecture, University of Florence, Florence, Italy

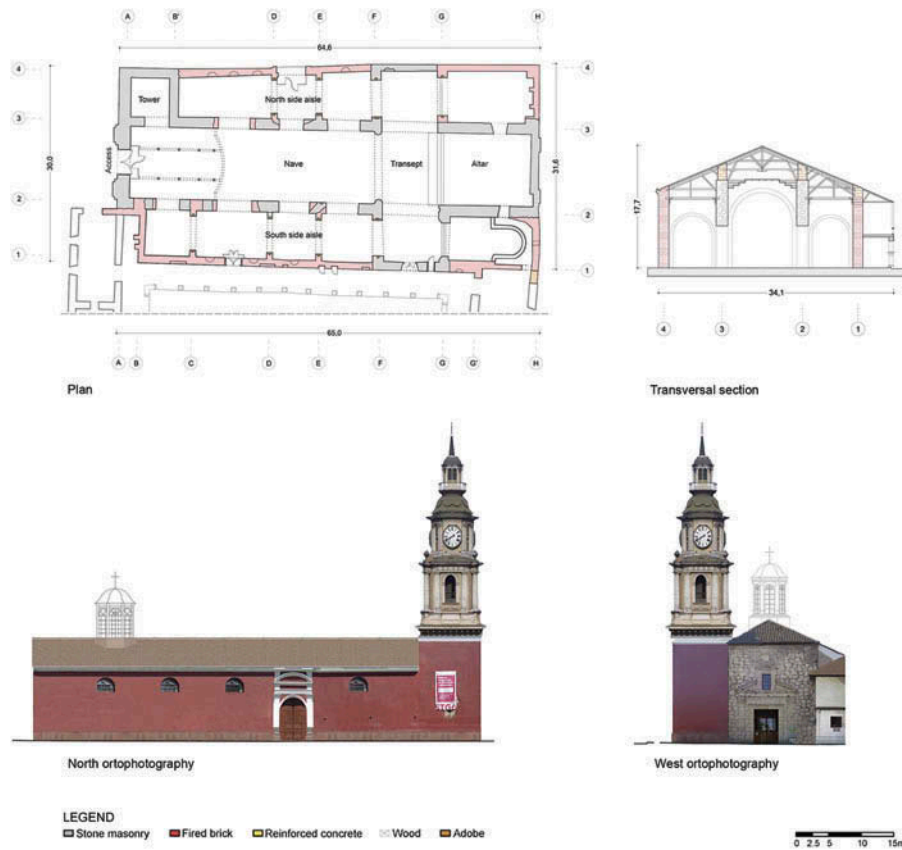
**Figure 1.** Plans, section and elevations of San Francisco in its current state, with information of the main building materials.

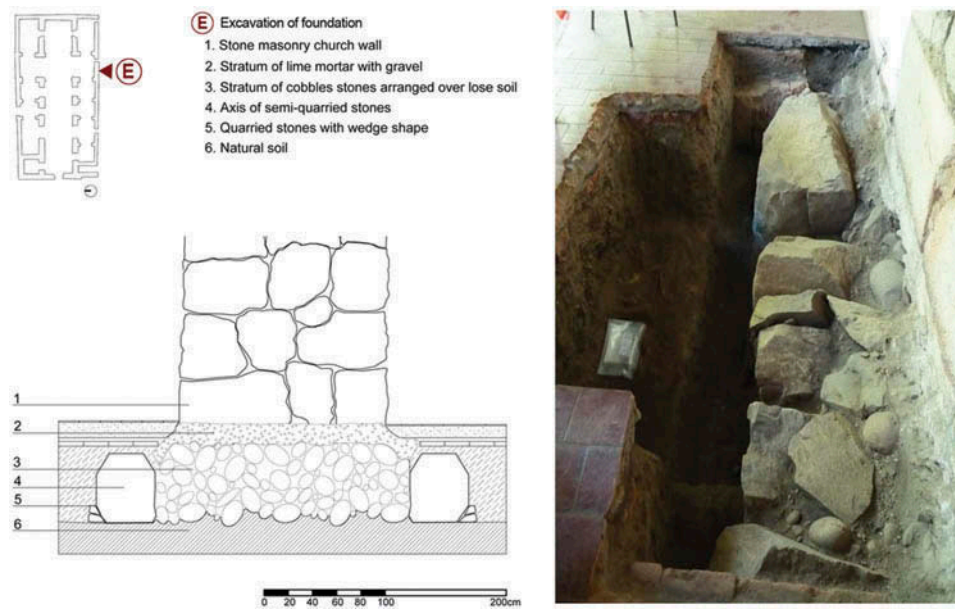
Figure 6. Section and image of the foundation of the church.

There is no historical information regarding the foundations of the buildings but a 4 m long excavation near the transept, carried out as part of the present research in collaboration with a team of archaeologists, revealed a special system of foundation. This comprises of round river boulders under the walls—with variable dimensions between 10–30 cm—placed without mortar and contained laterally by a course of large and hewed stones of dimension of around 60x60x60 cm with a larger stone in the corner of 90x60x60 cm. Thus, during an earthquake, the stones can

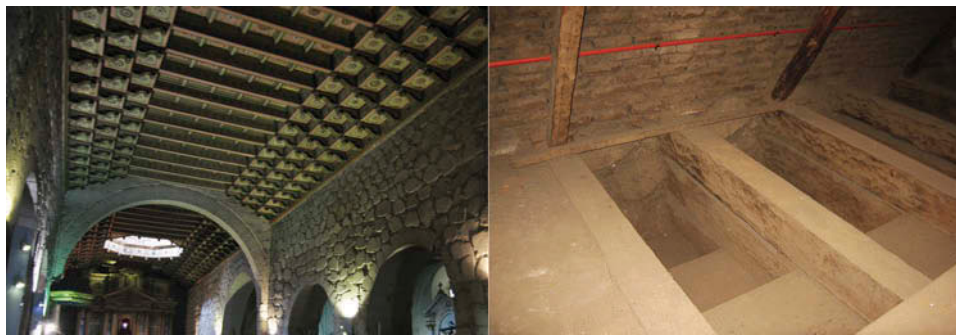
Figure 7. View of the horizontal diaphragm, both from the central nave and from the roof.

Since its origin, the church was equipped with a strong horizontal “diaphragm”, placed on the central nave under the roof (Figure 7; see also Figures 5, 10, and 14). This system comprises of a series of big cypress (*Austrocedrus chilensis*) wooden beams (30x35 cm cross section) well connected to the walls and placed with 1.2 m spacing that widens to 2 m close to the façade proving a reconstruction intervention, (De Ramón 2000). This original structure still exists today even if it has been partially modified to accommodate the roof lantern that lights up the space over the altar.

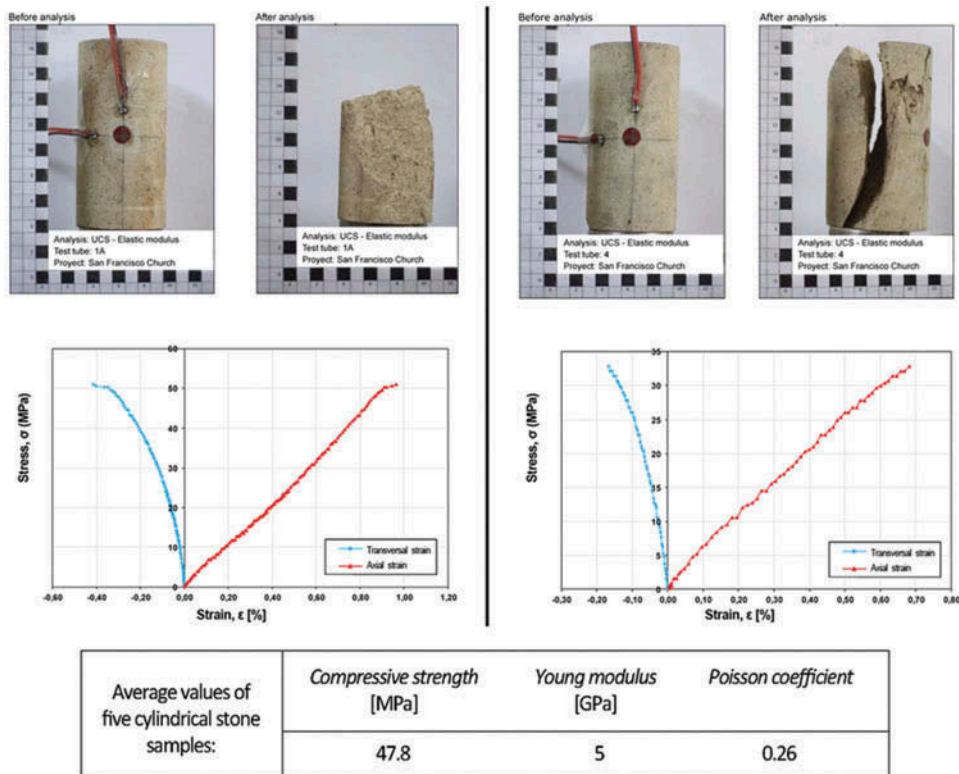
Figure 9. Compression test on biotite samples.

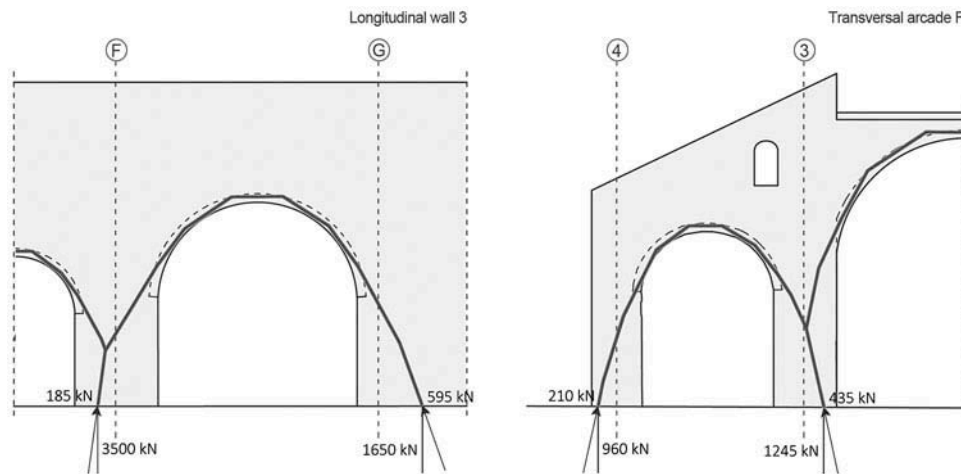
**Figure 12.** Thrusts line of wall portion in interception of longitudinal wall 3 and transverse arcade F (Figure 1).

To achieve a safety estimation of the static consistency of the church, a preliminary graphical analysis for vertical loads has been first carried out on a significant portion of the main nave and transept wall through the *Safe Theorem of Limit Analysis* (Heyman 1966). An equilibrated solution has been found (drawn as a set of thrust lines) contained inside the masonry structure, compatible with the loads and which does not violate the yield conditions. This condition has guaranteed the safety of structure for vertical loads. Figure 12 shows the thrust line of each arch (1, 2, 3, and 4) with the related values of thrusts. It is worth noting that the thrust line of the transverse arcade F (Figure 12b) highlights a limit condition for the stability of portion F4, considering the thrust position at the ground. As expected from direct surveying activities, the thrust lines converging on pillar F3 are influenced by loads of both the longitudinal arcade (3) and the transverse wall facing the transept (wall F), determining a high loading level on a reduced portion of masonry which is in fact heavily damaged. Linear static analysis for vertical loads on the global 3D FEM has been carried out, and results show comparable stress levels ranging 1–1.2 MPa on portions F3 and F4.

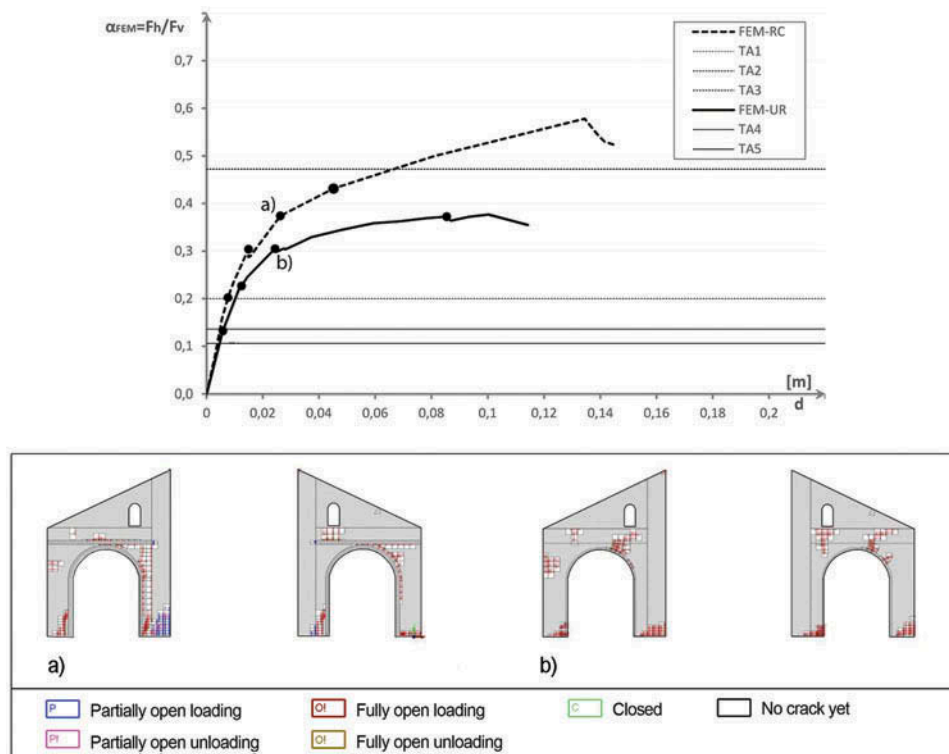
**Figure 18.** Structural nonlinear FEM output: curves load factor over lateral displacement and corresponding crack status for model representing the current state at load factor equal to a) 0.374; and for the state prior to the brick reconstructions or concrete reinforcements at load factor equal to b) 0.305.

Figure 18 compares curves load factor over lateral displacements of centers of gravity of the UR and Reinforced models, with outputs from kinematic analyses of the correspondent mechanisms. Circle pointers show load step as reported for the reinforced configuration in Figures 18a and in the unreinforced configuration in Figures 18b. A good agreement is found between the results of the two analyses.
