Performance of tall buildings in Viña del Mar in the 27 February 2010 offshore Maule, Chile earthquake[‡]

SUMMARY

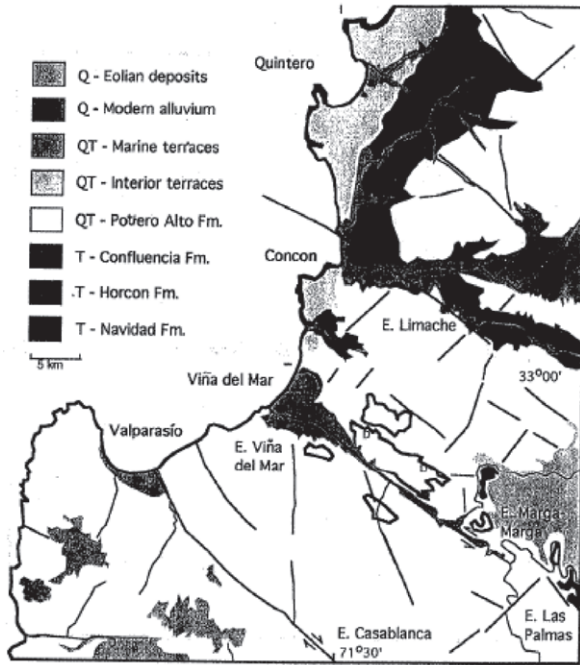
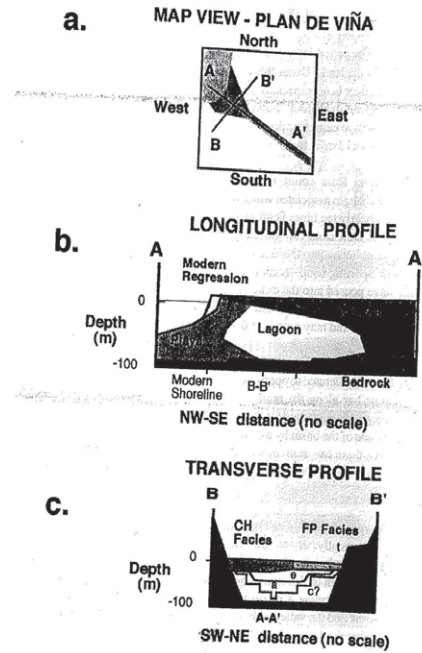
Figure 2. La Falla Marga-Marga Viña del Mar Map and Profiles (Thorson, 1999).

The Thorson report indicates that the Viña area is basically over a fault area trending east-west, which formed the deep gorge that was infilled in the river zone. Figure 2a indicates the variations in surficial soils and Figure 3b indicates[§] mostly sandy materials. However, Figure 2b shows a more telling view of the subsoil conditions in two cross sections, which indicates an underlying lagoon, which is covered by the more sandy materials. The plan in Figure 2b shows the river is narrow until reaching an enlarged area near to the shore. Figure 3a indicates more detailed soil profiles and the approximate thickness of 15 m to 20 m of upper soils above the lagoon materials.

of damaged buildings is within the roughly triangular area noted in figure 15 of the Thorson report and above the 'Marga-Marga' fault zone. This area includes a large portion of the Viña del Mar area and roughly corresponds to the zone of the soft underlying soils.
