Soil Dynamics and Earthquake Engineering

Performance of bridges with seismic isolation bearings during the Maule earthquake, Chile

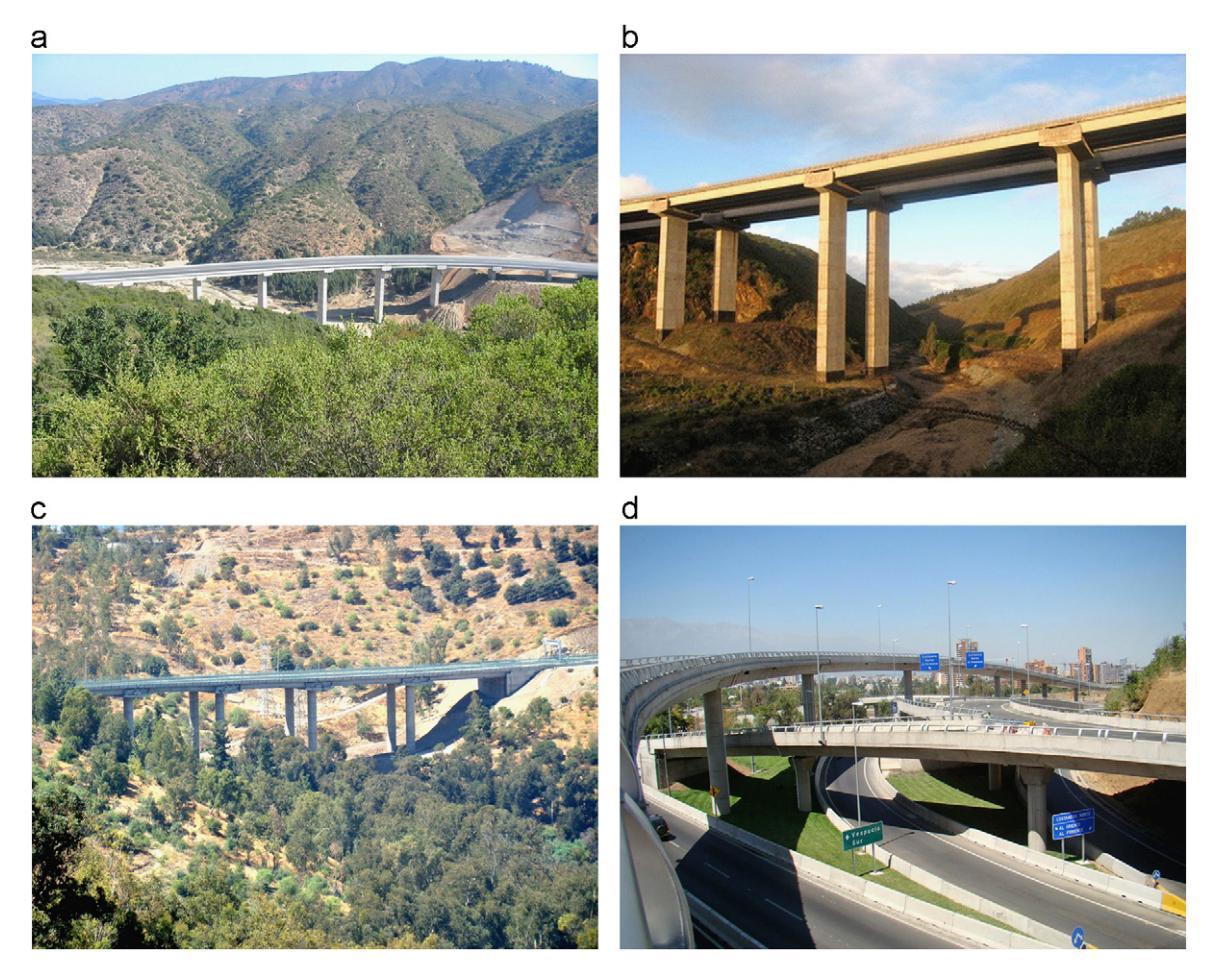
All seismically isolated bridges, with the exception of Cardinal Silva Henriquez Bridge in Constitución, had good performance. Some of them can be seen in Fig. 4. Detailed damage in Cardinal Silva Henriquez Bridge is described in [8]. The main damage was a lateral displacement of the supporting plates that produced failure of the stoppers. The welded connection of the beams to one of the abutments was also fractured. Despite the damage, light vehicles were allowed to cross the bridge while it was repaired.

Fig. 4. Undamaged isolated bridges: Marga Bridge, Cartagena Viaduct, El Bosque Radial Nororiente, Américo Vespucio.

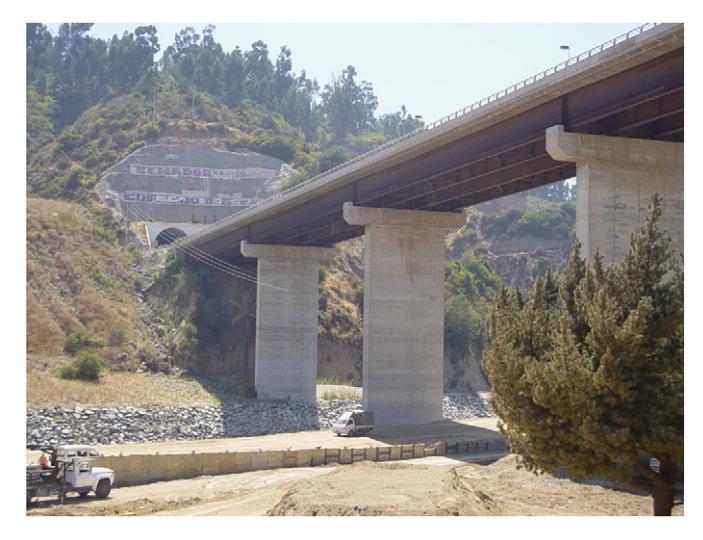
The Marga Marga Bridge, built in 1996, is located in Viña del Mar. A view and a general scheme are shown in Fig. 5. The superstructure consists of a reinforced concrete deck, 0.27 m thick and 18 m wide, and 4 continuous steel I-beams, which rest on 36 rubber isolators located at the two abutments and the 7 piers. The piers have a hollow rectangular section of 2×10 m, 0.25 m thick. The deck can move only longitudinally at the abutments. There are reinforced concrete transverse elements connecting the steel beams at both ends. All spans, except the southernmost one, are 50 m long. The total length of the bridge is 383 m. Pier height varies between 22 and 32 m. Groups of ten one-meter diameter piles, with depths ranging from 14 to 31 m, bear piers C2–C6, whereas the piers C1, C7 and the abutments are supported directly on rock. A complete description of this bridge is in [9].

Fig. 5. General view, Marga Marga Bridge Viña del Mar.

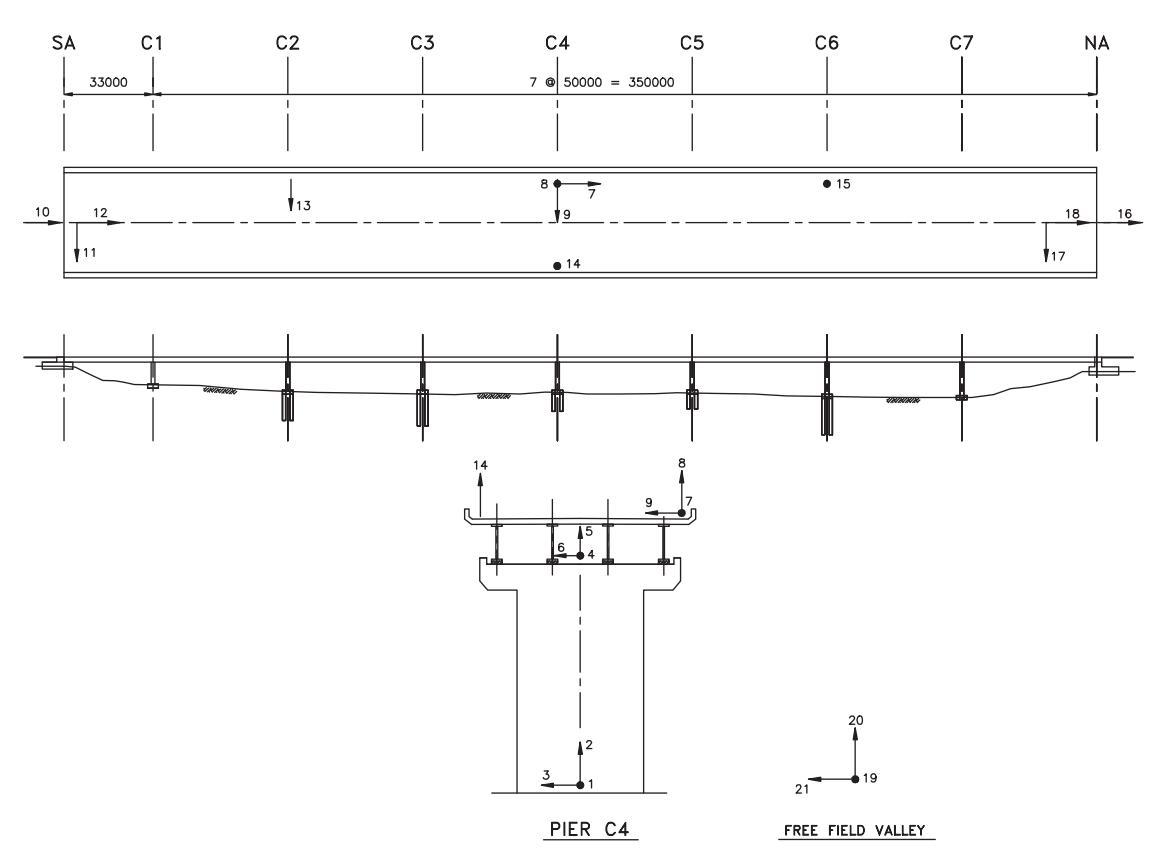
base and top of pier C4, north and south abutments and several positions on the deck, as shown in Fig. 6. The top of Fig. 6 shows the deck with the sensors in the transverse and longitudinal directions and the bottom shows pier C4 with sensors 2, 5, 8 and 14 that measure in the vertical direction. Using this network for ambient vibrations, frequencies in longitudinal (L) and transverse (T) direction, as well as damping of the superstructure were determined (see Table 1). This table also shows the corresponding frequencies and equivalent damping obtained from the July 24, 2001 earthquake records. At the deck, the predominant frequencies in both horizontal directions were reduced considerably during the strong motion interval of the earthquake, while the equivalent damping in longitudinal direction increased, reaching up to 15%.

Fig. 6. Local acceleration network in Marga Marga Bridge.

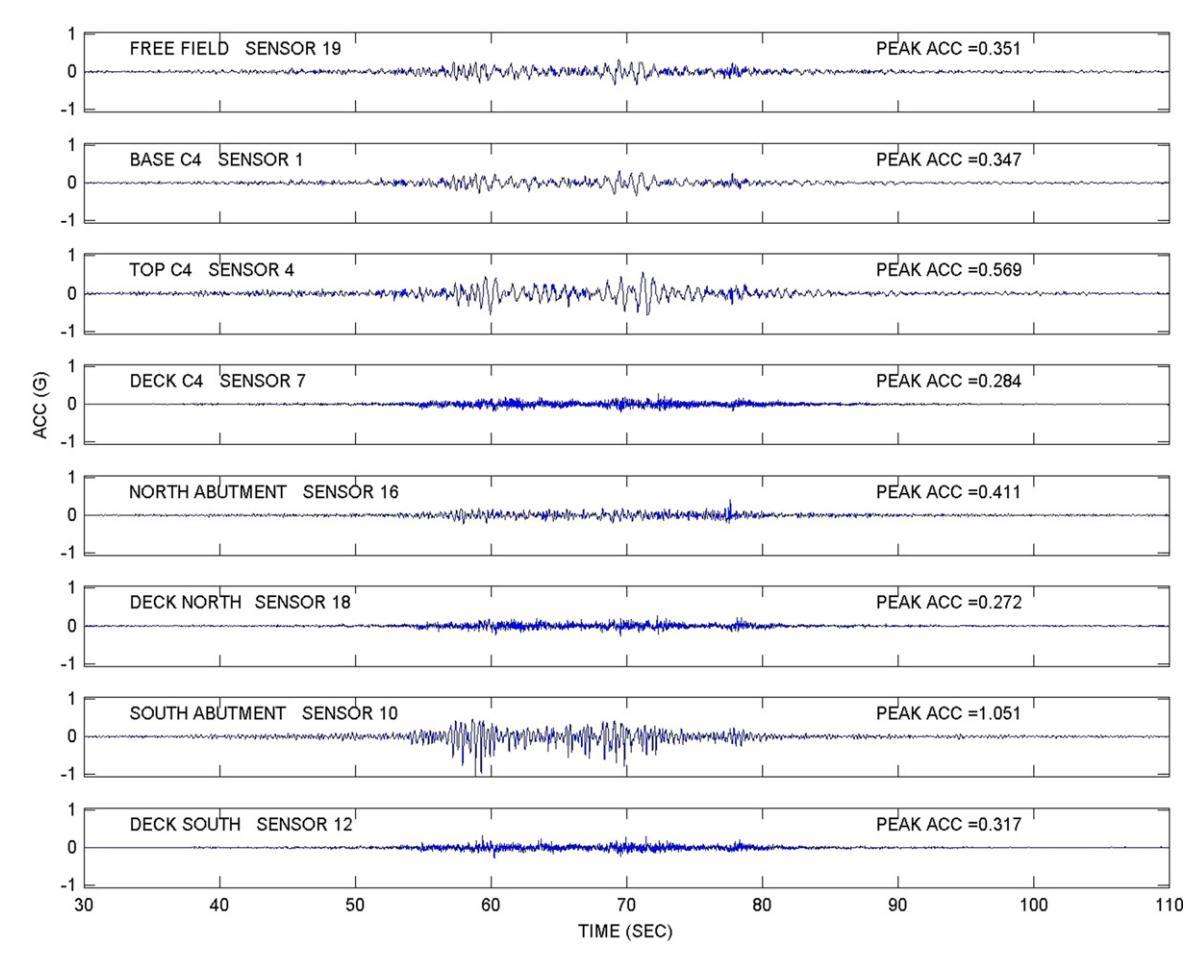
Figs. 7, 8 and 9 show the acceleration records, in fractions of *g*, obtained during the February 27th, 2010 earthquake in the longitudinal, transverse and vertical directions, respectively. Peak accelerations are listed at the right end of each diagram. There is a significant reduction of accelerations in the longitudinal direction between the pier and the deck and also between the abutments and the deck. Accelerations at the south abutment are much larger than at the north one, although both sites may be classified as hard soils. The differences in topographic conditions between one abutment and the other could explain the differences in accelerations. There is also a considerable change in the dominant frequency of the different records. Acceleration on the deck at sensors 7, 18 and 12 are quite similar, indicating nearly a rigid body motion in the longitudinal direction.

Fig. 7. Longitudinal records, 27/02/2010 earthquake. Marga Marga Bridge.

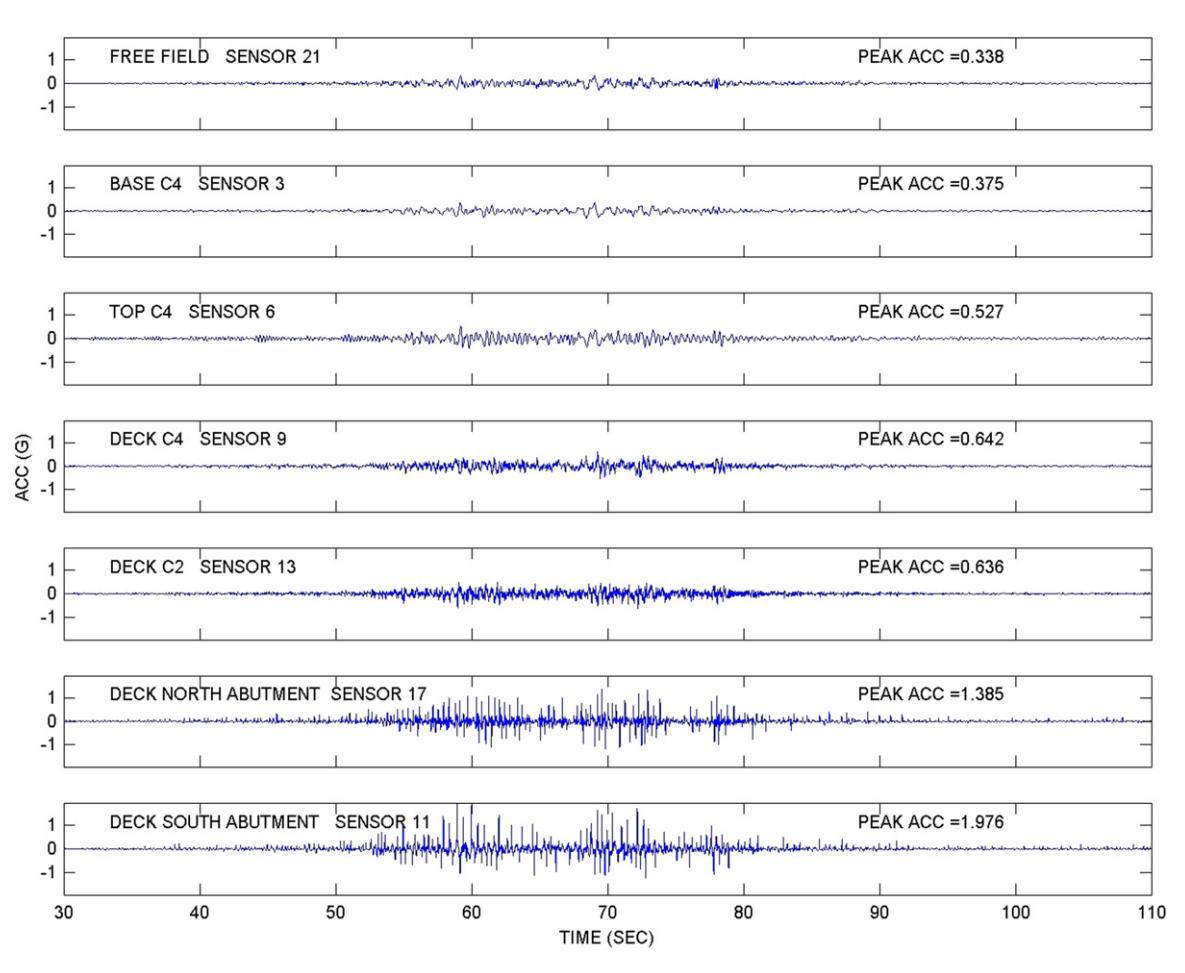
In the transverse direction, the accelerations are of the same order of magnitude at the deck and at the piers, but almost twice the "free-field values". Peak accelerations at the deck reached the largest values, 1.9 g and 1.4 g at the north and south abutments, respectively. This fact could be explained by the existence of friction between the deck and the lateral stoppers. For moderate earthquakes, it has been observed that the horizontal accelerations are generally higher at the valley than at the base of the pier, which seems to indicate that the piles attenuate the ground motion. However, this effect was not observed this time.

Fig. 8. Transverse records, 27/02/2010 earthquake. Marga Marga Bridge.

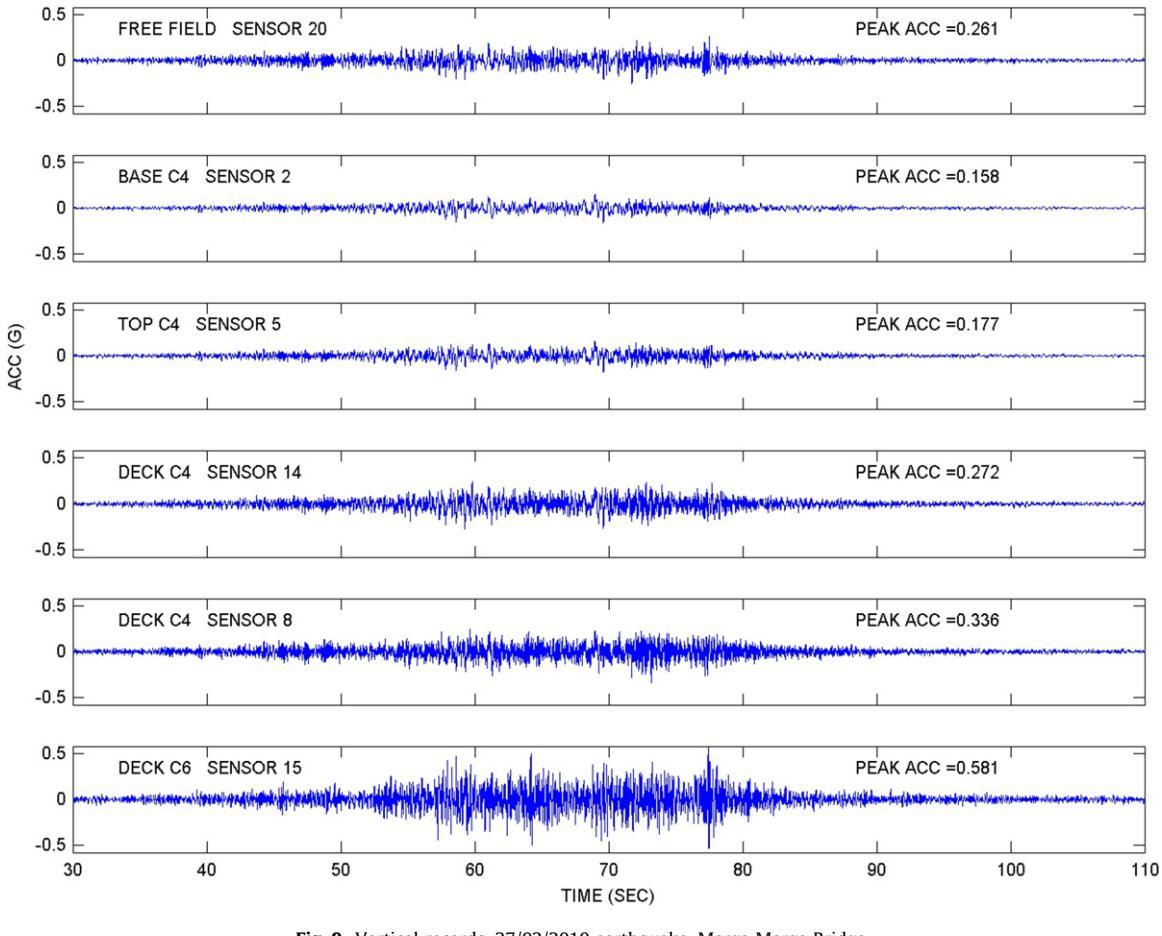
There was a significant reduction between the free field and the base of the pier in the vertical direction (first two graphs of Fig. 9), probably due to the effect of the piles that are embedded in the soil to reach harder layers. On the deck, the amplification in the vertical direction is apparent, especially in sensor 15, located on top of pier C6. Differences between sensors 8 and 14 may indicate some torsion of the deck. Finally, it is confirmed that the bridge is exposed to differential support motions, so this effect should be taken in account in any analytical study of this bridge.

Fig. 9. Vertical records, 27/02/2010 earthquake. Marga Marga Bridge.

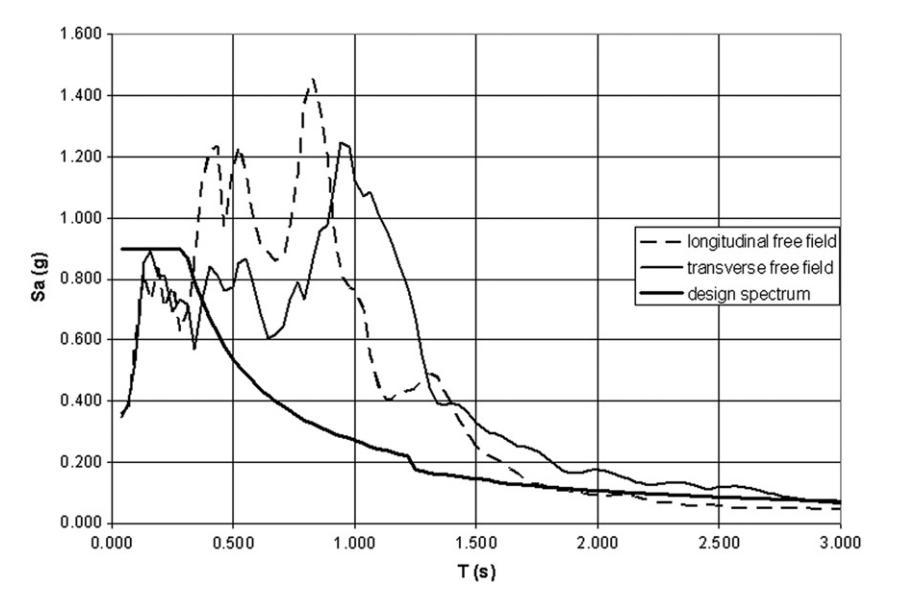
Elastic acceleration spectra (5% damping) of the longitudinal and transverse valley free field ground motions and the design spectrum are shown in Fig. 10. Although the design spectrum is lower than the spectra obtained from the records, the bridge performed as expected at the design stage.

Fig. 10. Elastic response spectra, Marga Marga bridge.

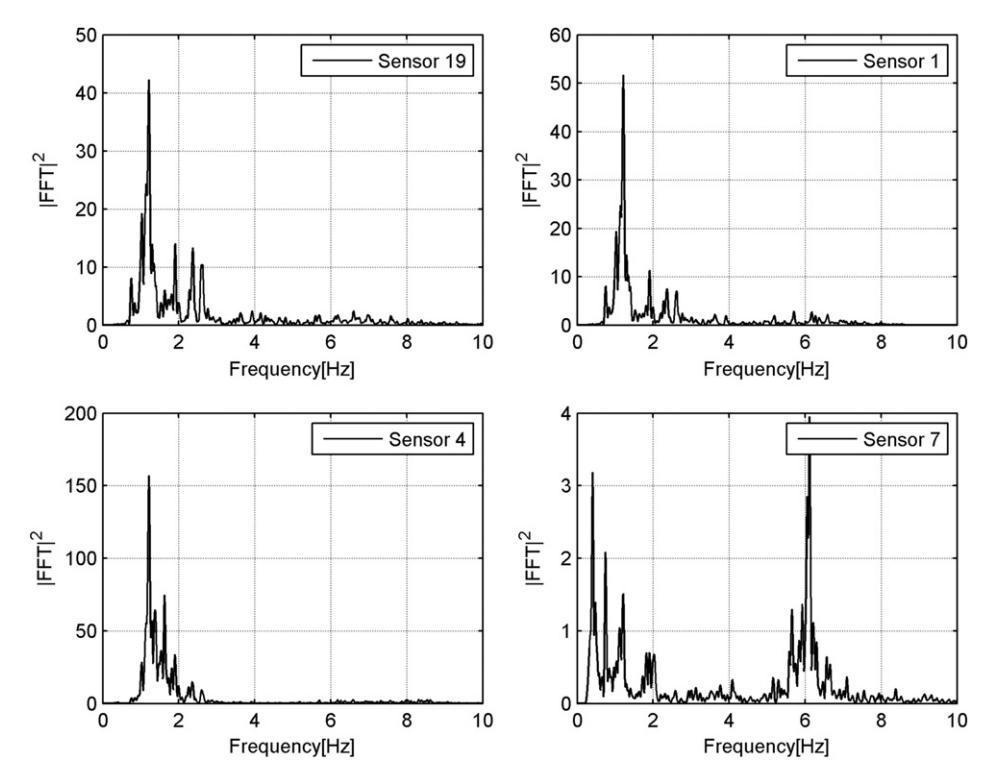
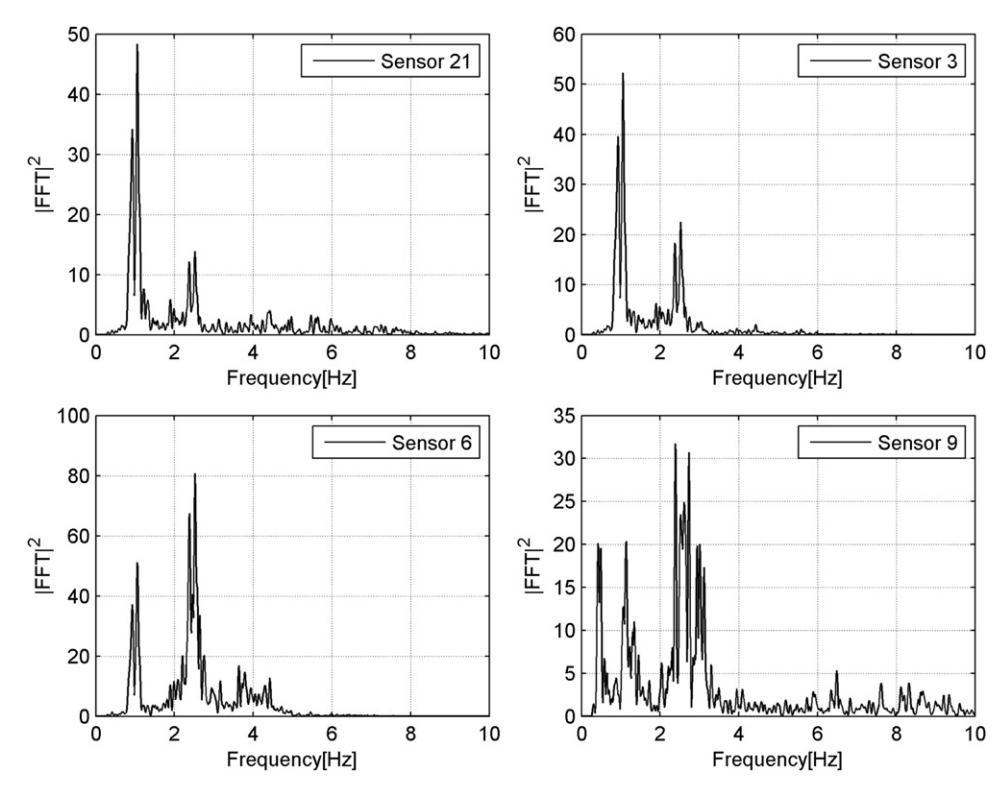
The square of the Fourier spectra of the records, in both horizontal directions, are shown in Figs. 11 and 12. The free field-valley motions have large peaks, with amplitudes of the

order of 40 around 1.21 Hz, and 50 around 0.95–1.05 Hz in the longitudinal and transverse directions, respectively. In both horizontal directions there are small peaks of the order of 10 around 1.9 and 2.4 to 2.6 Hz. The motions at the bottom of the pier are very similar to the free-field motion, with larger amplitudes at these same frequencies. At the top of the pier, in the longitudinal direction, the amplitude at 1.21 Hz increases up to 150, while in the transverse direction the largest amplitude (around 80) is between 2.4–2.6 Hz. The motion at the free field and at the pier for frequencies above 5 Hz show very little energy. The motion at the deck in the longitudinal direction shows very small peak amplitudes: 3.2 for 0.42 Hz, 2.1 for 0.7 Hz and 4 for 6.1 Hz. The first peak of the square of the Fourier spectrum on the deck is associated with the natural frequency of the deck sliding as a rigid body on the bearings.

These results show clearly the beneficial effect of the isolation bearings on the response in the longitudinal direction, in which the deck is free to move. The motion in the transverse direction experiences a significant change in its frequency content and their amplitudes are reduced with respect to the top of the pier to less than half. Note that in this direction there are stoppers that prevent the motion at the abutments.

Fig. 11. Square Fourier Spectra, 27/02/2010 earthquake. Marga Marga Bridge.

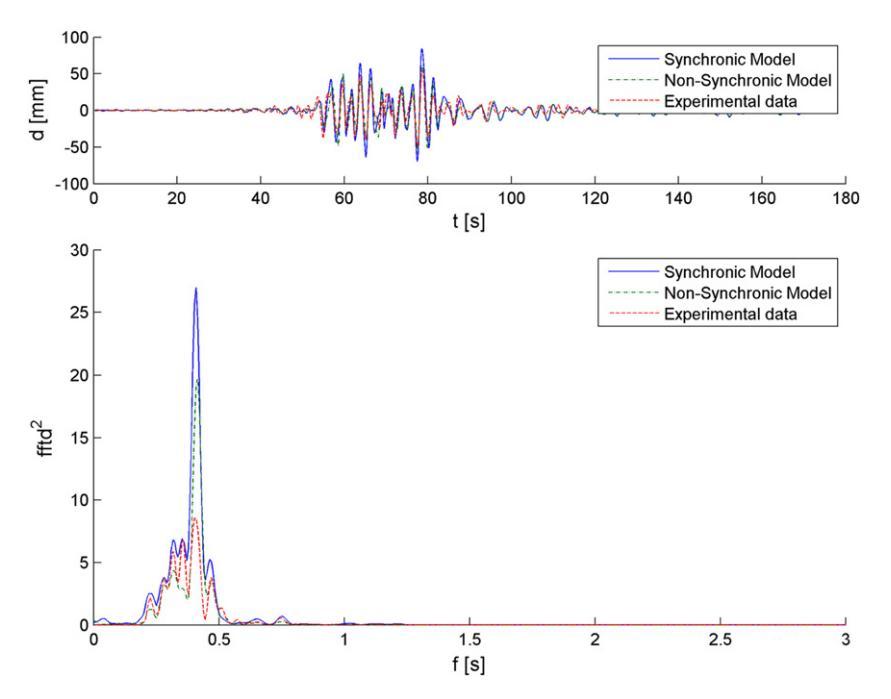
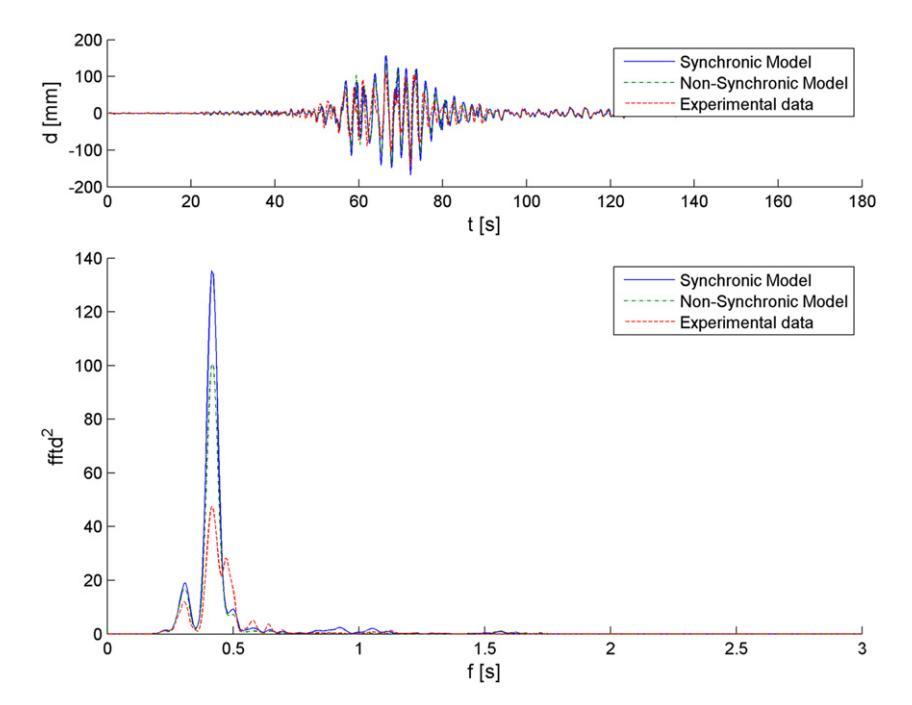
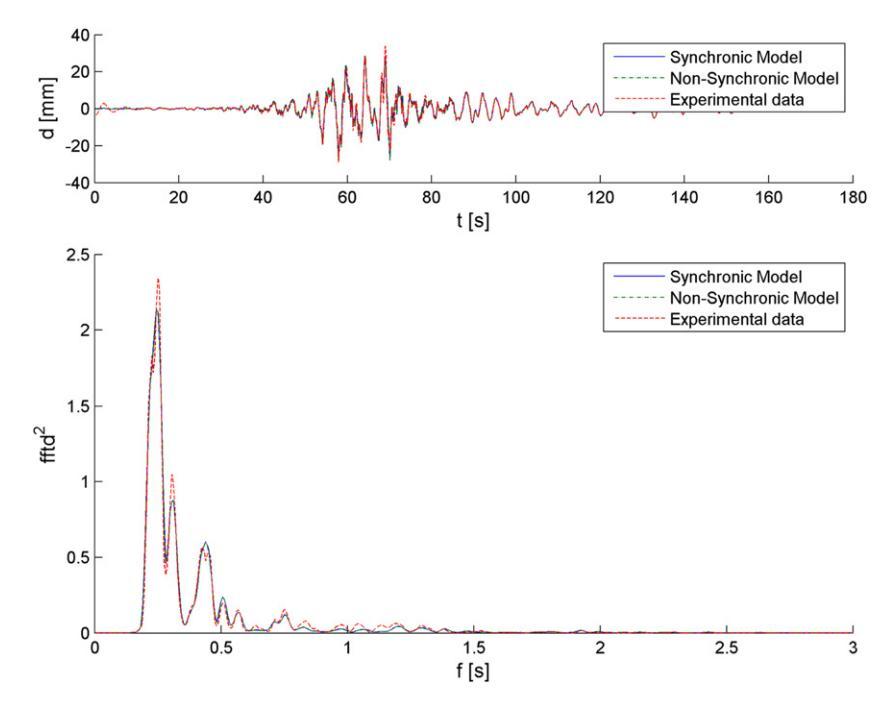
Rayleigh damping was used in both cases with 2% critical damping for modes 1 and 3. Figs. 13, 14 and 15 show theoretical and experimental displacements and spectral power densities obtained by longitudinal sensor 7, transverse sensor 9, and vertical sensors (8+14)/2, for both type of input. A significant improvement is observed with the use of non-synchronic motions at the supports.

Fig. 13. Comparison between experimental and theoretical response, Marga Marga Bridge, longitudinal direction.

Fig. 14. Comparison between experimental and theoretical response, Marga Marga Bridge, transverse direction.

Fig. 15. Comparison between experimental and theoretical response, Marga Marga Bridge, vertical direction.

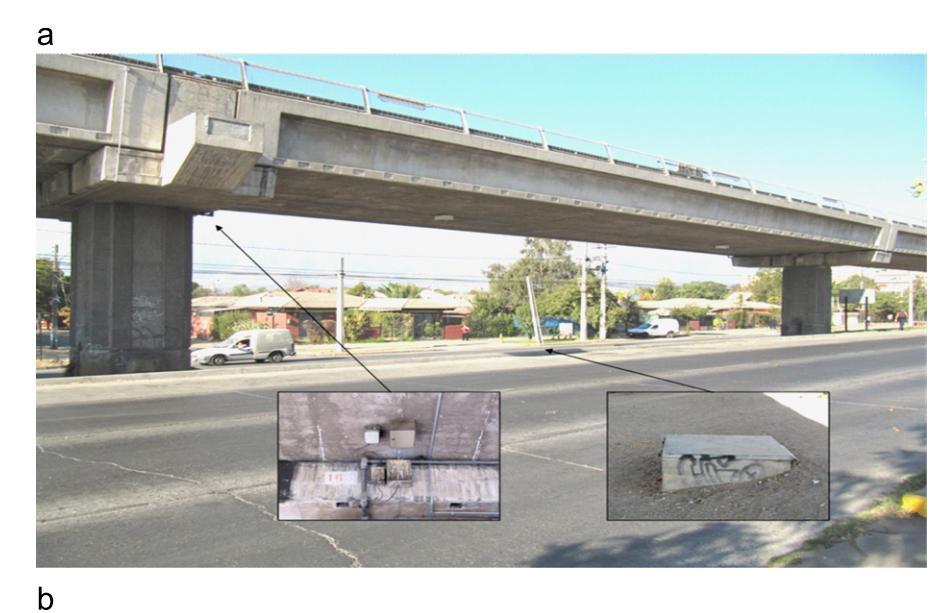
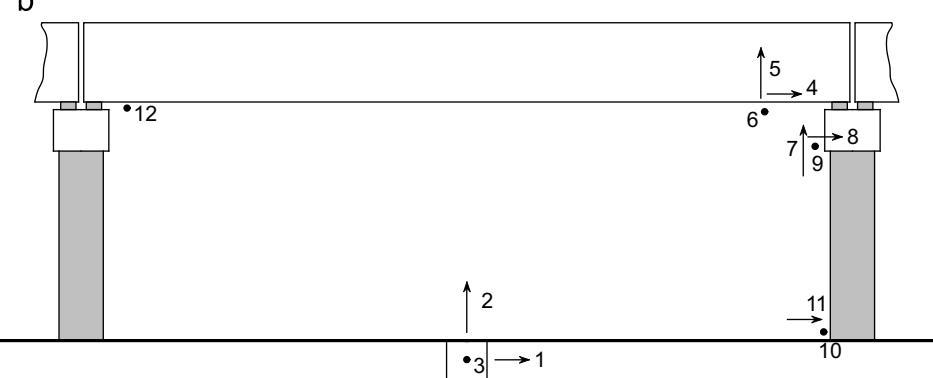
Agrícola, San Joaquin, Pedrero and Mirador. The viaduct is composed of two 1.8 m high external prestressed concrete beams connected by means of a transversally post-tensioned concrete slab, 30 cm thick. The spans range from 27 to 36 m and widths from 6.3 to 7.5 m. The beams are simply supported on reinforced neoprene pads, 30×60 cm in plan and 5.2 cm thick, located at the ends of cantilevers spanning from a hollow central column. Column dimension are: 2.4×1.4 m and 30 cm thickness wall. At the stations, the columns are 2.4×2.2 m. The columns are connected monolithically to the foundations, which consist of a hollow reinforced concrete parallelepiped, with variable depth between 7 and 12 m, filled with compacted soil. Detailed information is in [12]. A view of a section and the station area is shown in Fig. 16a.

The instrumentation installed at the Metro Line 5 is a local network of three uniaxial and three triaxial accelerometers, as shown in Fig. 16b. Frequencies obtained in the longitudinal, transverse and vertical directions, from records of moderate earthquakes, are listed in Table 3.

Fig. 16. General view, Line 5 viaduct and Local acceleration network in Line 5 viaduct.

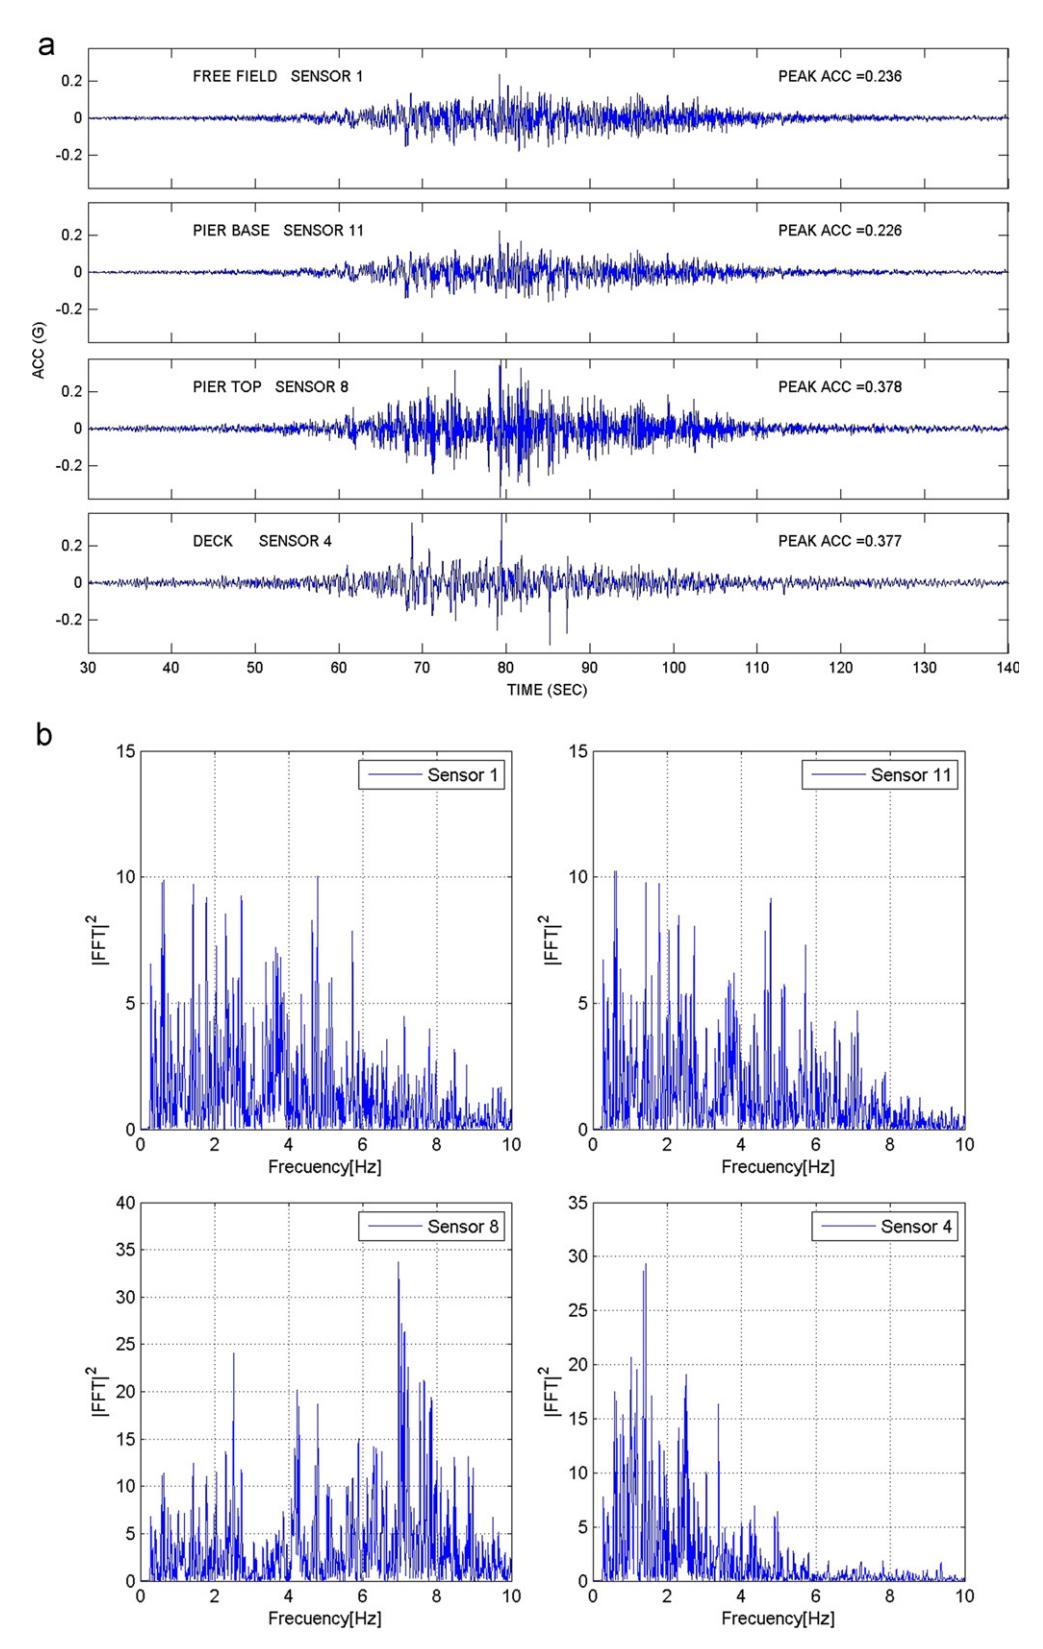
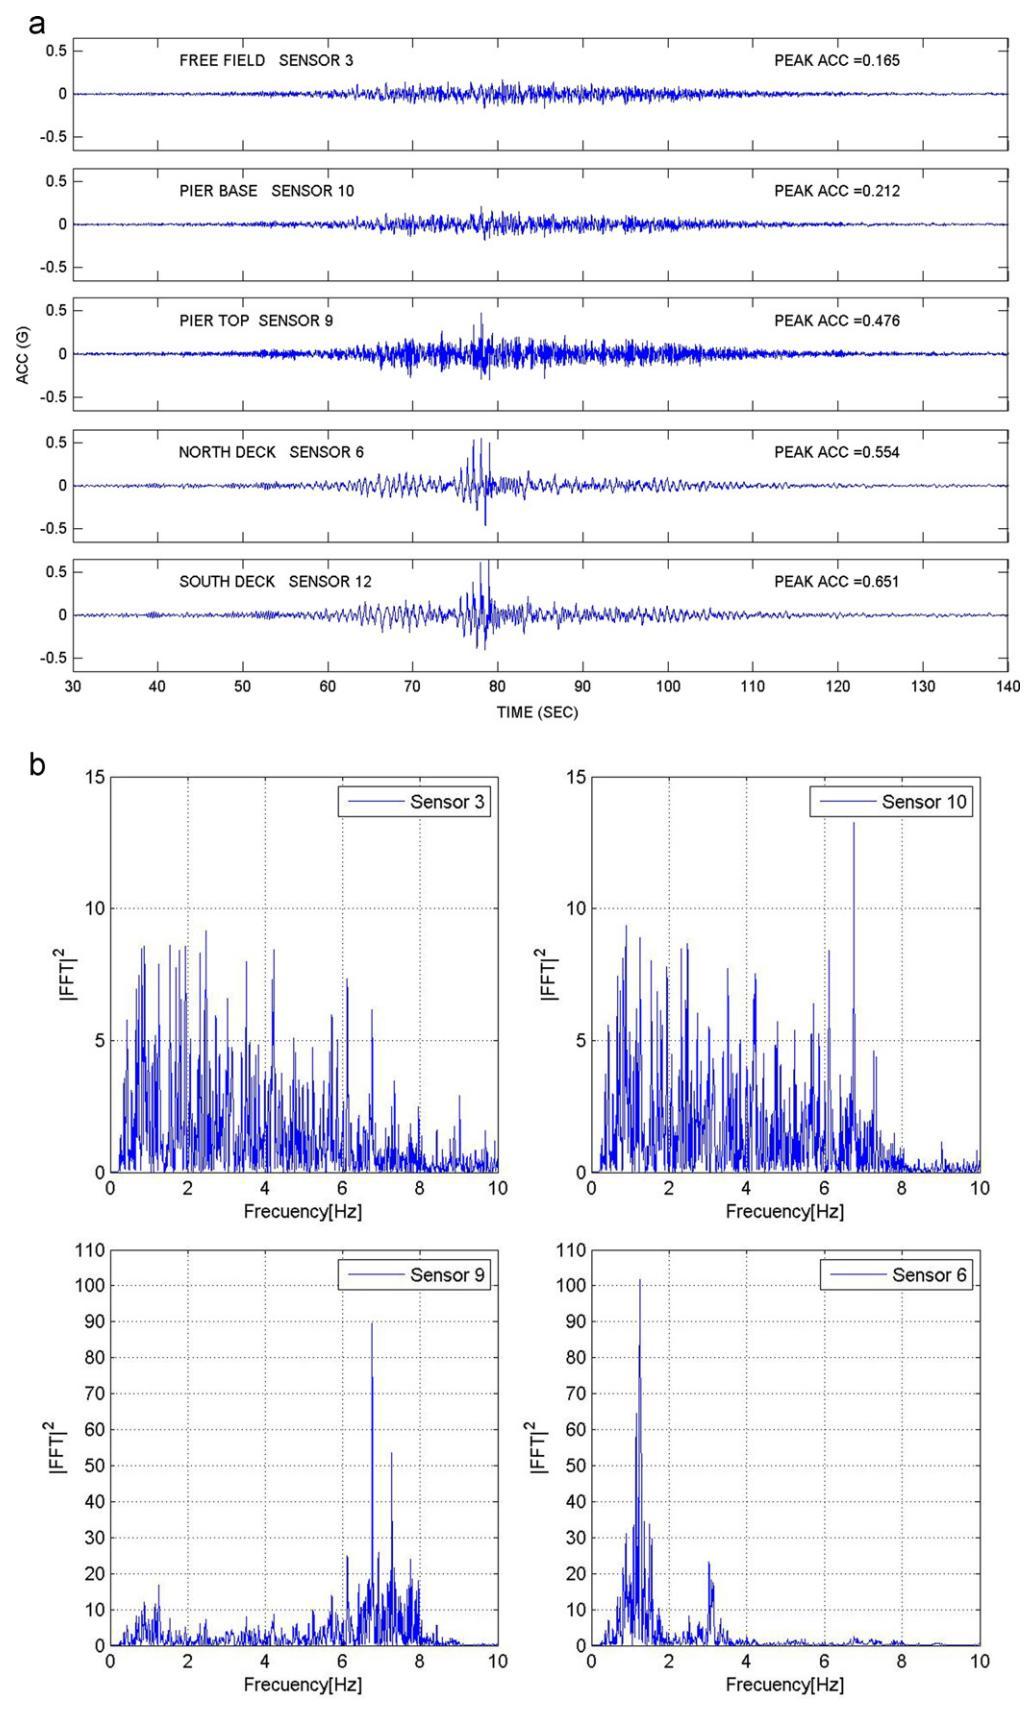
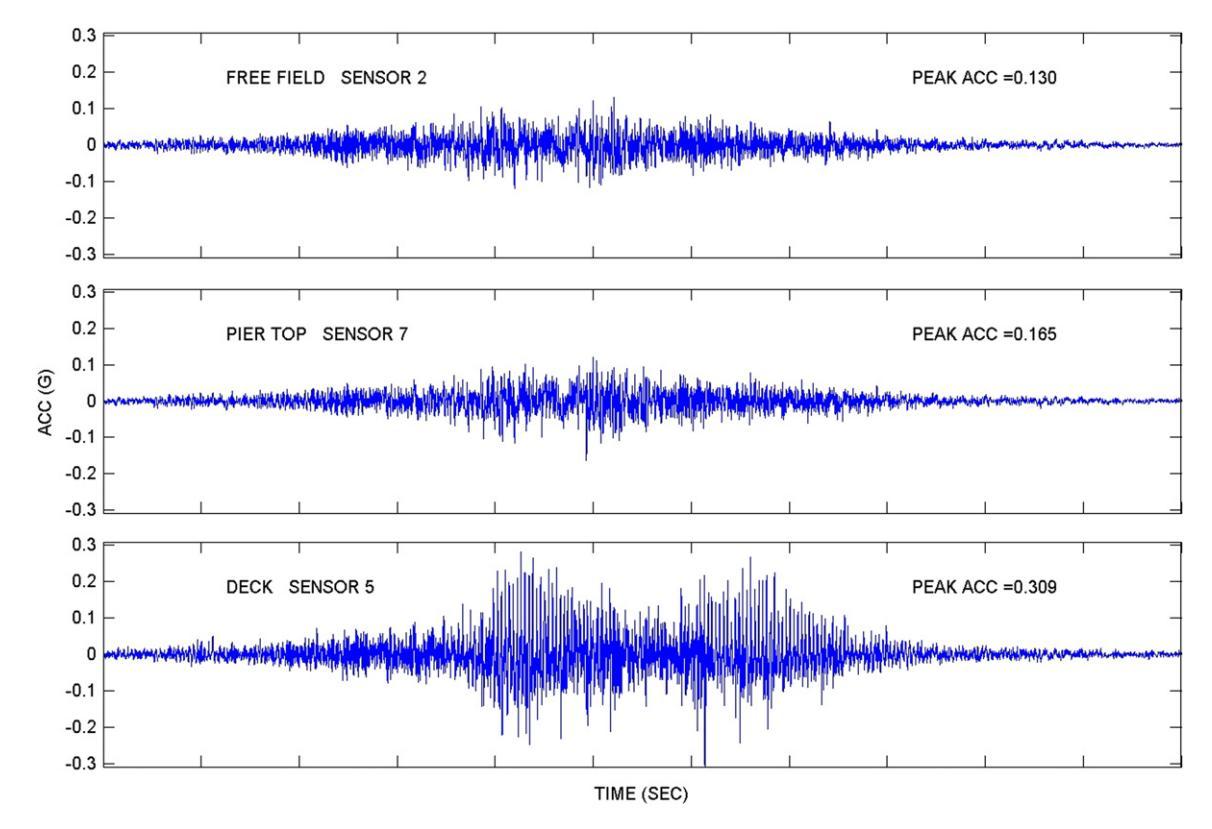
The Metro was able to operate normally after the quake, except for some minor damage to non-structural elements at some stations. Figs. 17–19 show the records obtained on February 27th, 2010 and also the square of the Fourier spectra of the motion in the longitudinal, transverse and vertical directions. Peak accelerations are listed at the right of each diagram. The reduction of acceleration in the longitudinal direction between the beam

(sensor 4) and top of pier (sensor 8) is apparent. The acceleration in both horizontal directions at the pier top (sensors 8 and 9) is almost twice the acceleration at the bottom pier (sensors 10 and 11). The longitudinal acceleration is quite similar between the "free field" (sensor 1) and the pier bottom (sensor 11). Transverse accelerations at both ends of the beam (sensors 6 and 12) are very similar, which indicates the absence of torsion. The motion in the transverse direction on the deck shows quite different frequency content with respect to the pier top. Vertical acceleration at the deck almost double the pier top's and it is almost 2.5 the value at the free field.

Fig. 17. Longitudinal acceleration records and square Fourier spectra, 27/02/2010 earthquake. Line 5 viaduct.

Fig. 18. Transverse acceleration records and square Fourier spectra, 27/02/2010 earthquake. Line 5 viaduct.

Fig. 19. Vertical acceleration records and square Fourier spectra, 27/02/2010 earthquake. Line 5 viaduct.

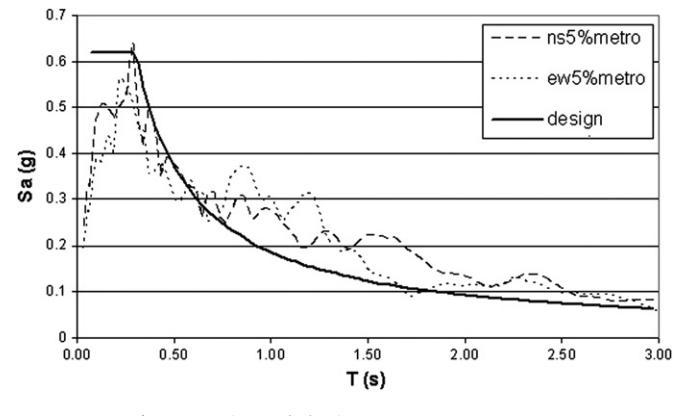
The elastic acceleration spectra at the free field ground motions and the design spectrum are quite similar, as can be seen in Fig. 20.

Fig. 20. Design and elastic response spectra, Metro.
