## Catastrophic, rainfall-induced debris flows in Andean villages of Tarapacá, Atacama Desert, northern Chile

**Keywords** Debris flows · Landslides · Atacama · Altiplano

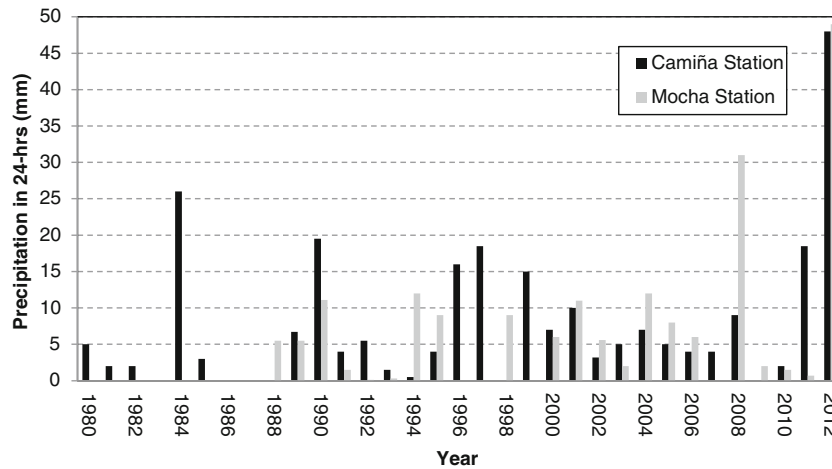
**Fig. 3** Annual maximum precipitation in 24 h at Camiña and Mocha (Tarapacá valley) meteorological stations

From the historical data of maximum rainfall in 24 h, the largest recorded events in the 2012 summer period correspond to the ones registered on 13 March (records are taken at 8 a.m.) in the Camiña valley (Camiña station) and 26 February in the Tarapaca valley (Mocha station, Table 1 and Fig. 3), with a total daily rainfall of 48 and 49 mm, respectively. The March event was not captured by the Mocha station; however, in the Chusmiza station located close to the valley at 3,400 m a.s.l., a total of 101 mm was recorded during the 11th–14th

According to the statistical analysis of the timeseries of Camiña and Mocha stations, the events in 2012 exceeded the 100-year return period and are the largest in at least the last three decades (Table 2 and Fig. 3). The peak rainfall duration is estimated between 1 and 2 h. Studies in the last 15 years by Arrau, (2009) report the occurrence of mud flows in January 26, 1998 and March 10, 2001 in Camiña valley.

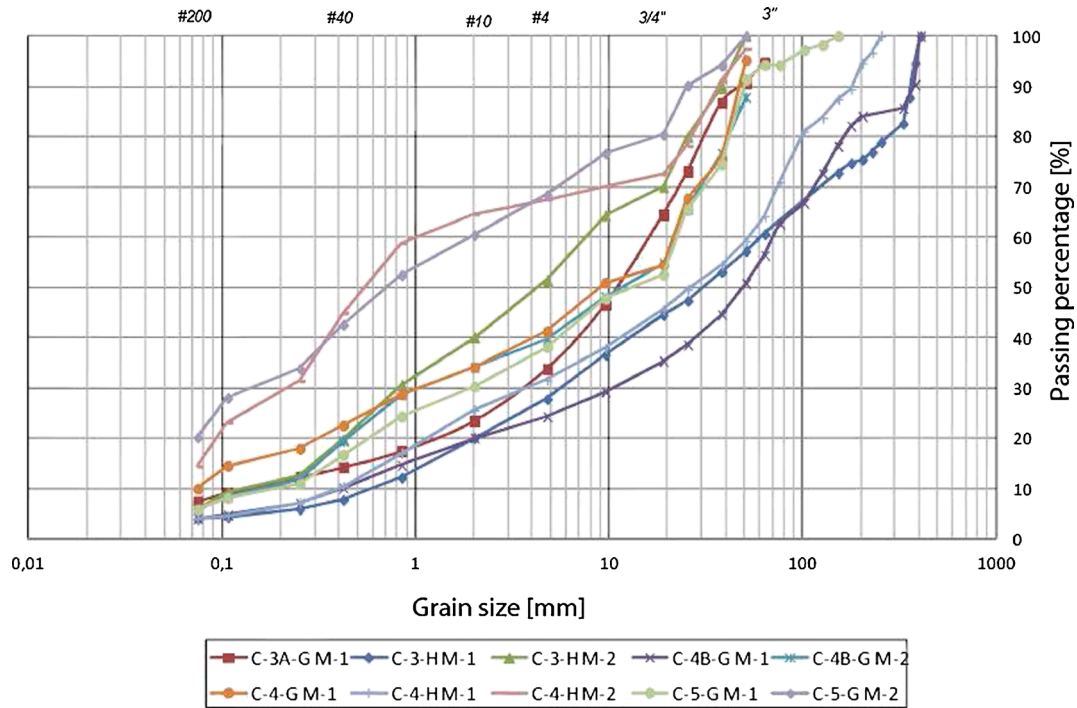
Fig. 5 Granulometric curves from debris flow deposits in alluvial fans in Camiña area (IDIEM 2013)
