The 2014 Earthquake in Iquique, Chile: Comparison between Local Soil Conditions and Observed Damage in the Cities of Iquique and Alto Hospicio

In this study, we present comparisons between the local soil conditions and the observed damage for the 1 April 2014 Iquique earthquake. Four cases in which site effects may have played a predominant role are analyzed: (1) the ZOFRI area, with damage in numerous structures; (2) the port of Iquique, in which one pier suffered large displacements; (3) the Dunas I building complex, where soil-structure interaction may have caused important structural damage; and (4) the city of Alto Hospicio, disturbed by the effects of saline soils. Geophysical characterization of the soils was in agreement with the observed damage in the first three cases, while in Alto Hospicio the earthquake damage cannot be directly related to geophysical characterization. [DOI: 10.1193/111014EQS188M]

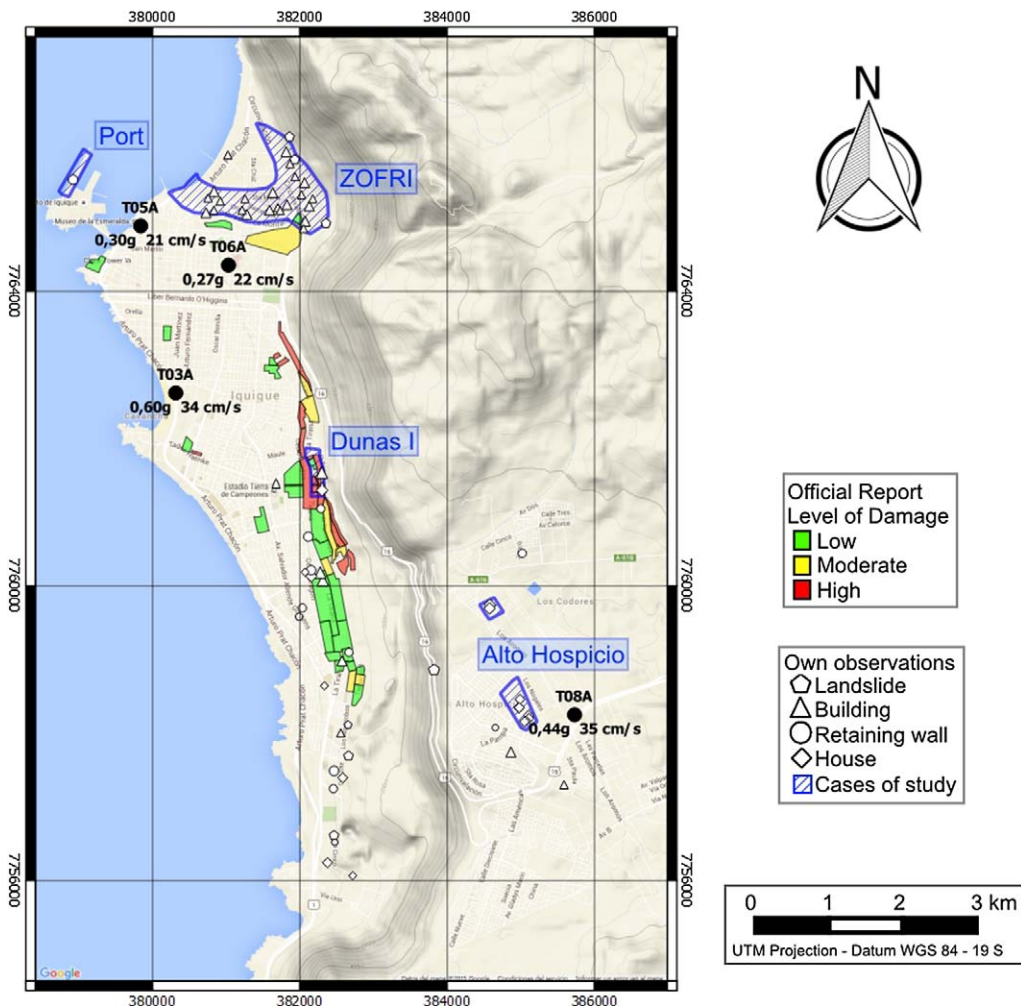
Figure 2. Observed damage in Iquique after the 2014 Iquique earthquake. Comparison between the official government report of damage (obtained from the Ministry of Housing and Urban Development) The size of the symbols represents, qualitatively, the level of damage observed in each case. Coordinates are in UTM, Datum WGS84. The figure also displays the seismic stations in Iquique and Alto Hospicio with their registered PGAs and PGVs.

The differences in Iquique and Alto Hospicio are significant. In terms of accelerations, station T03A shows a PGA twice as large as station T05A (Figure 2), with a distance of barely 2 kilometers between them. In terms of Peak Ground Velocities there are some differences among the stations though they are not as significant as the former, with a maximum PGV of 35 cm/s in Alto Hospicio (station T08A).

The damage reconnaissance campaign took place in Iquique and Alto Hospicio between 9 and 13 April 2014, a week after the earthquake. During that period, we explored the entire cities and registered the zones where significant damage was concentrated. Figure 2 shows the observed damage in each city and marks the case studies that will be detailed in this research, it also shows the official government report of the registered damage in the city. In this figure, we may note that most of the damage observed in our reconnaissance campaign was observed in the north on the city. Very few cases were reported toward the southwest. In the south of the city, damage concentrates to the east and an unexpected high number of cases were detected in Alto Hospicio area. It is worth mentioning that in the center of the city, near stations T05A and T06A of Figure 2, no damage was observed, historical buildings of over a hundred years old remained intact, just as most of the other structures in the zone.

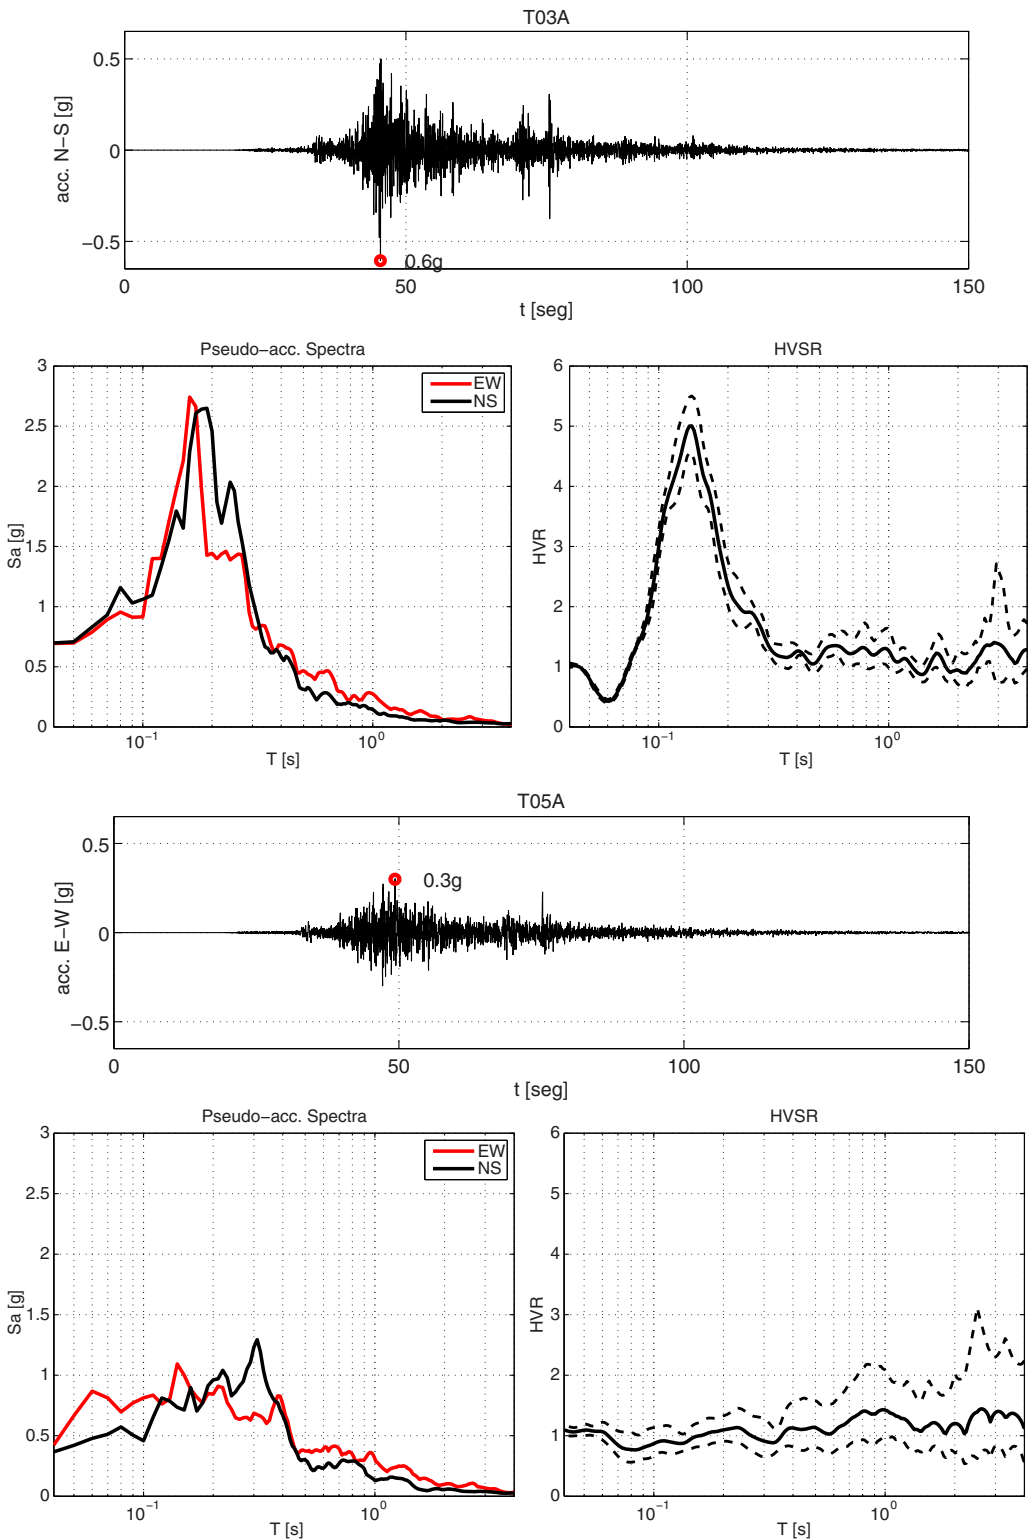
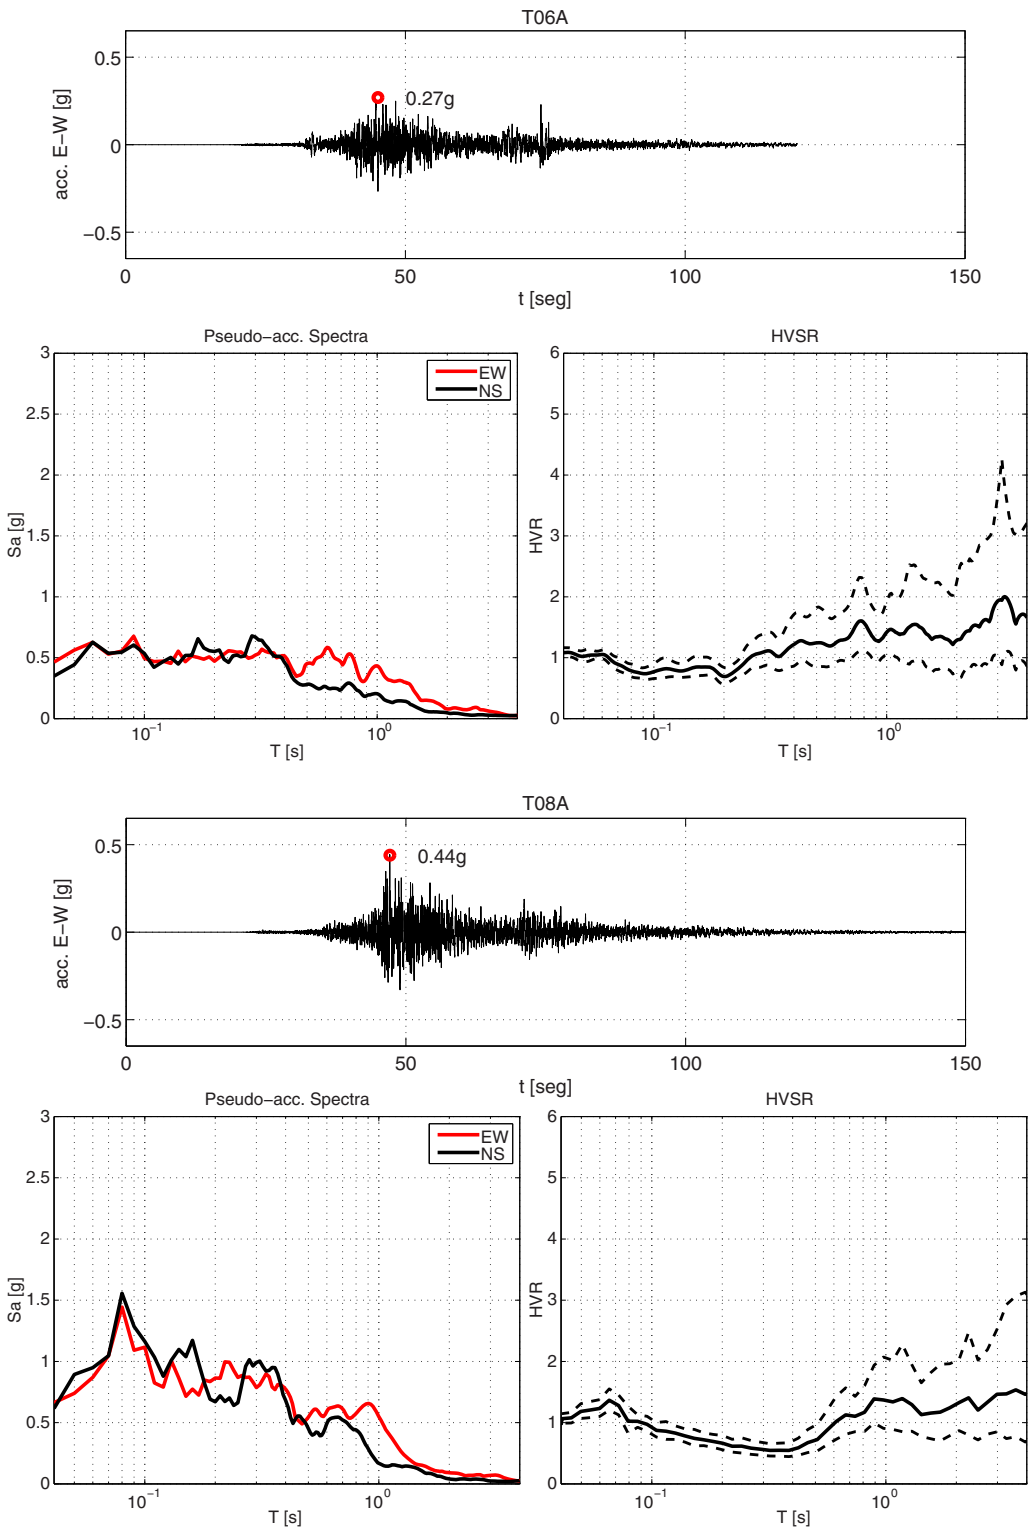
The pseudo-acceleration response spectra of (a) and (d) show a peak period of 0.16 s (6.25 Hz) and 0.08 s (12.5 Hz) for stations T03A and T08A, respectively; there are no noticeable differences between orientations for each spectra. Note that the peak period in T03A is twice as much as in the T08A station.

Figure 3. Strong motion records, pseudo-acceleration response spectra (5% damping) and HVSR results for the seismic stations located in Iquique and Alto Hospicio.

The predominant frequency of the sites that show a clear peak, such as T03A, are in agreement with the shape of spectra of the strong motion records, particularly in the station that showed the highest PGA.

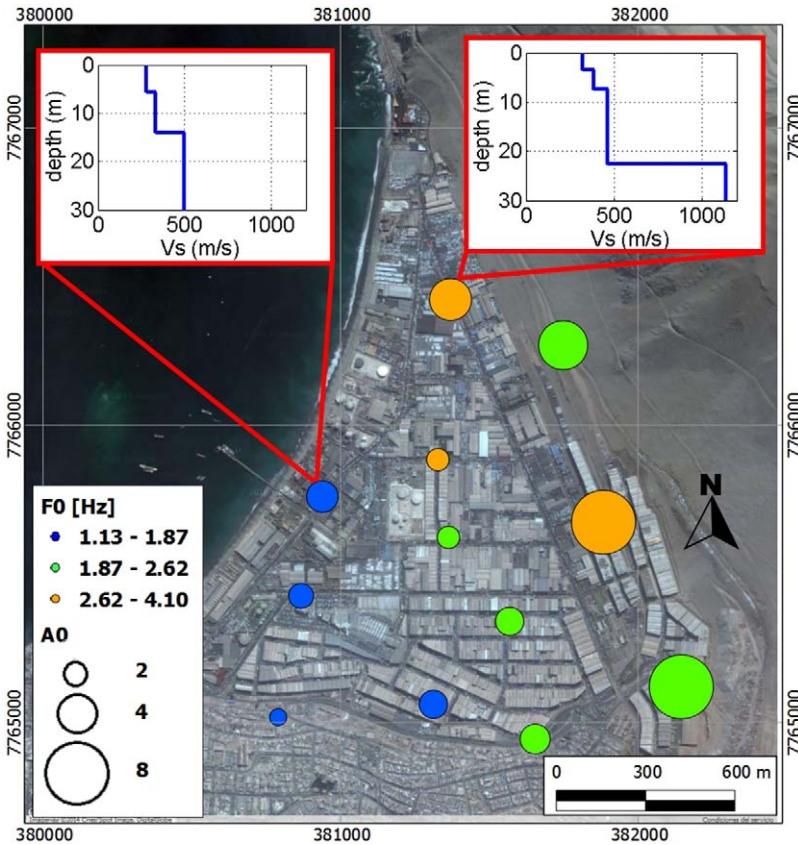
Figure 4. Geophysical characterization of the ZOFRI zone. The image shows the predominant frequency of the soil (obtained from HVSr using microtremors) and typical shear wave velocity profiles for two different areas (obtained by surface wave methods). The circle size represents the amplitude of the peak frequency while the color represents the frequency range.

Figure 4 shows the predominant frequency of each site obtained through HVSr and typical shear wave velocity profiles for different zones; this figure also presents the corresponding amplitude of the HVSr. We can see that higher amplitudes characterize the data toward the east, which suggest a significant impedance contrast between the soil layers and the bedrock (Leyton et al. 2013). This result would strengthen the hypothesis of the increase in peak acceleration taking place in this area; however, we could not confirm this hypothesis because no seismographs were installed in this sector during the earthquake.

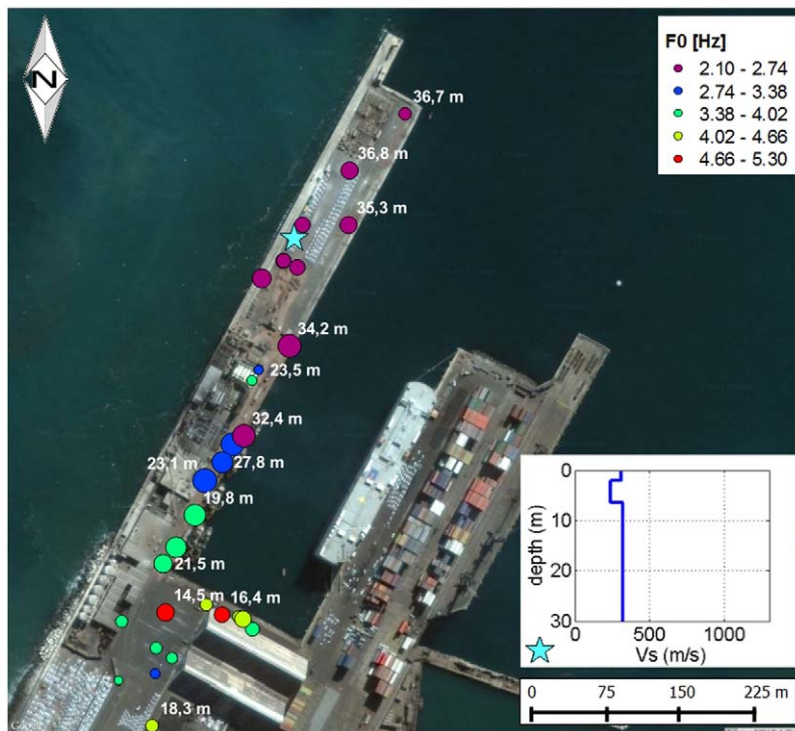
Since the predominant frequency of the soil has been estimated in several points of the pier through the HVSr technique, it was possible to evaluate the change in thickness along the western pier, as shown in Figure 7. We can see that, in general, the thickness of the artificial landfill tends to increase toward the end of the pier, whereas toward the terminal it is thinner. Since a constant shear wave velocity is unlikely in sand deposits and artificial fills, this depth should be considered as an approximation only.

Figure 7. Geophysical characterization of the port of Iquique. The figure shows the predominant frequency of the soil and a typical shear wave velocity profiles for the pier. The white numbers indicate the estimated depth to bedrock.
