Geotechnical Aspects of the 2015 M_w 8.3 Illapel Megathrust Earthquake Sequence in Chile

The 2015 Illapel earthquake sequence in Central Chile, occurred along the subduction zone interface in a known seismic gap, with moment magnitudes of M_w 8.3, M_w 7.1, and M_w 7.6. The main event triggered tsunami waves that damaged structures along the coast, while the surface ground motion induced localized liquefaction, settlement of bridge abutments, rockfall, debris flow, and collapse in several adobe structures. Because of the strict seismic codes in Chile, damage to modern engineered infrastructure was limited, although there was widespread tsunami-induced damage to one-story and two-stories residential homes adjacent to the shoreline. Soon after the earthquake, shear wave measurements were performed at selected potentially liquefiable sites to test recent V_S -based liquefaction susceptibility approaches. This paper describes the effects that this earthquake sequence and tsunami had on a number of retaining structures, bridge abutments, and cuts along Chile's main highway (Route 5). Since tsunami waves redistribute coastal and near shore sand along the coast, liquefaction evidence in c

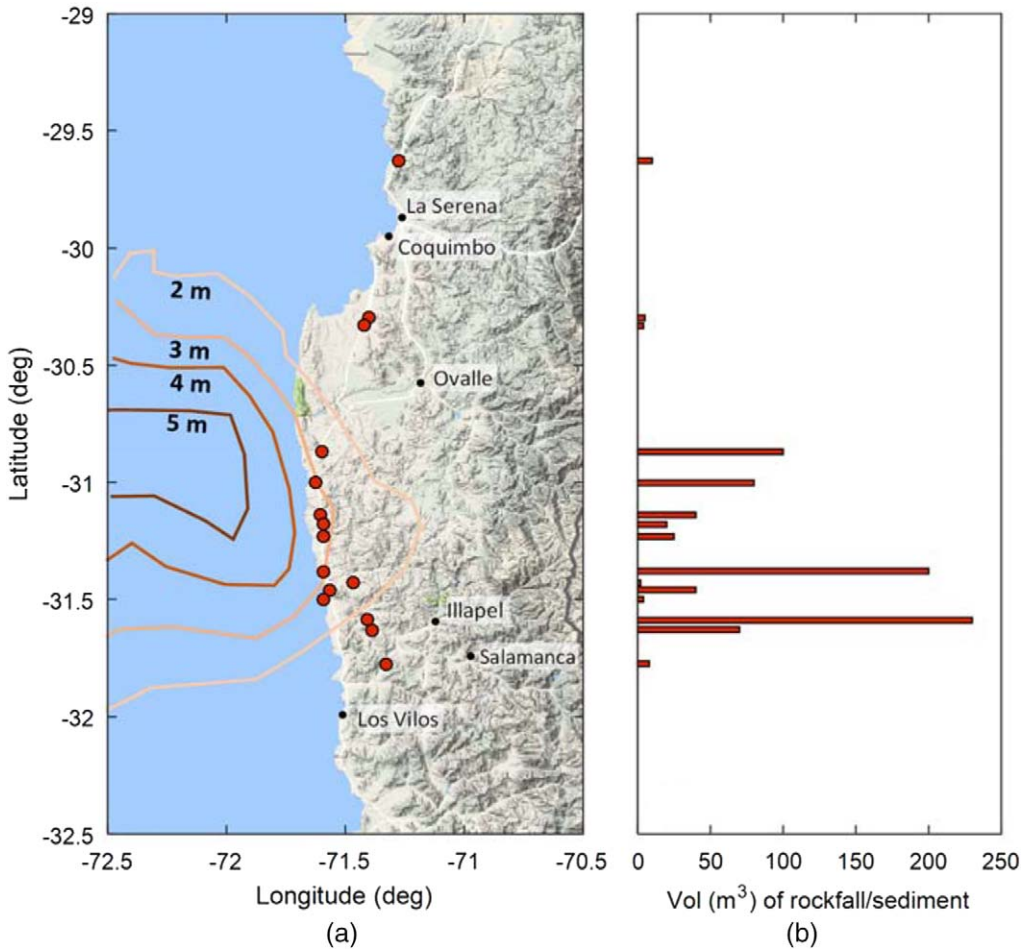
Importantly, by comparing the distribution of slip within the event as revealed by seismic and GPS studies (Tilmann et al. 2016), with our distribution of rockfall/mass-wasting (Figure 14), zones within the coseismic deformation zone, experienced the most amount of rockfall. This suggests that in future earthquakes, a model of coseismic tectonic slip (which can be generated rapidly post-earthquake) may provide insight important into where the most amount of rockfall or landslides will be located and where resources should be devoted to keep lifelines open.

Figure 14. (a) Map showing some key rockfall locals along Route 5 (red dots) with a coseismic slip model (in m), after [Tilman et al. 2016](#). (b) Rockfall volumes (m^3) versus latitude observed along the Route 5. Note the striking correspondence between the slip and observed rockfall, which suggests that rockfall is greatest and concentrated in the locations where the most tectonic slip occurred.
