ANALYSIS OF FAILURES AND DEGRADATION MODES OF SMALL SCALE  
DOMESTIC/FARM PHOTOVOLTAIC POWER PLANTS IN RURAL COMMUNITIES  
OF THE ATACAMA DESERT

TESIS PARA OPTAR AL GRADO DE  
MAGÍSTER EN CIENCIAS DE LA INGENIERÍA, MENCIÓN ELÉCTRICA

PIA JAVIERA VASQUEZ RIVERA

SANTIAGO DE CHILE  
2020

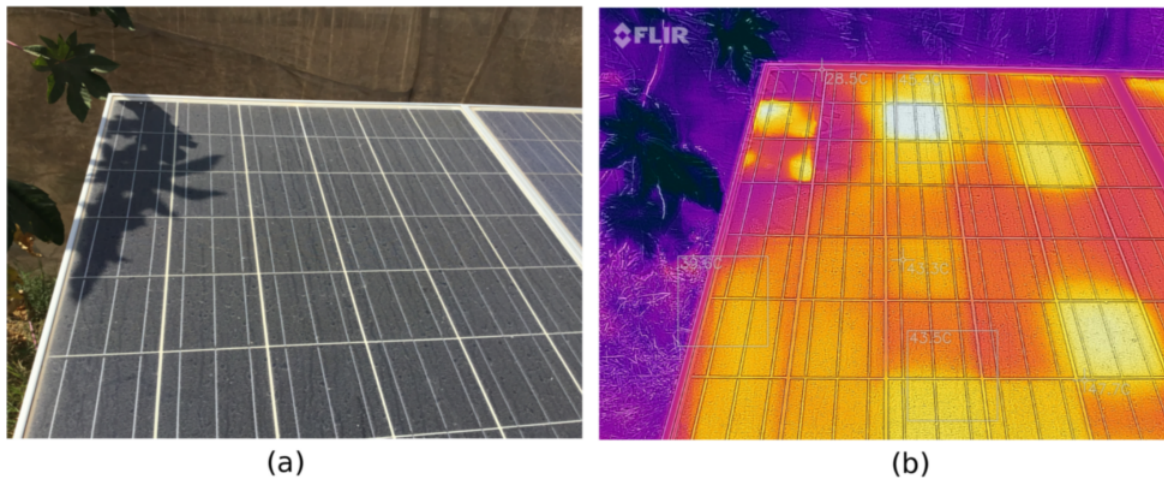
Figure 2.9: Partially shaded module by the presence of a plant: (a) Visual inspection, (b) Thermal image where the abnormal heat distribution can be observed.

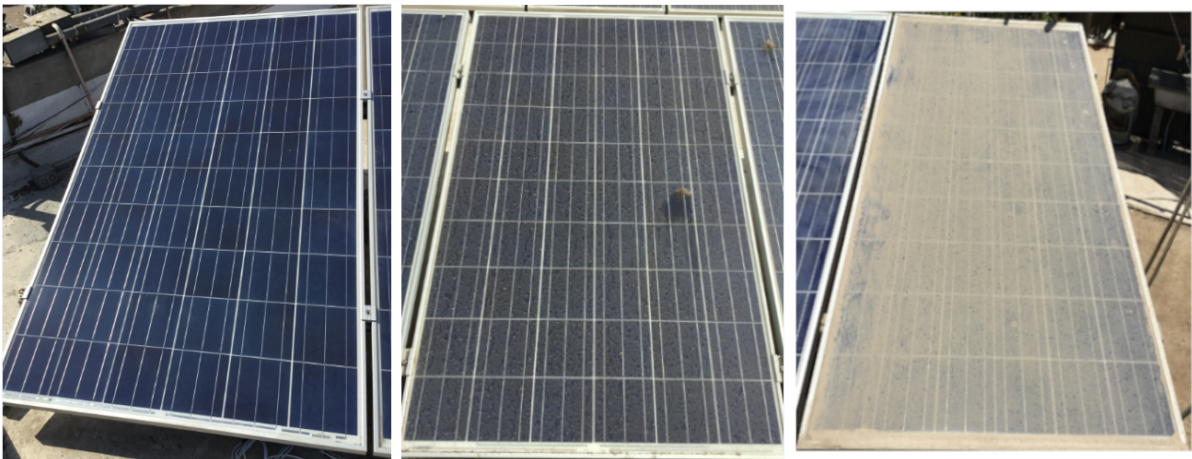
Figure 2.10: Different degrees of soiling deposited on modules surfaces detected by visual inspection.

Soiling over PV modules can be detected by simple visual inspection. The effects of soiling deposition can range from a simple aesthetic issue (without affecting any output parameter) to a severe reduction in the energy output, so electrical measurements greatly influence the failure diagnosis. Moreover, the response of individual affected modules/cells depends on their inherent characteristics (materials quality, current mismatches, manufacturing issues), which affects the energy output, but also the thermal behaviour of modules. Therefore, it can be found that two soiled modules with similar soiling deposition patterns present very different thermal patterns and operating temperature. This can be characterized with high accuracy by IR Thermography. An important feature of soiling, treated as a failure/degradation mode, is that it is reversible as the module is cleaned. However, continuous operation under severe soiling conditions can lead to permanent degradation and damage of solar modules.

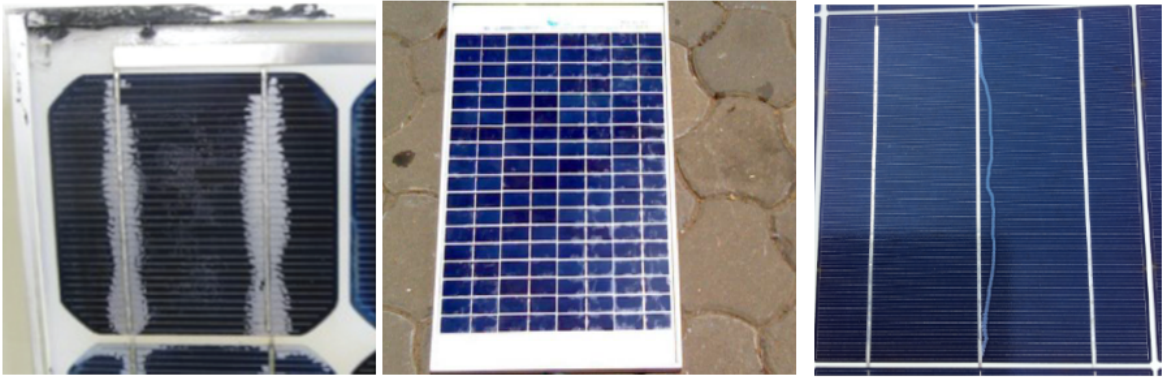
Another failure/degradation mode that can be detected by visual inspection is delamination. As shown in Figure 2.12, the visual manifestation of delamination is not unique, but shows a characteristic whitening over cells produced by the loss of adhesion of EVA [102]. As discussed in Section 2.1.2, the optical effect of delamination is the loss of transmittance across the EVA layer, thus decreasing the amount of light that reaches the cell in delaminated zones. This leads to heating and eventually to hotspot generation [103]. The decrease in transmittance also produces a drop in the short circuit current  $I_{sc}$  of the I-V characteristics [63].

Figure 2.12: Delamination of EVA encapsulant detected by visual inspection.

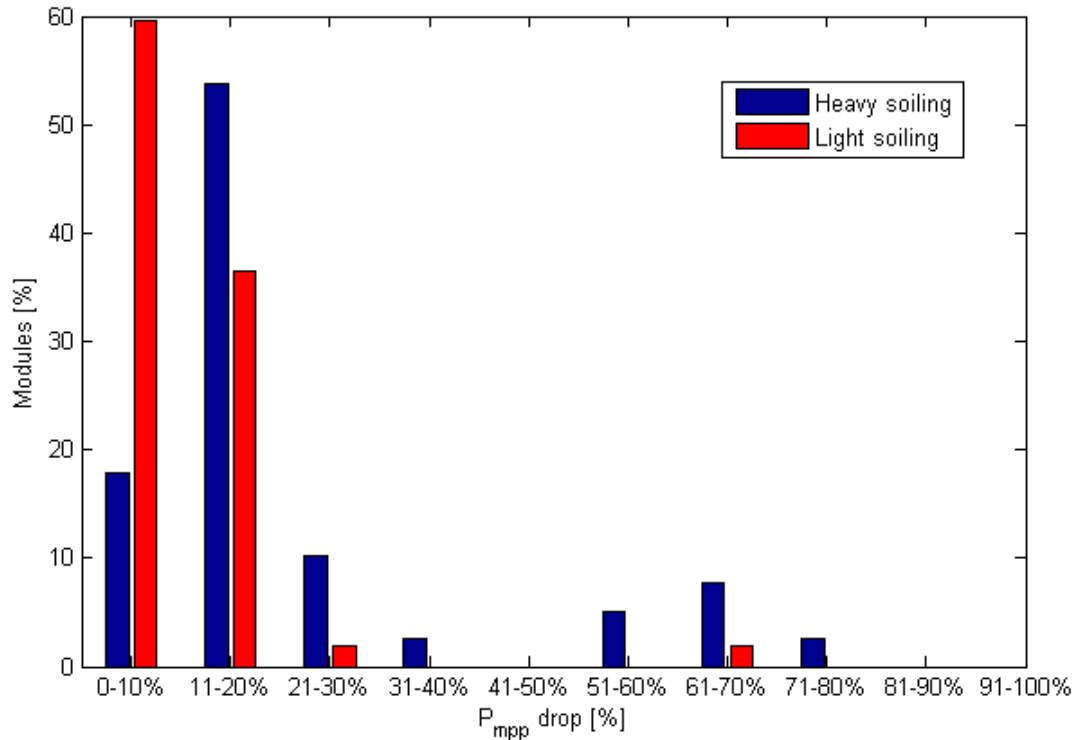
A relationship between the drop in the Maximum Power Point ( $P_{mpp}$ ) and the degree of soiling is shown in Figure 3.2. As shown, 60% of lightly soiled modules (red) show a Maximum Power drop below 10% from their nominal value, and 96.15% of the lightly soiled modules show power drop below 20%. The remaining 3.85% (2 modules) show power drops in the range 21-30% and 61-70%, which can be indicative of additional problems that will be later studied individually. Regarding to heavily soiled modules, 53.85% show power drop between 11-20% while 82.06% present  $P_{mpp}$  drop below 30% from the nominal value. As it will be detailed below, those modules with higher power drop belong to a set affected by a particularly thick and uniform layer of dust, which presumably prevents the generation of photo-current in the entire modules surface.

Figure 3.2: Distribution of  $P_{mpp}$  drop of heavily (blue) and lightly (red) soiled modules.

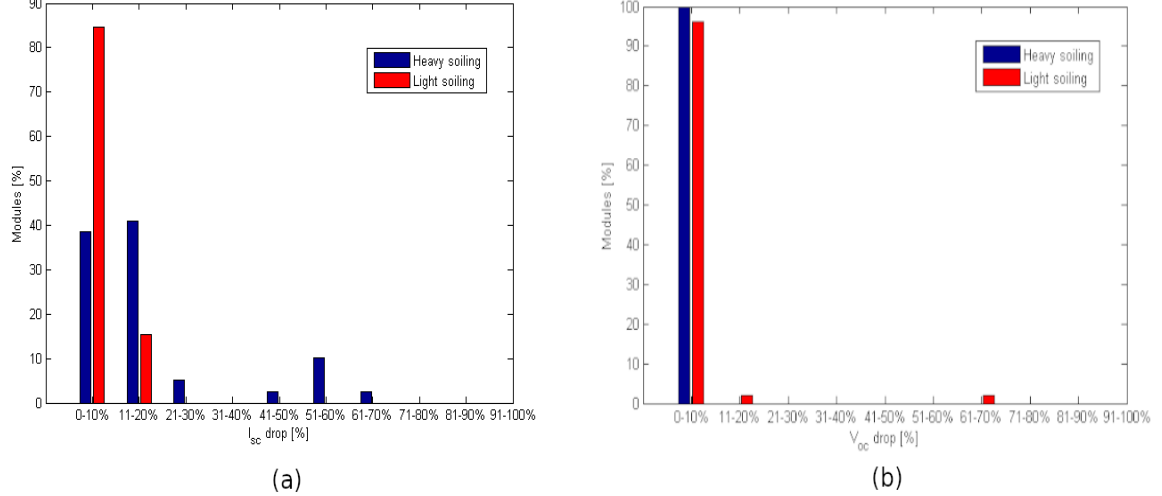
Power output of the modules is determined by the Open Circuit Voltage ( $V_{oc}$ ) and Short Circuit Current ( $I_{sc}$ ). The parameter that is most related to soiling corresponds to reductions in  $I_{sc}$ , given that its effect is equivalent to lower irradiation levels seen by the module (and thus lower generation of charge carriers). As shown in Figure 3.3 (a), the vast majority (84.62%) of lightly soiled modules present a reduction of  $I_{sc}$  less than 10% with respect to nominal value, and all of them present less than 20% reduction. For heavily soiled modules, 79.49% of the total sample show less than 20%  $I_{sc}$  reduction, but 15% show values higher

than 40%. Regarding to  $V_{oc}$ , it is known that changes in irradiance do not affect the open circuit voltage (as temperature does), as it can be seen in Figure 3.3 (b). All heavily soiled modules show  $V_{oc}$  reduction less than 10%, while for lightly soiled modules one of them shows a very high drop (64.08%) but this is presumably not related to soiling phenomena.

Figure 3.3: Distribution of (a)  $I_{sc}$  and (b)  $V_{oc}$  drop of heavily (blue) and lightly (red) soiled modules.

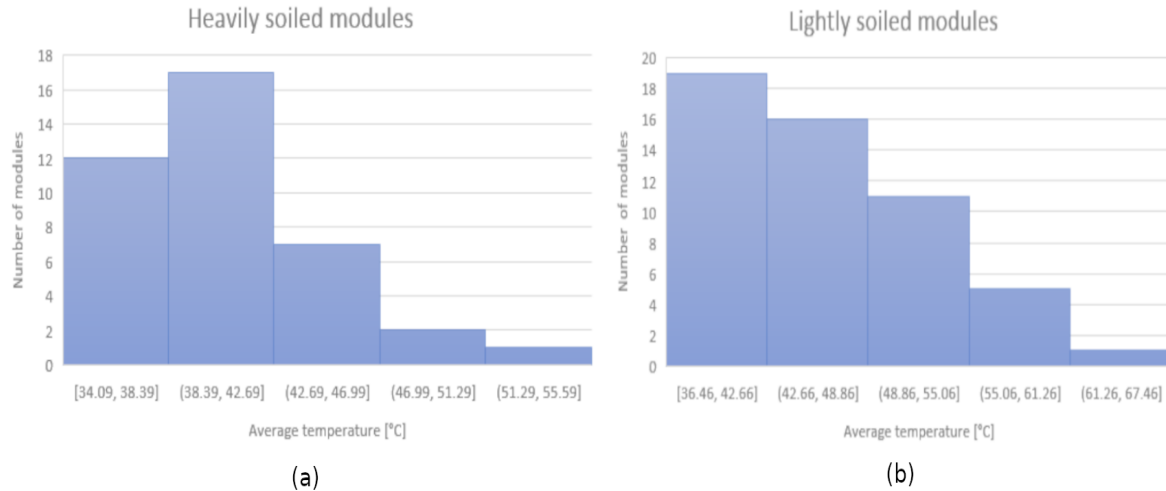
Regarding to the operating temperature of the soiled modules, it was found that the average operating temperature on the surface of heavily soiled modules is 40.94°C. For lightly soiled modules this temperature is 46.02°C. Temperatures were calculated from the IRT data, with the same approach shown in Section 2.4, but using a greater amount of squares to fit the desired area.

The distribution of temperatures, divided in four ranges is shown in Figure 3.4. It can be noted that most of the heavily soiled modules remain within the range [38.39,42.69]°C, and three modules operate with an average temperature between 46.99 and 55.59°C. In contrast, most of lightly soiled modules (35) operate below 48.86°C but six modules operate between 55.06 and 67.46°C. This may be because severe and uniform soiling layers, can act as a screen over the surface, preventing the generation of charge carriers and thus, the temperature rising. When a photon of energy larger than the energy *bandgap* of the absorbing material (around 1.1 eV in the cells analyzed in this work) is absorbed, the excess energy is dissipated as thermal energy across the crystal lattice. When the amounts of incident photons is decreased by screening the active surface (in this case with a thick layer of dust), the electron-hole pairs generation rate is also decreased, and consequently the thermal loss. This decreases the total current of the module and consequently the temperature. Additionally, this can also contribute to adjust the short circuit current ( $I_{sc}$ ) mismatch between the cells on the module, avoiding to force higher currents through defective cells. This is not observed in lightly soiled modules, considering that modules average temperature considers also cells operating at very high temperatures (>70°C) probably due to other (and less evident) reasons, like broken cells, uneven light transmission across encapsulant layers or high shunted cells.

Figure 3.4: Average temperature distribution of (a) heavily and (b) lightly soiled modules.

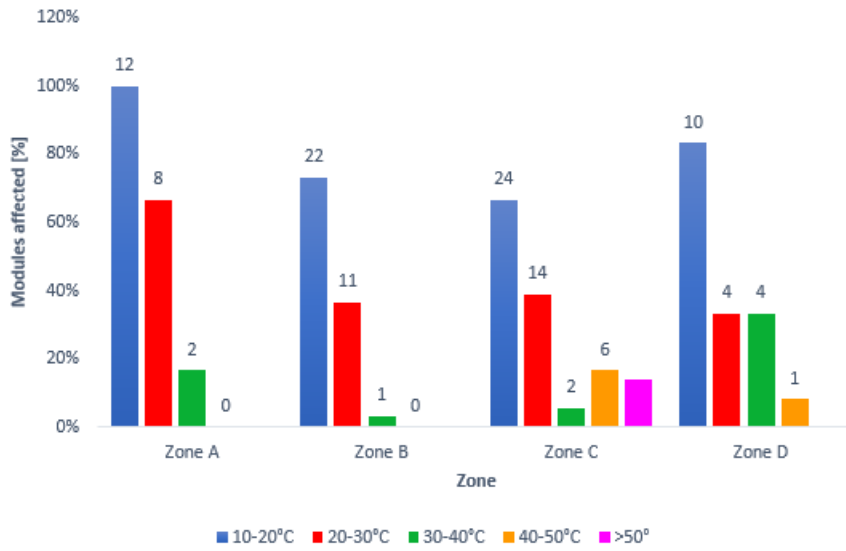
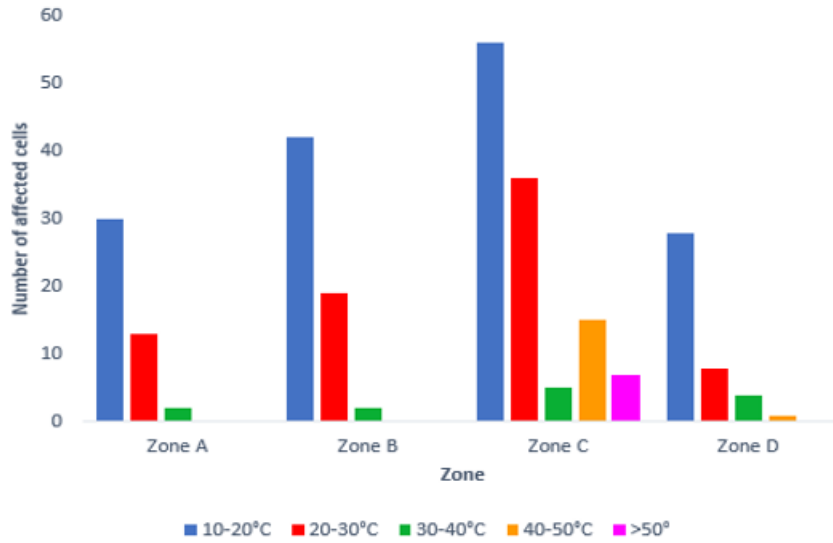
Figure 3.31: Distribution of modules with hot cells, sorted by operating zone.

The amount of modules affected by hot cells and the amount of hot cells on the intervals  $I_1 = [10-20]^\circ\text{C}$ ,  $I_2 = (20-30]^\circ\text{C}$ ,  $I_3 = (30-40]^\circ\text{C}$ ,  $I_4 = (40-50]^\circ\text{C}$  and  $I_5 = > 50^\circ\text{C}$  is shown in Figures 3.31-3.33 (a). The bars indicate the % of modules which show hot cells with respect to the total amount of modules considered for each criteria (zone, manufacturer, time). Above each bar it can be seen the number of affected modules. As it can be seen, when sorting by geographical operating zone, the hottest cells ( $I_5$ ) are found only in zone C, and cells belonging to the range immediately below ( $I_4$ ) are found in the inner zones (valley and inner coast) rather than coastal zones (A, B).

Regarding to hot cells themselves, graphical information is shown in Figures 3.31 to 3.33 (b), and is based on the temperature deviation of cells with respect to the average temperature of the respective modules. By sorting the information in terms of operating zone, it can be seen in Figure 3.31 (b) that the trend is similar to that of modules, but here the amount of hot cells in the range  $I_1$  is the highest for zone C, while modules from zone C were the less affected by hot cells in this range, shown in Figure 3.31 (a). Hence, in this zone a small amount of modules concentrate a big amount of hot cells. The same can be observed in zone B, which shows the second highest amount of affected cells but also the second smaller amount of modules affected, and the inverse occurs with modules from zones A and D, where it can be seen that the hot cells found within range  $I_1$  (30 and 28 respectively) are distributed in (almost) all the modules of the zone sample (12 for each zone).

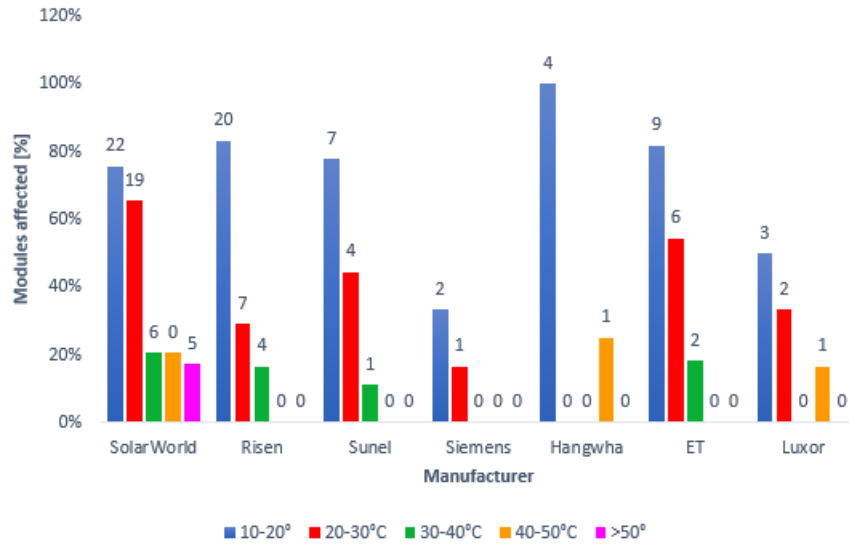
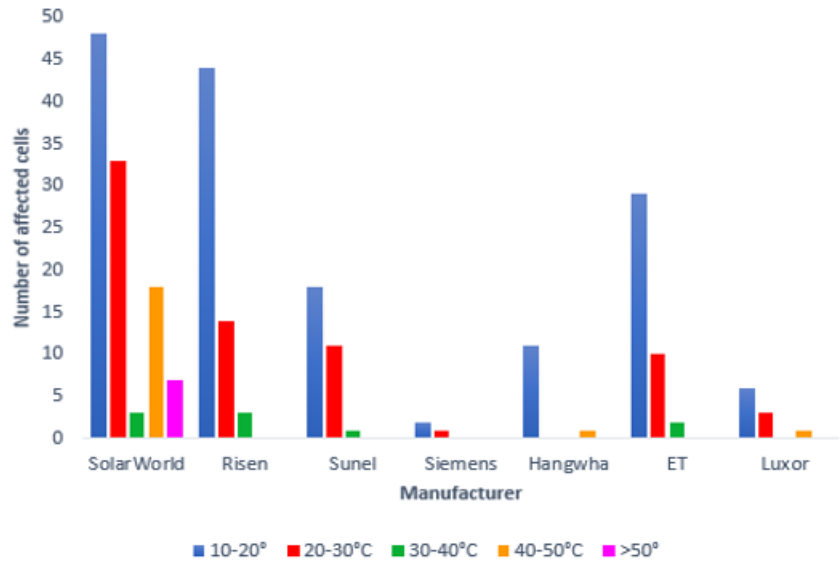
Figure 3.32: Distribution of modules with hot cells, sorted by manufacturer.

Sorting the information by manufacturer, the results show that modules from SolarWorld are the only ones with cells in the range  $I_5$  (17% of the total amount of SolarWorld modules). In the next range, there can be found, apart from SolarWorld, modules from Hangwha (25%) and Luxor (17%). However, given that these samples were only 4 and 6 modules for each manufacturer respectively, these results lack of statistical validation. Moreover, both Hanwgwha and Luxor show only one and two cells in the range  $I_4$  respectively, and in the case of Luxor (module F5, described in section 3.3.1) the thermal profile of the cells is more likely to be related (very roughly speaking) to severe defects such as shunt paths across the cells. Slightly hot cells ( $I_1$ ) were shown by all manufacturers, but this seems to be more related to the processes of cell sorting (when modules are manufactured) for which each manufacturer apply their own selection criteria, and normally power mismatches between cells of the same module less than  $\pm 5\%$  are not considered as harmful [79].

Regarding to hot cells, it can be seen in Figure 3.32 (b) that SolarWorld concentrates the larger amount of hot cells in all ranges, followed by Risen and ET, which show hot cells up to range  $I_3$ . Here, comparing with Figure 3.32 (a) it can be seen that in the case of lower temperature differences (ranges  $I_1$  and  $I_2$ ) the total amount of hot cells is distributed by more than 50% of modules (except for Siemens) and, except for Luxor, more than 70% of the total amount of modules of each manufacturer. In the case of higher temperature ranges, as commented before, certain isolated modules (1 in the case of Luxor and Hangwha) show one or two hot cells. In the case of SolarWorld, as stated before, is the only one that present

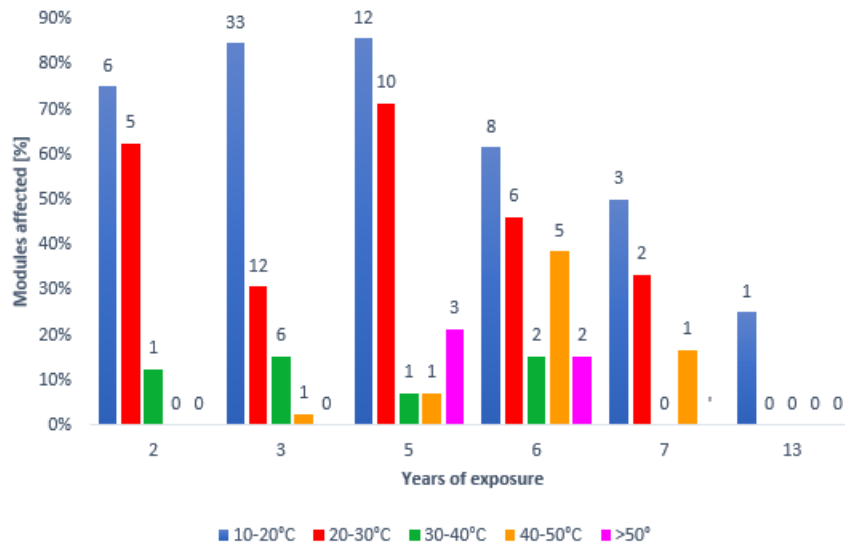
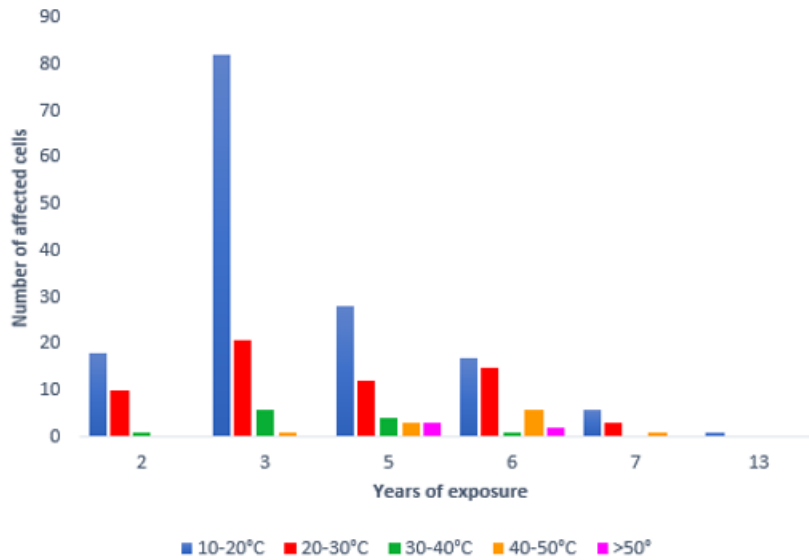
Figure 3.33: Distribution of modules with hot cells, sorted by years of exposure.

Sorting by time of exposure, as shown in Figure 3.33, it can be seen that modules of range I<sub>5</sub> belong to two separate sets, deployed in 2012 (6 years) and 2013 (5 years) respectively. As discussed in previous paragraphs, these modules belong to only one manufacturer (SolarWorld) and are located exclusively in zone C. Regarding to the remaining temperature intervals, the trend associated to manufacturer is still evident (for I<sub>4</sub> only Luxor, SolarWorld and Hangwha, deployed in 2011, 2012-2013 and 2015 are found), and the only modules that did not show temperatures higher than range I<sub>1</sub> belong to Siemens (2005).

For cells, when sorting by time of exposure, it can be seen in Figure 3.33(b) that hot cells

belonging to range  $I_1$  are by far more numerous (82 hot cells in total) for those modules deployed in 2015, distributed in the 85% of modules deployed that year, comparing with Figure 3.33 (a). For modules deployed in 2013 (5 years) 86% of them show hot cells (12 modules), and they concentrate 28 hot cells. In the second range  $I_2$  the largest amount of hot cells is again found for 3 years old modules (21 cells in 12 modules), while for higher temperature cells the amount of affected cells decreases for all intervals (less than 10).
