## Performance of the Torre Bosquemar and Olas buildings in San Pedro de la Paz and the Pedro de Valdivia building in Concepción in the 27 February 2010 offshore Maule, Chile earthquake

### SUMMARY

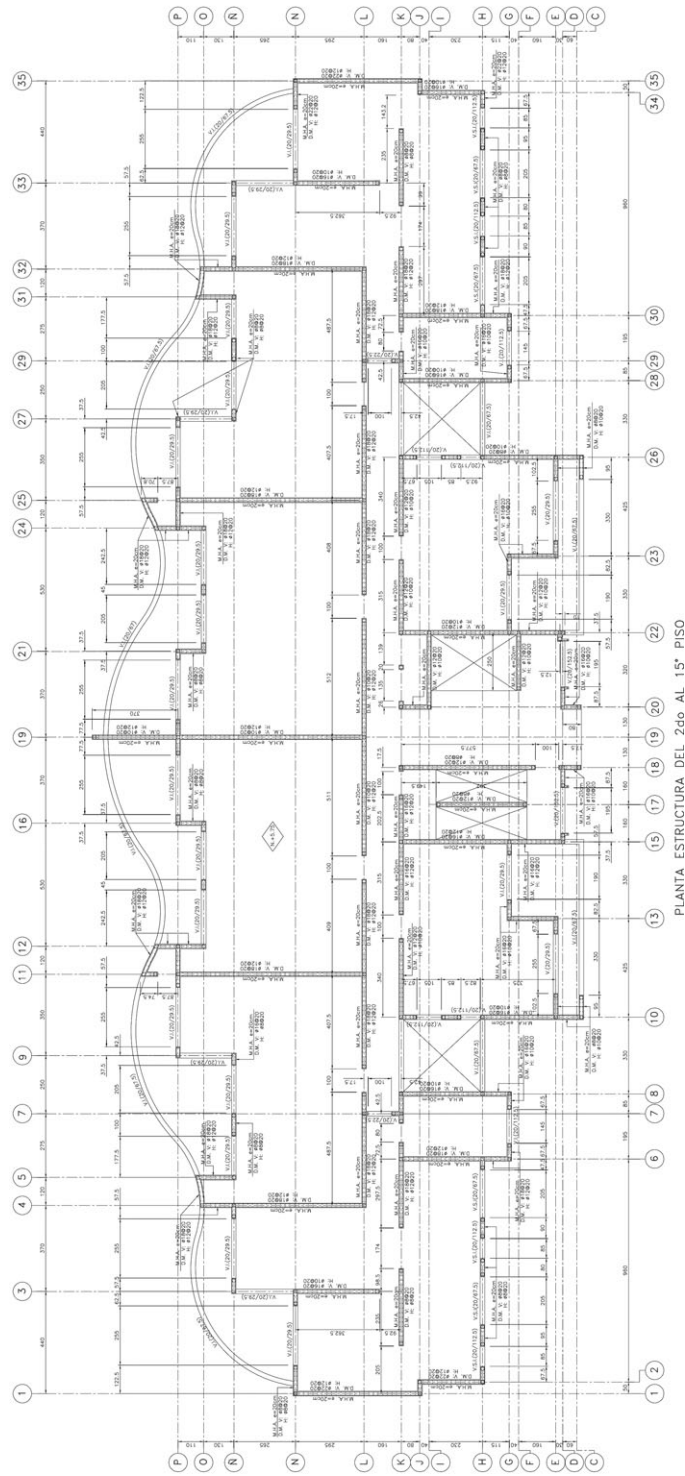
Figure 7. Typical plan for second to 15th floors.

Another location of significant damage occurred along the entrance side of the structure, facing inland. Significant cracking was seen along both walls of the entrance lobby as shown in Figures 12 and 13. Referencing Figure 7, these walls span along gridlines 15 and 22 from line K to D above the first floor. However, at the first floor, these walls extend out from the front face of the tower as seen in Figure 8, creating a vertical discontinuity and an outrigger effect.

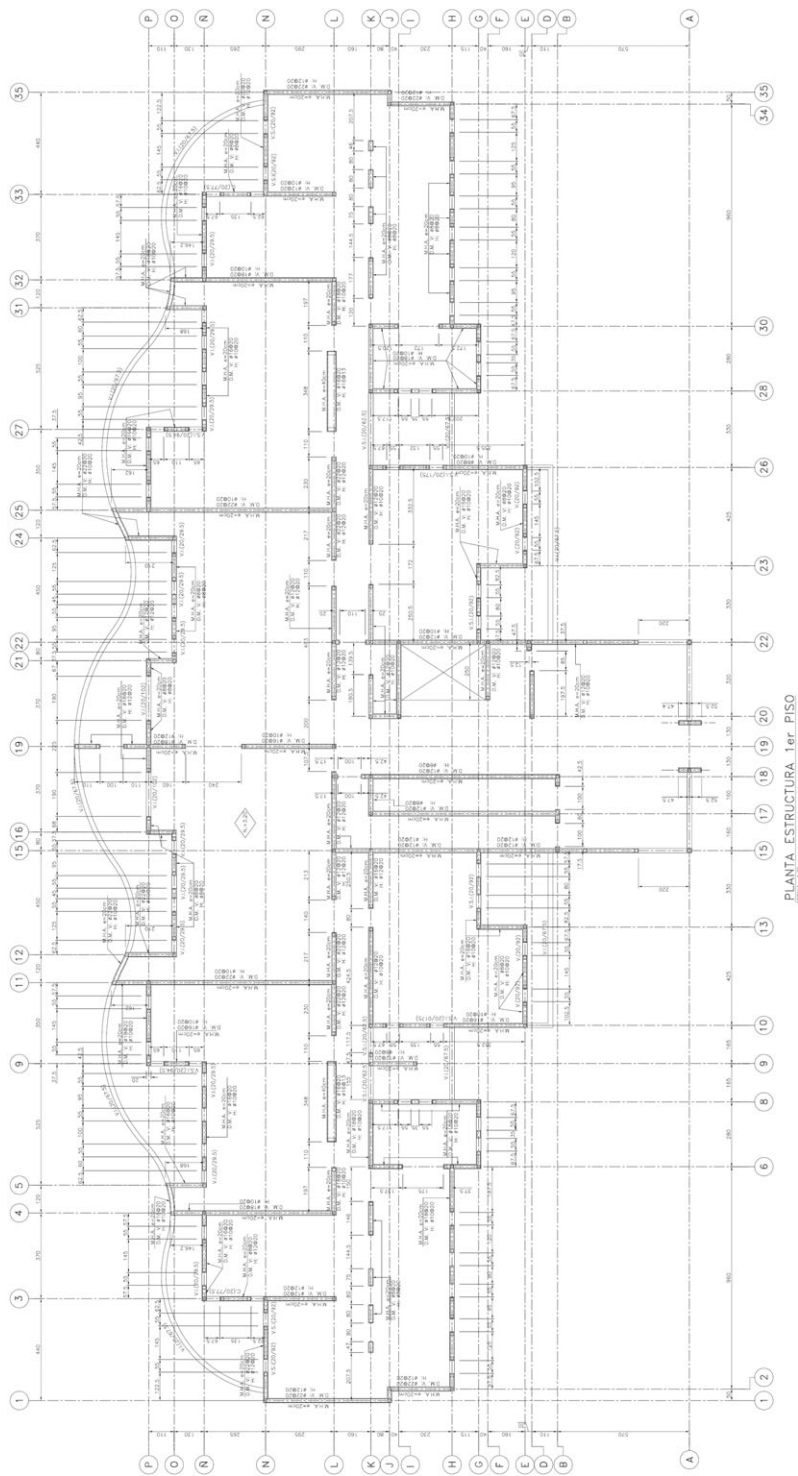
Figure 8. Floor 1 plan.

One of the more substantial cases of concrete crushing that resulted in the rupture of vertical bars was within an interior wall shown in Figure 16. This damage occurred at the first floor along line L on the wall centred along line 22 (refer to Figure 8). The large crack turns horizontal, with noticeable vertical bar buckling along its entire length until the edge, where both the vertical bars as well as the transverse bars confining them were ruptured as shown in Figure 16(b).

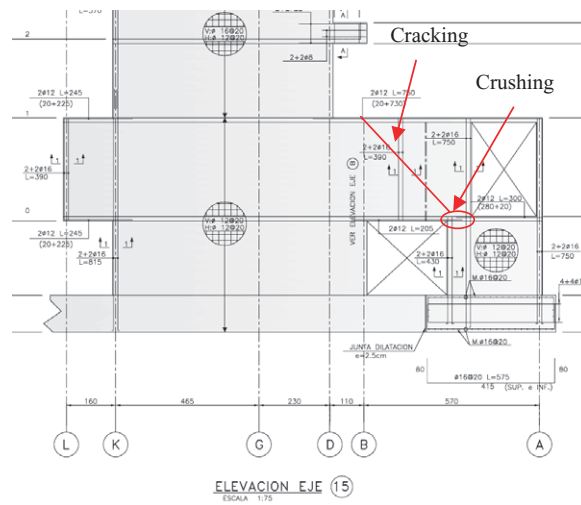
Figure 14. Elevation of gridline 15.

The elevation along gridline 15 (Figure 14) reveals that an opening exists directly under the diagonal cracking. While the extended wall acted similar to an outrigger and attracted large demands from the walls above, there is not a suitable load path down the through the structure for these large demands. This results in the concrete crushing shown at the edge of the ground level wall near the opening (Figure 15) as this crushing is occurring at the only location where there is another concrete wall underneath that is able to continue the load path down to the foundation.

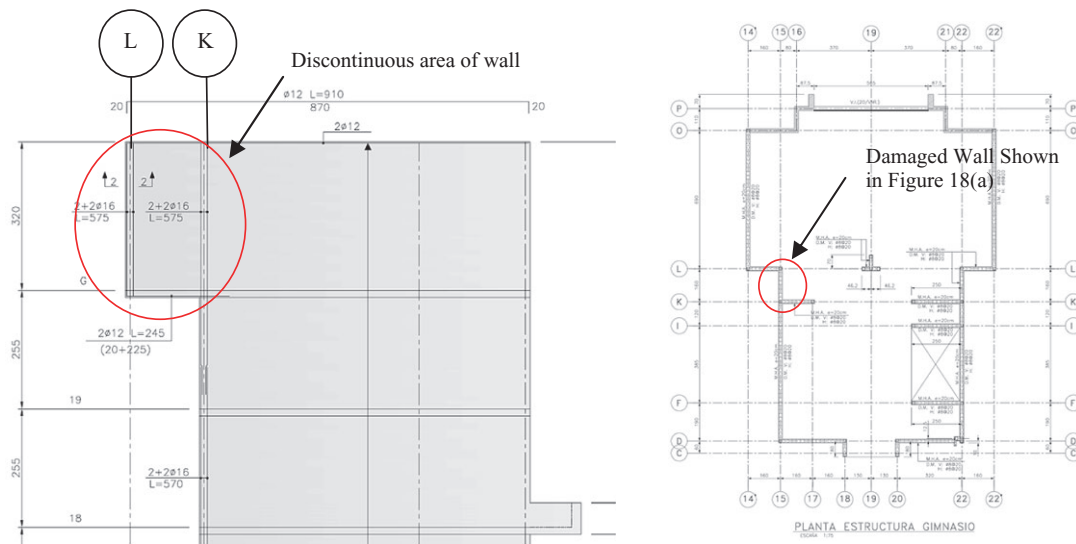
Figure 19. Elevation and plan of damaged wall.

The most substantial wall cracking observed in the upper floors came at the top of the structure in the gymnasium area as shown in Figure 18(a). This was another case of a vertical discontinuity in a shear wall. The location of the damaged wall is shown in plan and elevation in Figure 19. The portion of wall that is damaged does not continue to any of the lower floors below the gymnasium level but

is restrained by the wall along line L, which most likely caused large shearing demands through this short length of wall, resulting in the severe vertical cracking only over a limited section of the wall shown in the image. The bottom of the wall, where the largest amount of concrete spalling occurred, was a lap splice location as shown in Figure 18(b).

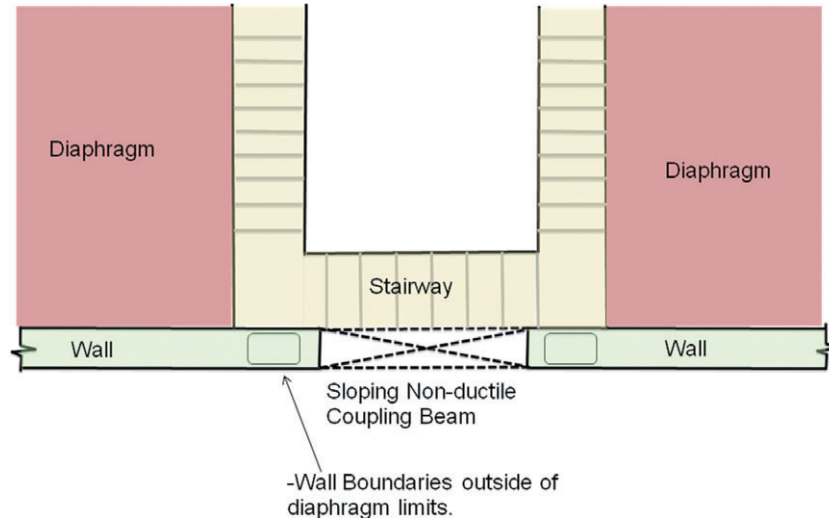
Figure 23. Qualitative plan of stairway and shear walls.

Figure 21 shows the exterior damage that occurred at the ends of the stairwells where the concrete was acting as a sloping non-ductile coupling beam. The interior of the stairwells revealed excessive crushing and spalling of concrete at each edge of the slanted window openings (Figure 22). It also reveals that although the walls on each of the stairwell were detailed with boundary confinement, these boundary zones occur within the span of the stairwell and not within the portion of the wall that is restrained within the structures diaphragm (see plan view in Figure 23).
