## Performance of tall buildings in Santiago, Chile during the 27 February 2010 offshore Maule, Chile earthquake

### SUMMARY

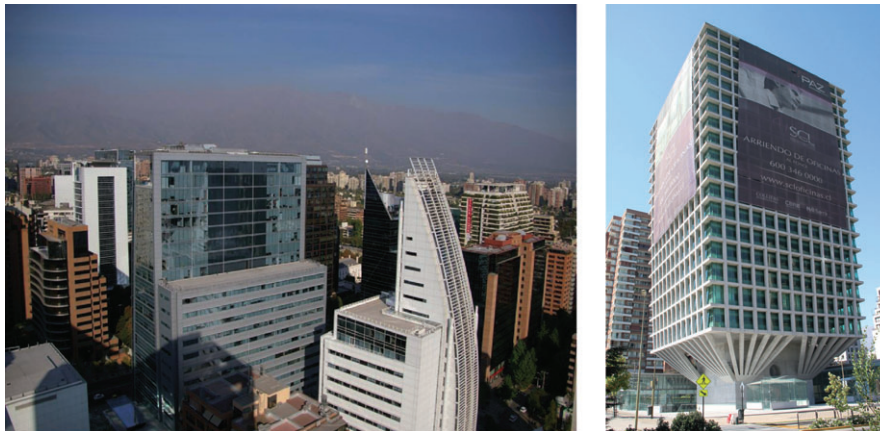
The Santiago skyline is filled with modern tall buildings the great majority of which performed very well during this earthquake and did not suffer any structural damage (Figure 5). This is noteworthy because this paper and most other papers dedicated to documenting damage due to the earthquake concentrate on the performance of damaged buildings, and the reader may be left with the impression that the damages reported were widespread throughout the city. In the case of Santiago, this was definitely not the case as our team had to hunt for damaged buildings, and an ordinary visitor to the city who was not aware of the location of damaged building may have wrongfully concluded that there were no significantly damaged buildings in the city.

Figure 5. The great majority of tall buildings in Santiago did not suffer any structural damage.

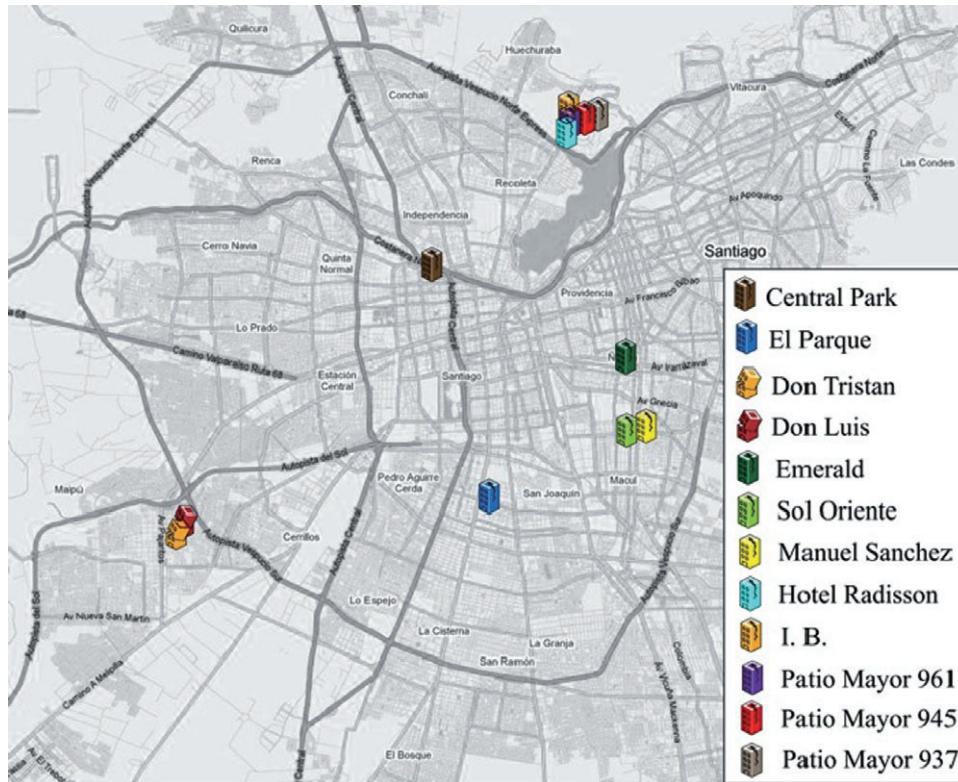
We will begin our review of performance of tall buildings with a look at two buildings that were not damaged, and then we proceed with review of the buildings that did suffer structural damage. Locations of damaged buildings visited by our team are superimposed on the map of Santiago presented in Figure 6.

Figure 6. Location of damaged buildings in Santiago visited by our team. (a) Typical tension-compression failure of the wall (El Parque building). (b) Tearing of main bars at the wall failure zone near the end of the wall; transverse ties typically had only 90° hooks (Sol Oriente building). (c) Lack or shortage of transverse reinforcement and/or inadequate confinement (Empresarial Complex).

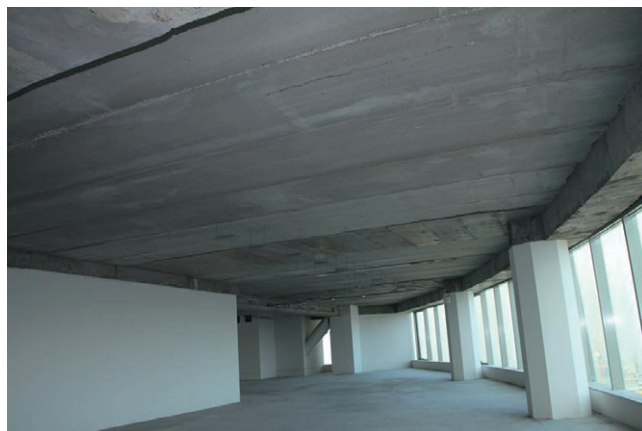
Figure 9. The precast columns and floor system implemented at the Titanium Tower. (a) Connection of damping brace to the floor above. (b) Damping system at the middle of braces. (c) Passing of the damping brace through intermediate floor.

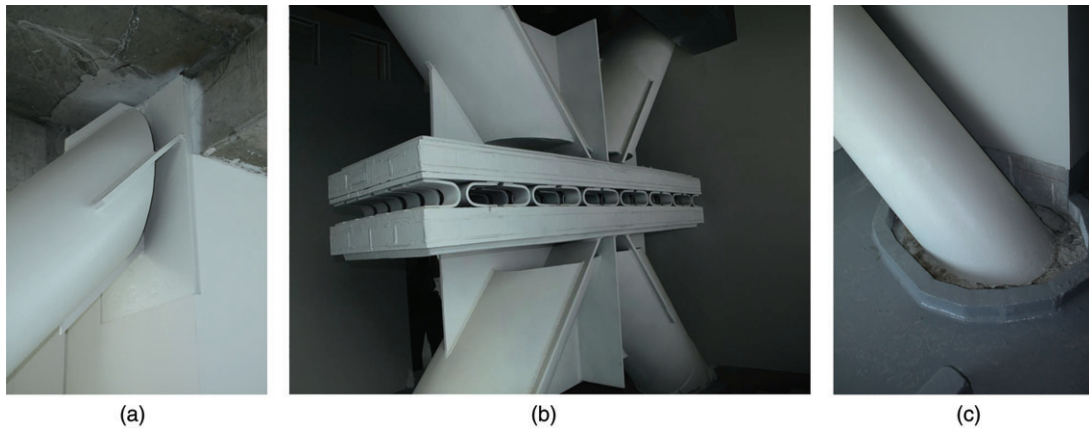
Figure 10. The precast system and passive energy dissipating system implemented in Titanium Tower.

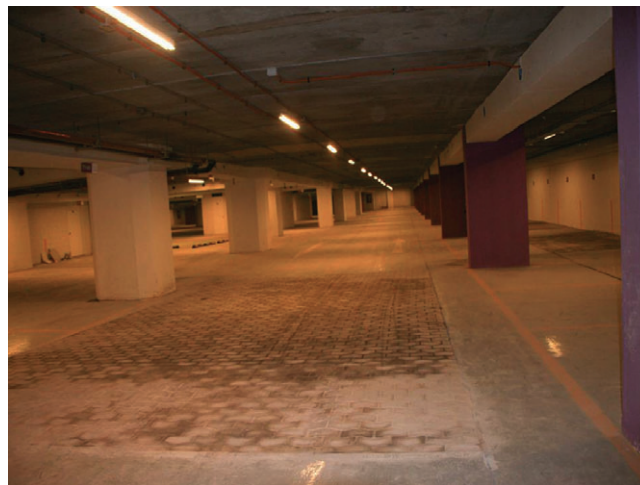
Figure 11. No damage occurred at any of the seven subterranean floors or the basement walls in the Titanium Tower.

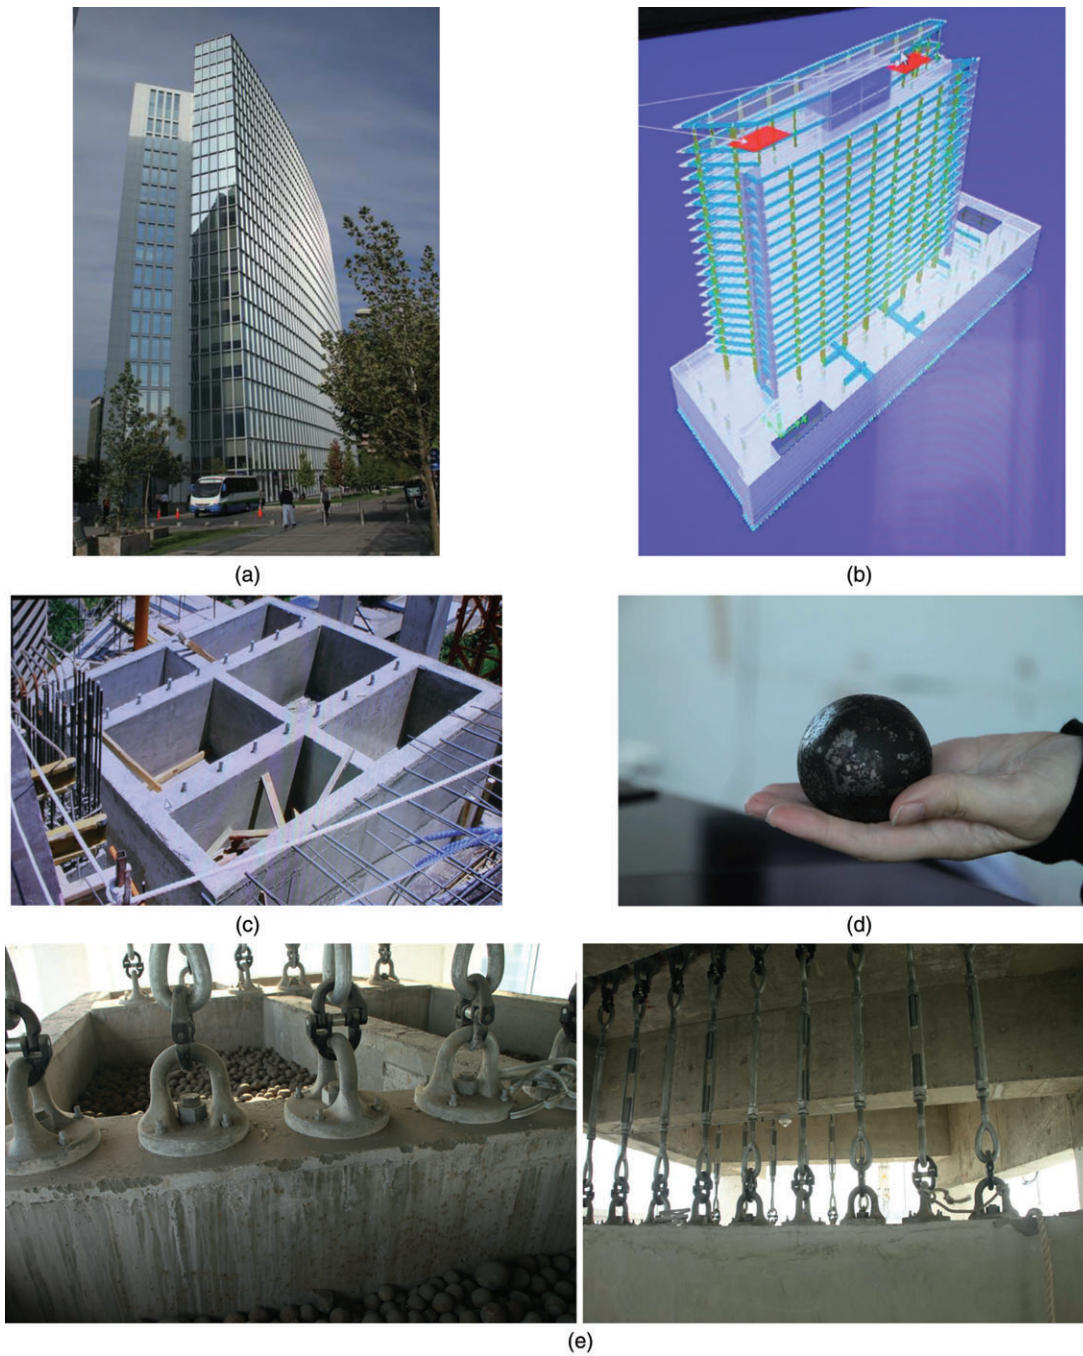
The TMD units were constructed as multi-cell reinforced concrete boxes on the 21st floor, jacked up to the desired elevation and hung from the roof above with a series of bolted plates and then filled with metal balls to attain the desired mass. The system performed very well during the earthquake and the building did not suffer any damages above the ground or at any of the six subterranean floors and basement walls.

Figure 12. The Parque Araucano building and its TMD systems. (a) Post-earthquake view from outside. (b) Computer model with TMDs shown in red. (c) TMD box during construction. (d) Size of metal balls filling the TMD cavities. (e) Completed and filled TMD hanging from the roof above.

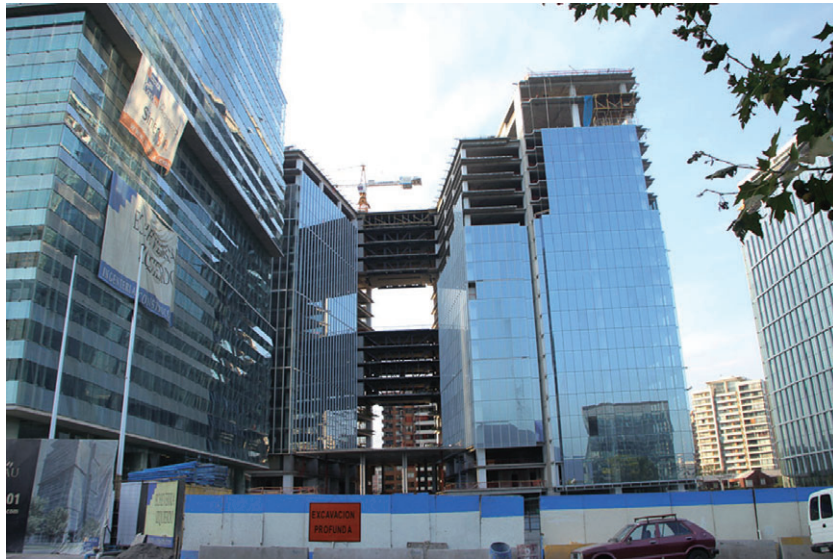
This 22-storey building having 9 subterranean floor levels was under construction when the earthquake occurred. The building consists of two separate wings that were interconnected by a series of bridges at several floors (Figure 13).

Figure 13. The Echeverria Izquierdo Building.

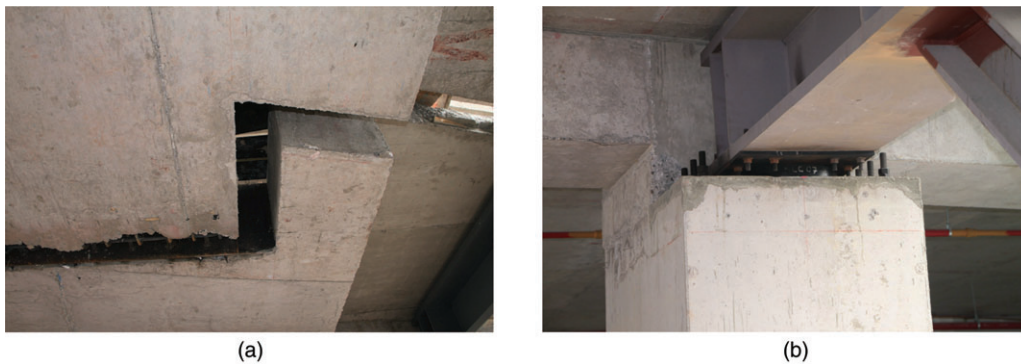
This is a reinforced concrete building with a post-tensioned system deployed for the bridges connecting the two wings. Although a large gap and isolation bearings were placed to protect the bridge from the adverse effects of the relative movement of the two wings (Figure 14), it appears that the likelihood of buildings moving towards each other was not properly contemplated either during design or implementation. As a result, during the earthquake, there was relative movement of the wings and damage was observed at the bridge–wing interfaces (Figure 15).

Figure 14. Bridge Details. (a) Separation gap at the bridge-wing junction. (b) Isolation bearing supporting the bridge truss.

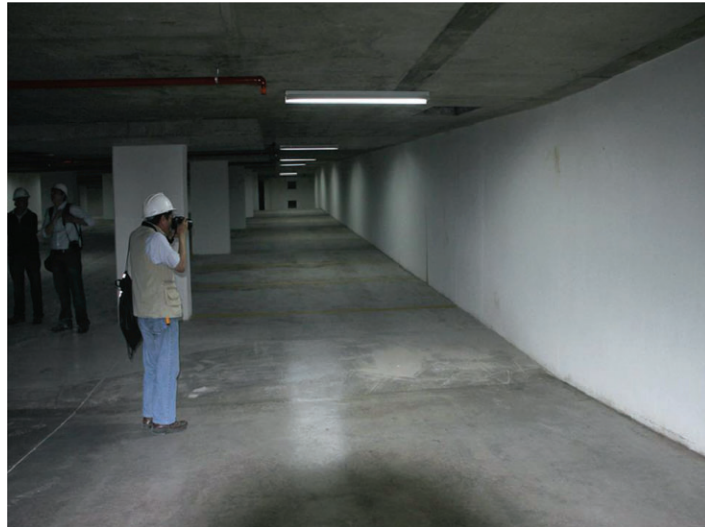
Inspection of the subterranean levels below grade found no evidence of any damage to the lower floors or the deep basement walls as shown in Figure 16.

Figure 16. A photo of the Echeverria Izquierdo building at the ninth subterranean floor where no damage was observed to basement walls or floors.

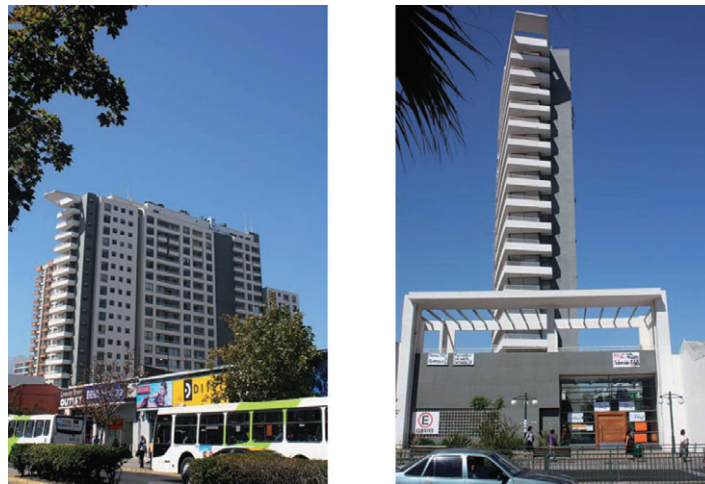
There are two 16-storey buildings on this site with similar general geometry. One of the buildings was significantly damaged while the other one was not. The buildings have a narrow front in the transverse direction (plan dimension of about 7 m) that widens towards the back (plan dimension of about 14.5 m). The plan length in the longitudinal direction is about 56.5 m. With a ground-to-roof height of about 52.6 m, the largest aspect ratio of the building is about 8 to 1 which makes it very slender and susceptible to potential overturning issues (Figure 19). Our cursory review of the plans of the two buildings at the site revealed a difference in termination of the walls, where in the damaged building, a long wall was interrupted at the level immediately above the ground, transferring its load to two perpendicular walls of significantly shorter length. These shorter walls were severely damaged (Figure 20).

Figure 19. Views of the Emerald Building.
