Performance of tall buildings in Concepción during the 27 February 2010 moment magnitude 8.8 offshore Maule, Chile earthquake

SUMMARY

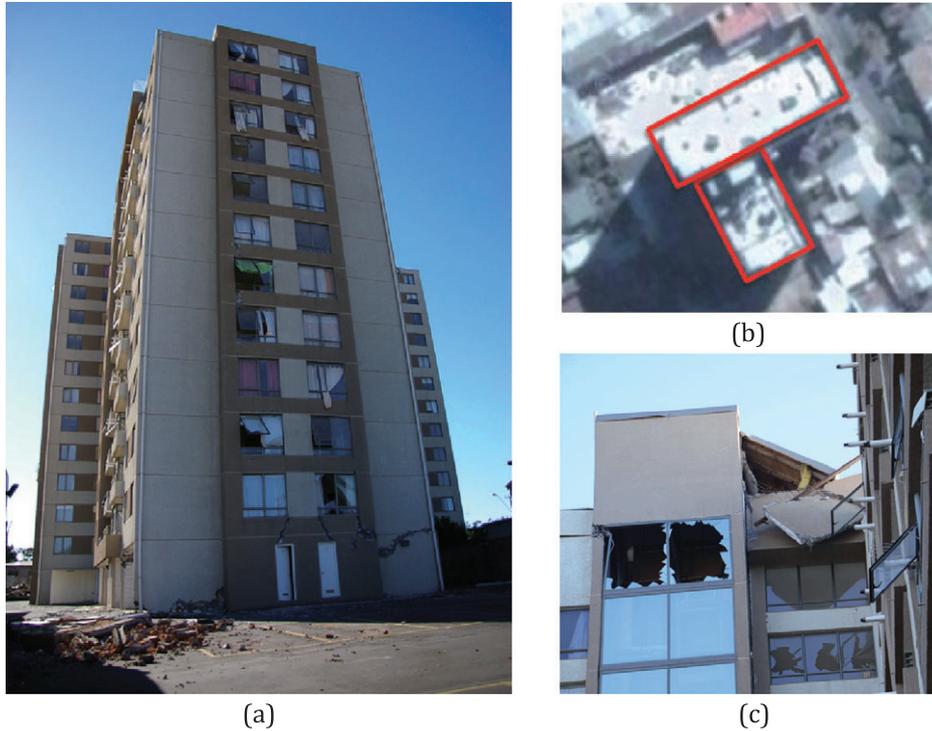
This L-shape reinforced concrete building is 13 storeys in height with no basement and consists of two structures separated with a seismic joint (see Figure 11). The two structures or wings are shown in Figure 11b. The south wing suffered more severe structural damage than the other wing.

Figure 11. (a) Elevation view of Building A (b) Plan view (Google Maps, 2010), (c) seismic joint between the two structures.

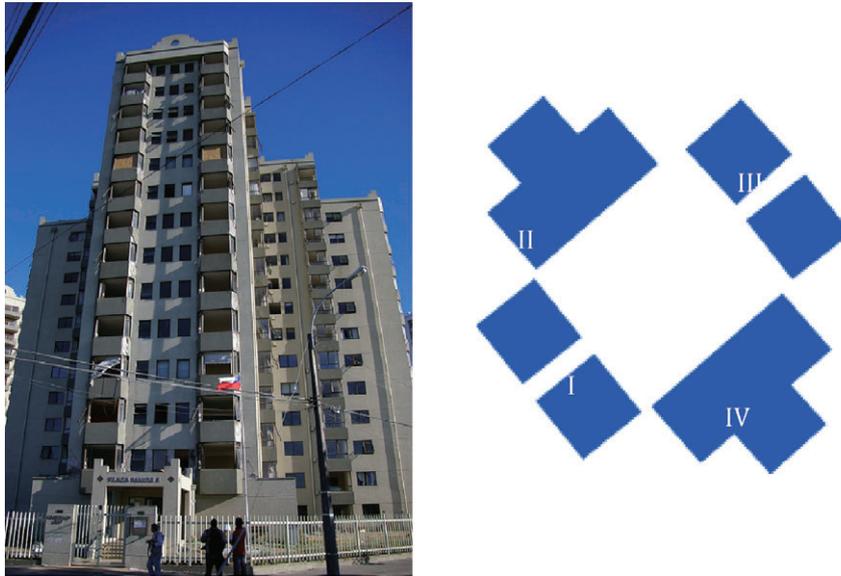
Plaza Mayor is a complex of six reinforced concrete buildings that was built in four phases. Figure 14 shows the layout of the six buildings; Plaza Mayor I and Plaza Mayor III consist of a single each and Plaza Mayor II and IV consist of two buildings each.

Figure 14. Plaza Mayor I (left) and plan view of Plaza Mayor complex (right).

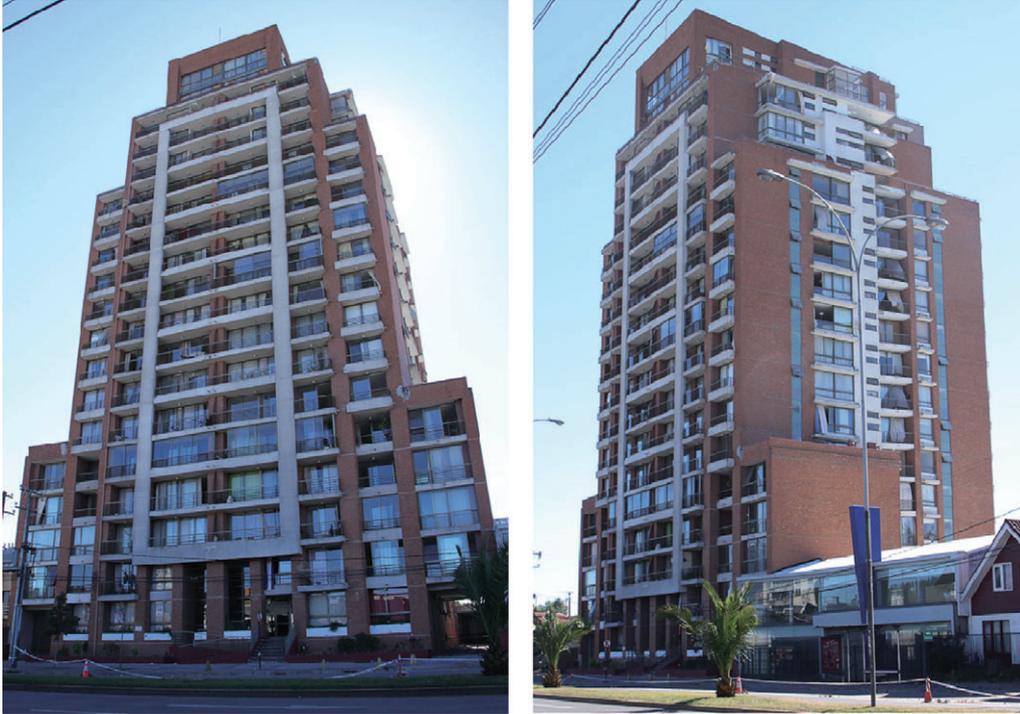
The Alto Arauco II is an 18-storey reinforced concrete building without a basement. The structural system is a wall system. This structure suffered severe structural damage in the first floor of the building and at the fifth floor where some irregularities in plan configuration occur as shown in Figure 19.

Figure 19. Front (south) and Right (east) elevation of Alto Arauco II.

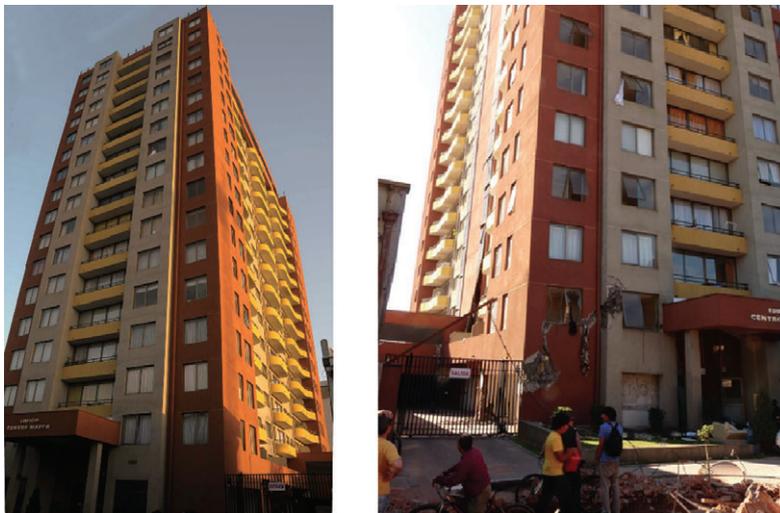
Figure 22. Elevation View Building D (La Tercera, 2010).

The Centro Mayor is a 17-storey reinforced concrete building without a basement, with plan dimensions of 17 m by 45 m (Betanzo, 2010); this building suffered damage in the first and second floors (Figure 22).

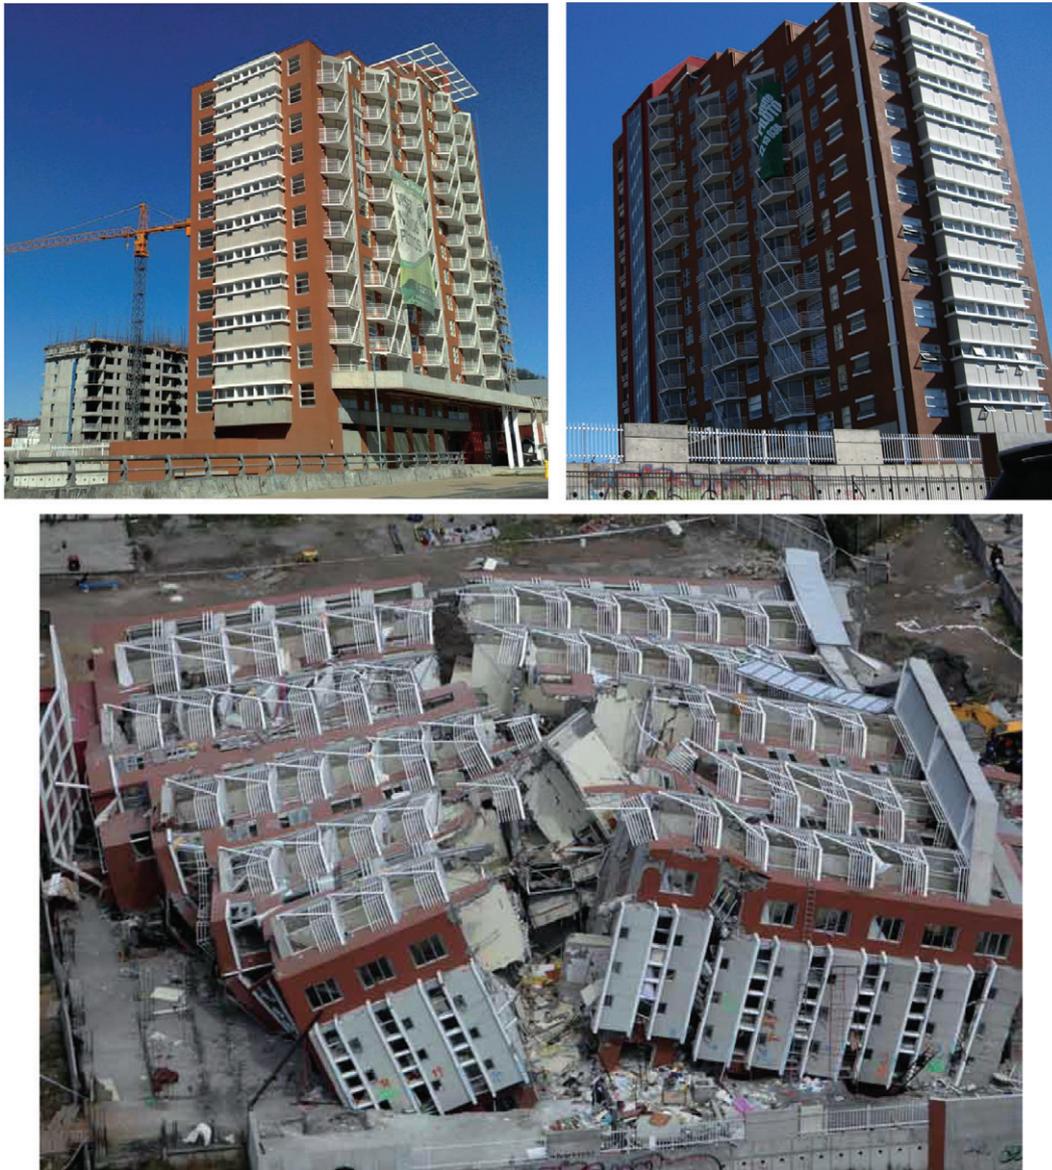
The Alto Rio is a 15-storey reinforced concrete building with two underground levels that has a structural wall system, see Figure 33. This was the only building over three storeys in height that completely collapsed in the area of Concepción during the earthquake. At the moment of the earthquake, there were 87 occupants in the building; there were 8 deaths with 79 survivors, of which 52 persons were able to evacuate the building on their own, and the remaining 27 were rescued from the debris (El Mercurio, 7 March 2010).

Figure 33. Views of the west and east sides of the building before the earthquake (Concepcion under Construction, 2010) (top), aerial view of the collapsed building (bottom) (El Periodista, 2010).
