Article

Inspection Data Collection Tool for Field Testing of Photovoltaic Modules in the Atacama Desert

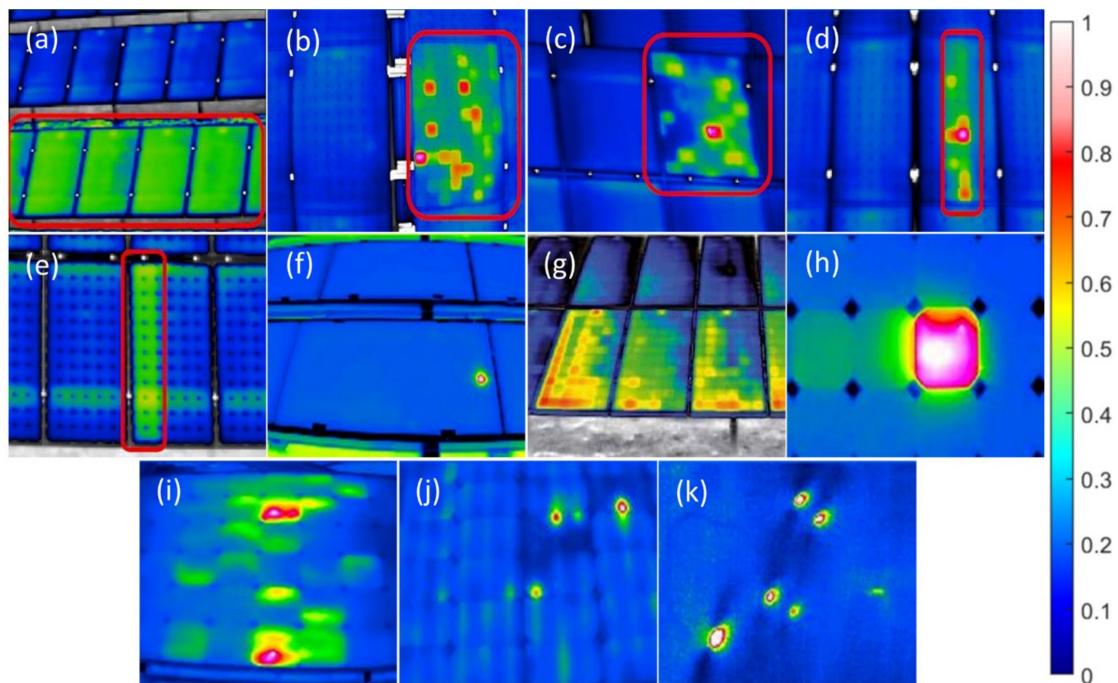
Figure 13 shows the number of modules having specific thermal patterns, which are sorted by zone; whereas Figure 14 depicts the corresponding thermal patterns [33–36] described in Table 2. In zone A, half of the modules (60) presents a short-circuit pattern and the other half (6) exhibits an uncertain pattern. It cannot be determined whether those 6 modules have a short-circuit pattern or PID, even observing the electrical and visual data. Regarding zone B, 75.9% of the modules present a short-circuit pattern, 2 modules present PID, 2 modules present a hot cell, 1 module shows a short-circuit pattern and indicating heating due to bird drop. In zone C, 77.8% of the modules present the short-circuit pattern while the remaining 22.2% present hot cells. Finally, in zone D all the modules present the patchwork pattern due to short-circuit condition.

Figure 14. Summary of considered thermal patterns [33–36], which are described in Table 2.
