International Journal of Architectural Heritage

Conservation, Analysis, and Restoration

Revealing Earthquake-Resistant Geometrical Features in Heritage Masonry Architecture in Santiago, Chile

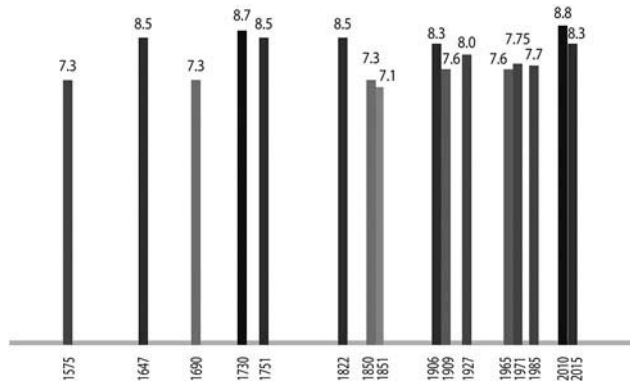
Figure 1. Earthquakes over magnitude Mw7 at their epicenter that have provoked damages in Santiago. (Based on information from the Chilean National Seismological Centre).

Sixteen earthquakes over a magnitude of Mw7 with an epicenter near Santiago have been registered since the Spanish foundation of the city in 1541 (Figure 1). The strongest registered were in 1647 and 1730 and were considered the largest earthquakes of the colonial period; in both cases, the city had to be completely reconstructed. The earthquake of 1647, called the “Magno Earthquake” of Mw8.5 “devastated the city of Santiago and killed approximately a thousand people, one-fifth of its population”¹ (Montessus of Ballore 1912, 18 in Cisternas 2012, 25). According to chronicles, the city was left “without buildings remaining or churches in which to celebrate the divine offices, or houses to be able to live in, or walls that did not threaten danger”² (Hearers of Santiago 1648 in Gay 1852, 456). The earthquake of 1730 of Mw8.7 devastated Santiago again, especially destroying religious buildings

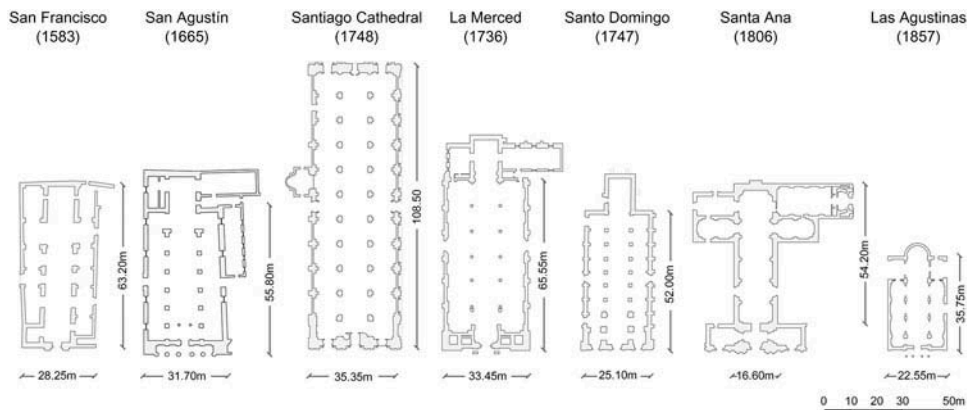
Figure 7. Comparative plans of churches.

the exception of *Santa Ana*, which has a cross-shaped plan that makes it much more vulnerable than the other churches in confronting seismic actions. In four of the cases, the plan is symmetric with respect to their longitudinal axis, with the exception of *San Agustín*, *La Merced*, and *Santa Ana* (Figure 7), due to the later addition of lateral chapels. This addition, nonetheless affects the symmetry, reduces the free-length of perimeter walls and controls the out-of-plane mechanism.

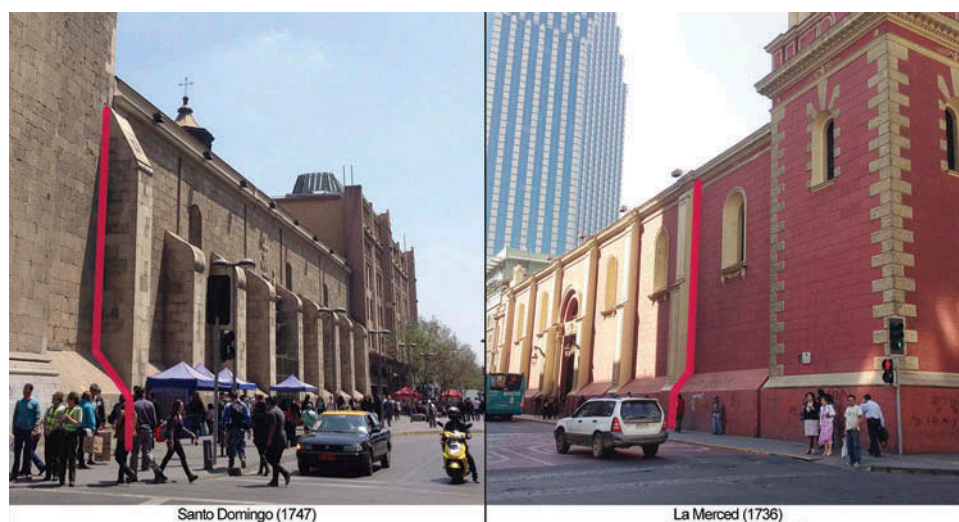
Figure 9. Buttresses and base reinforcement in the churches of Santo Domingo and La Merced.

La Merced, built after the earthquake of 1730 presented plinths in the base of the longer walls, which help to lower the center of gravity of the building (Figure 9), resist the overturning of the entire volume, and improve the in-plane and out-plane capacity of the walls.

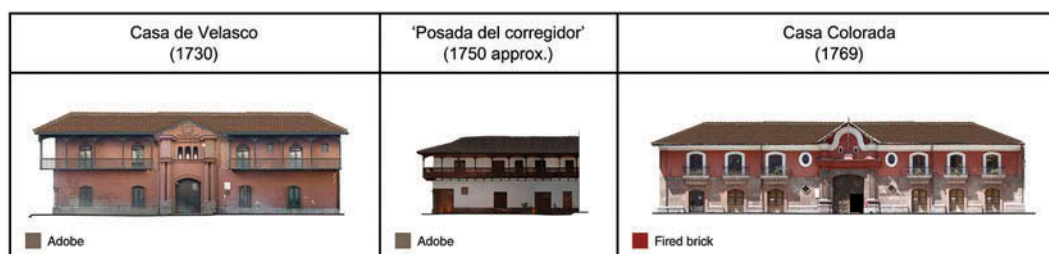
Figure 10. Photogrammetry survey of colonial two-story houses.

Two-story colonial houses are a typology that represents the high standard of housing during the 18th century. Today there are only three remaining houses of this typology in the Colonial historic center of Santiago: two of them built in adobe masonry and the newest one of fired-brick masonry. They are, in chronological order: *Casa Velasco* (1730), *Posada del Corregidor* (1750 approximately), and *Casa Colorada* (1769) (Figure 10).

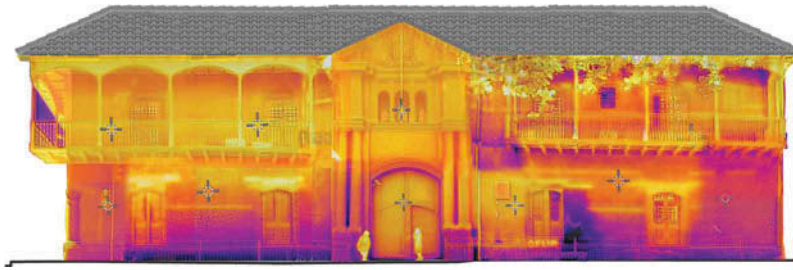
**Figure 13.** Thermographic analysis of the *Casa Velasco*.

were noticed: the non-symmetric distribution of walls and openings in addition to the disconnection of the different units, which generate the separation-of-the-walls-failure mechanism. The *Casa Velasco* is the most vulnerable building from the geometric point of view, but there, disconnections of the parts are counteracted by a wooden hoping that links portions of walls between the openings. This structural device was revealed using thermographic analysis (Figure 13).

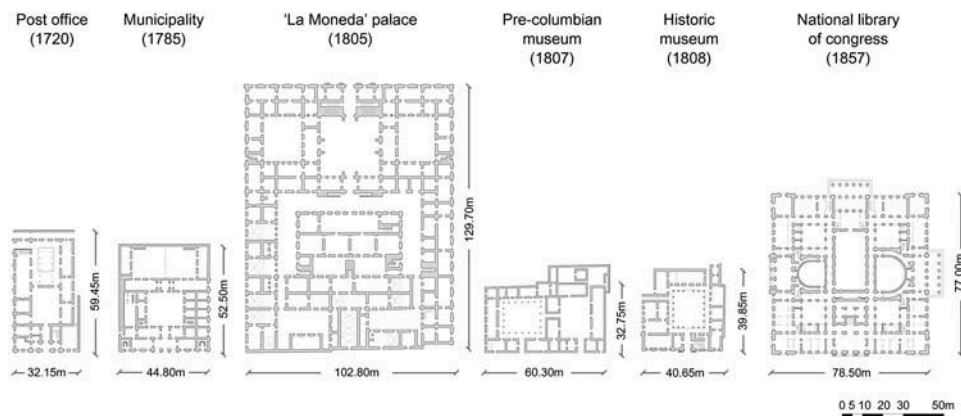
Figure 15. Plans of public buildings.

Public buildings have a simple and orthogonal square shape. Despite being large buildings (with lengths from 32–103 m), they are divided into many small volumes organized around one or more courtyards (Figure 15). All the plans are more or less symmetrical and the ratio of the length/width is one in four of the cases, and two in the current *Post-office* and the *Municipality*. This indicates a similar seismic response in both directions and no torsional problems, since in most of the cases the center of gravity coincides with the center of mass.

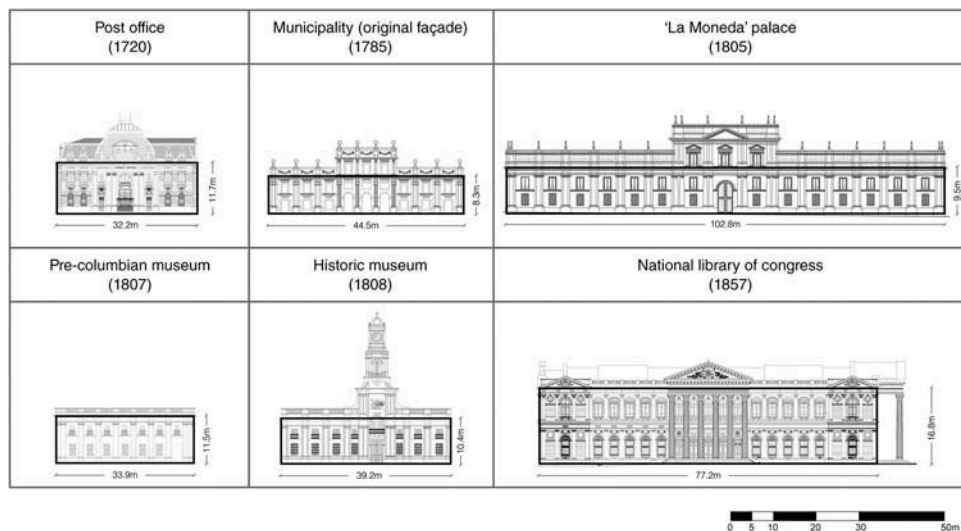
Figure 16. Comparison of elevations and study of proportions of public buildings.

As in the previous typologies, there is a predominance of horizontal shape (Figure 16) with proportions of the ratio height/width of facade volumes that range from 0.09 in “*La Moneda*” to 0.36 in the *Post Office*, values that indicate that no overturning of the buildings should occur during earthquakes. In addition, these values indicate the structures should not suffer amplification of the ground acceleration. Further, all the buildings present upper floors that are smaller and lighter than the ground floor, ensuring a low center of gravity. “*La Moneda*” additionally presents a 4.3 m-thick base plinth around the stairs on the ground floor, which further lowers the center of gravity. Only the *National Historic Museum* (1808) breaks the regular shape on the façade with the presence of a tower, built after the earthquake of 1850.
